DESCRIPTIVE REPORT

Lake Okeechobee

4124 to 4130

DESCRIPTIVE REPORT
A TOPOGRAPHICAL SURVEY OF
LAKE OKEECHOBEE FLORIDA

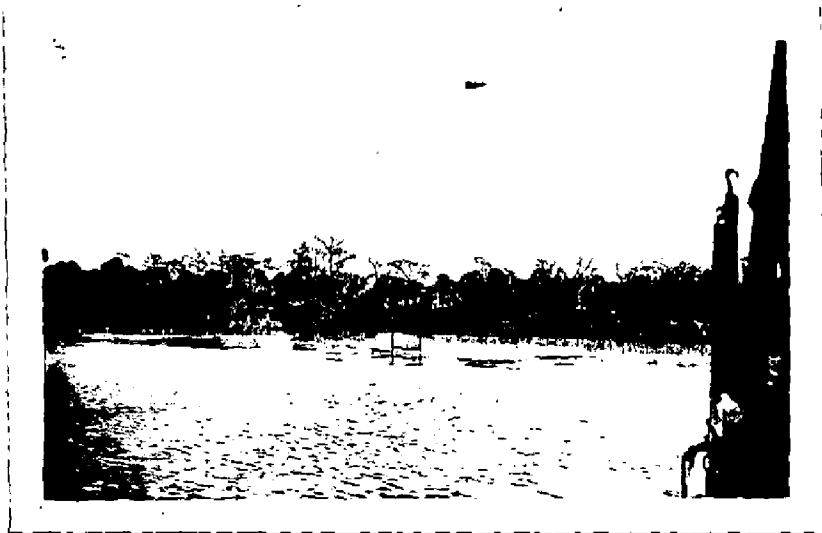
Typical high trees along northern and eastern shores

Around the greater part of the northern and eastern shores of the lake from Eagle Bay to Bacom Point there runs a narrow, comparatively high sandy ridge which is covered with high trees.

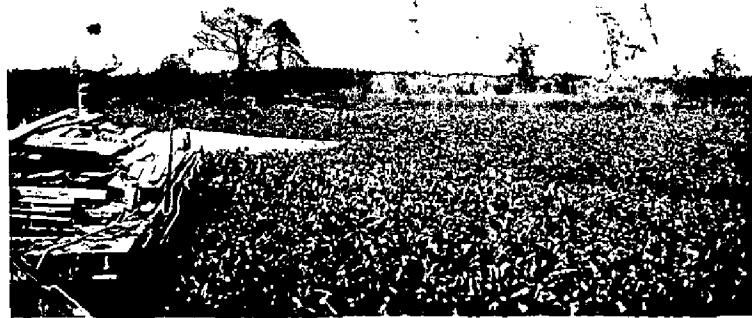
Water hyacinths along shore at Signal Kiss.

The shallow waters along the shore furnish an abundant growth of water hyacinths which float about with the wind and greatly obstruct navigation along some sections of the shore and in various streams. These hyacinths also grow in the streams and float downstream into the lake.
