**DESCRIPTIVE REPORT**

Lake Okeechobee

1924-'25

DESCRIPTIVE REPORT  
A TOPOGRAPHICAL SURVEY OF  
LAKE OKEECHOBEE FLORIDA

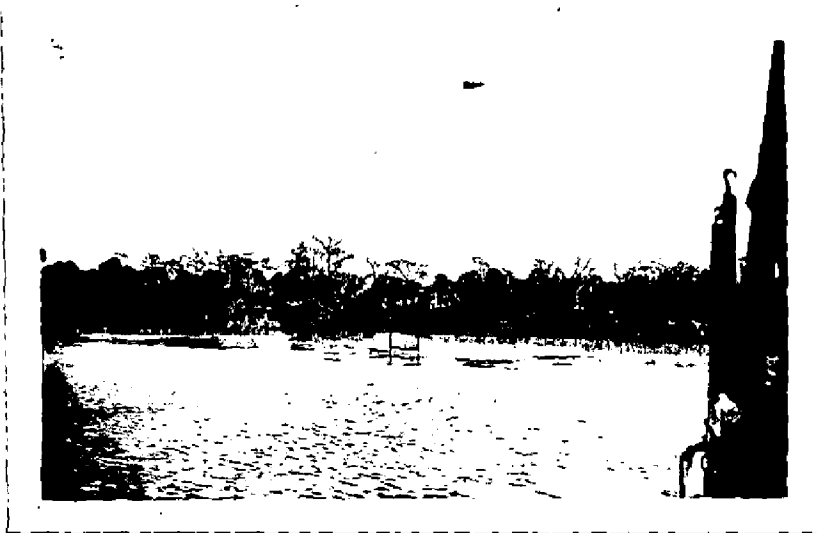
Typical high trees along northern and eastern shores

Around the greater part of the northern and eastern shores of the lake from Eagle Bay to Bacom Point there runs a narrow, comparatively high sandy ridge which is covered with high trees.

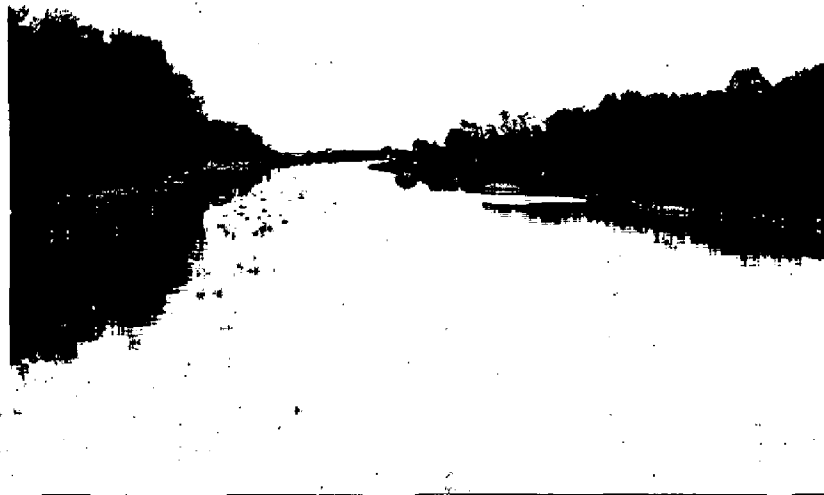
Taylor creek near mouth looking toward lake.
