DESCRIPTIVE REPORT

Form 504 DEPARTMENT OF COMMERCE U. S. COAST AND GEODETIC SURVEY
State: Florida
11-5613
DESCRIPTIVE REPORT.
7 <i>Topographic</i> Sheets No.
LOCALITY:
Lake Okeechobee
1924-'25
CHIEF OF PARTY:
L. D. Graham

DESCRIPTIVE REPORT
A TOPOGRAPHICAL SURVEY OF
LAKE OKEECHOBEE FLORIDA

This report covers seven topographic sheets, A-G inclusive, comprising a topographical survey of Lake Okeechobee, Florida. On account of the common nature of the seven topographic sheets and the information contained thereon, one report is made to cover the entire survey.

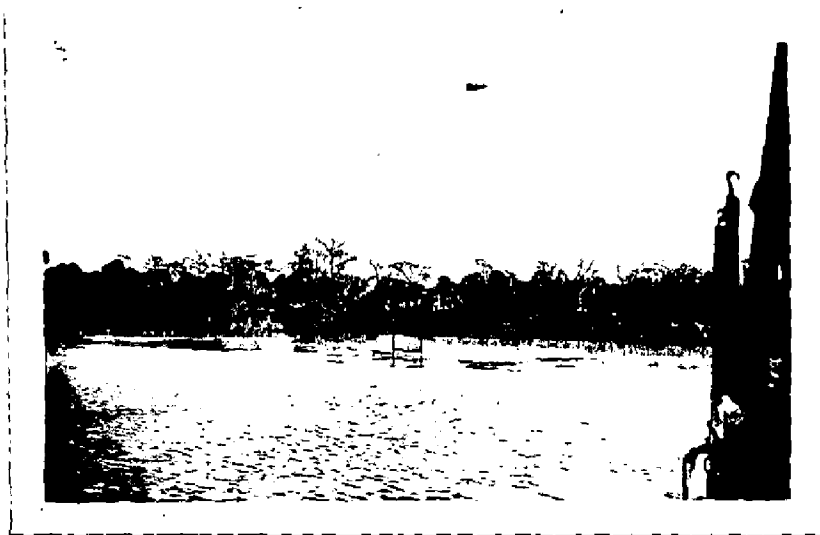
Typical high trees along northern and eastern shores

Around the greater part of the northern and eastern shores of the lake from Eagle Bay to Bacom Point there runs a narrow, comparatively high sandy ridge which is covered with high trees.

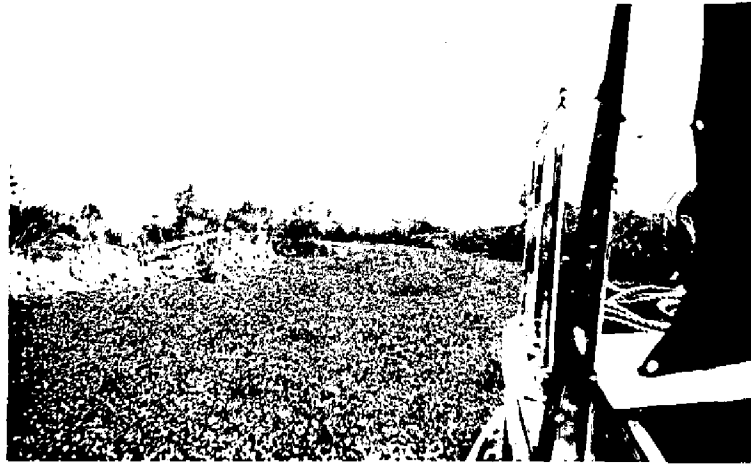
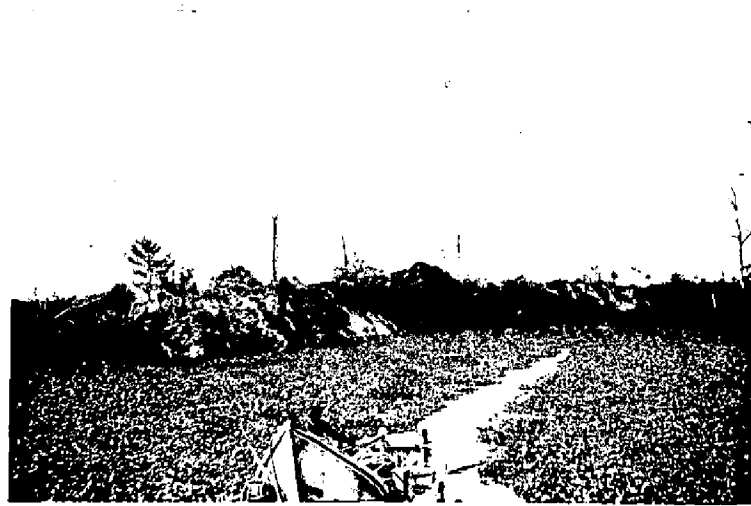
Hyacinths in Taylors Creek.

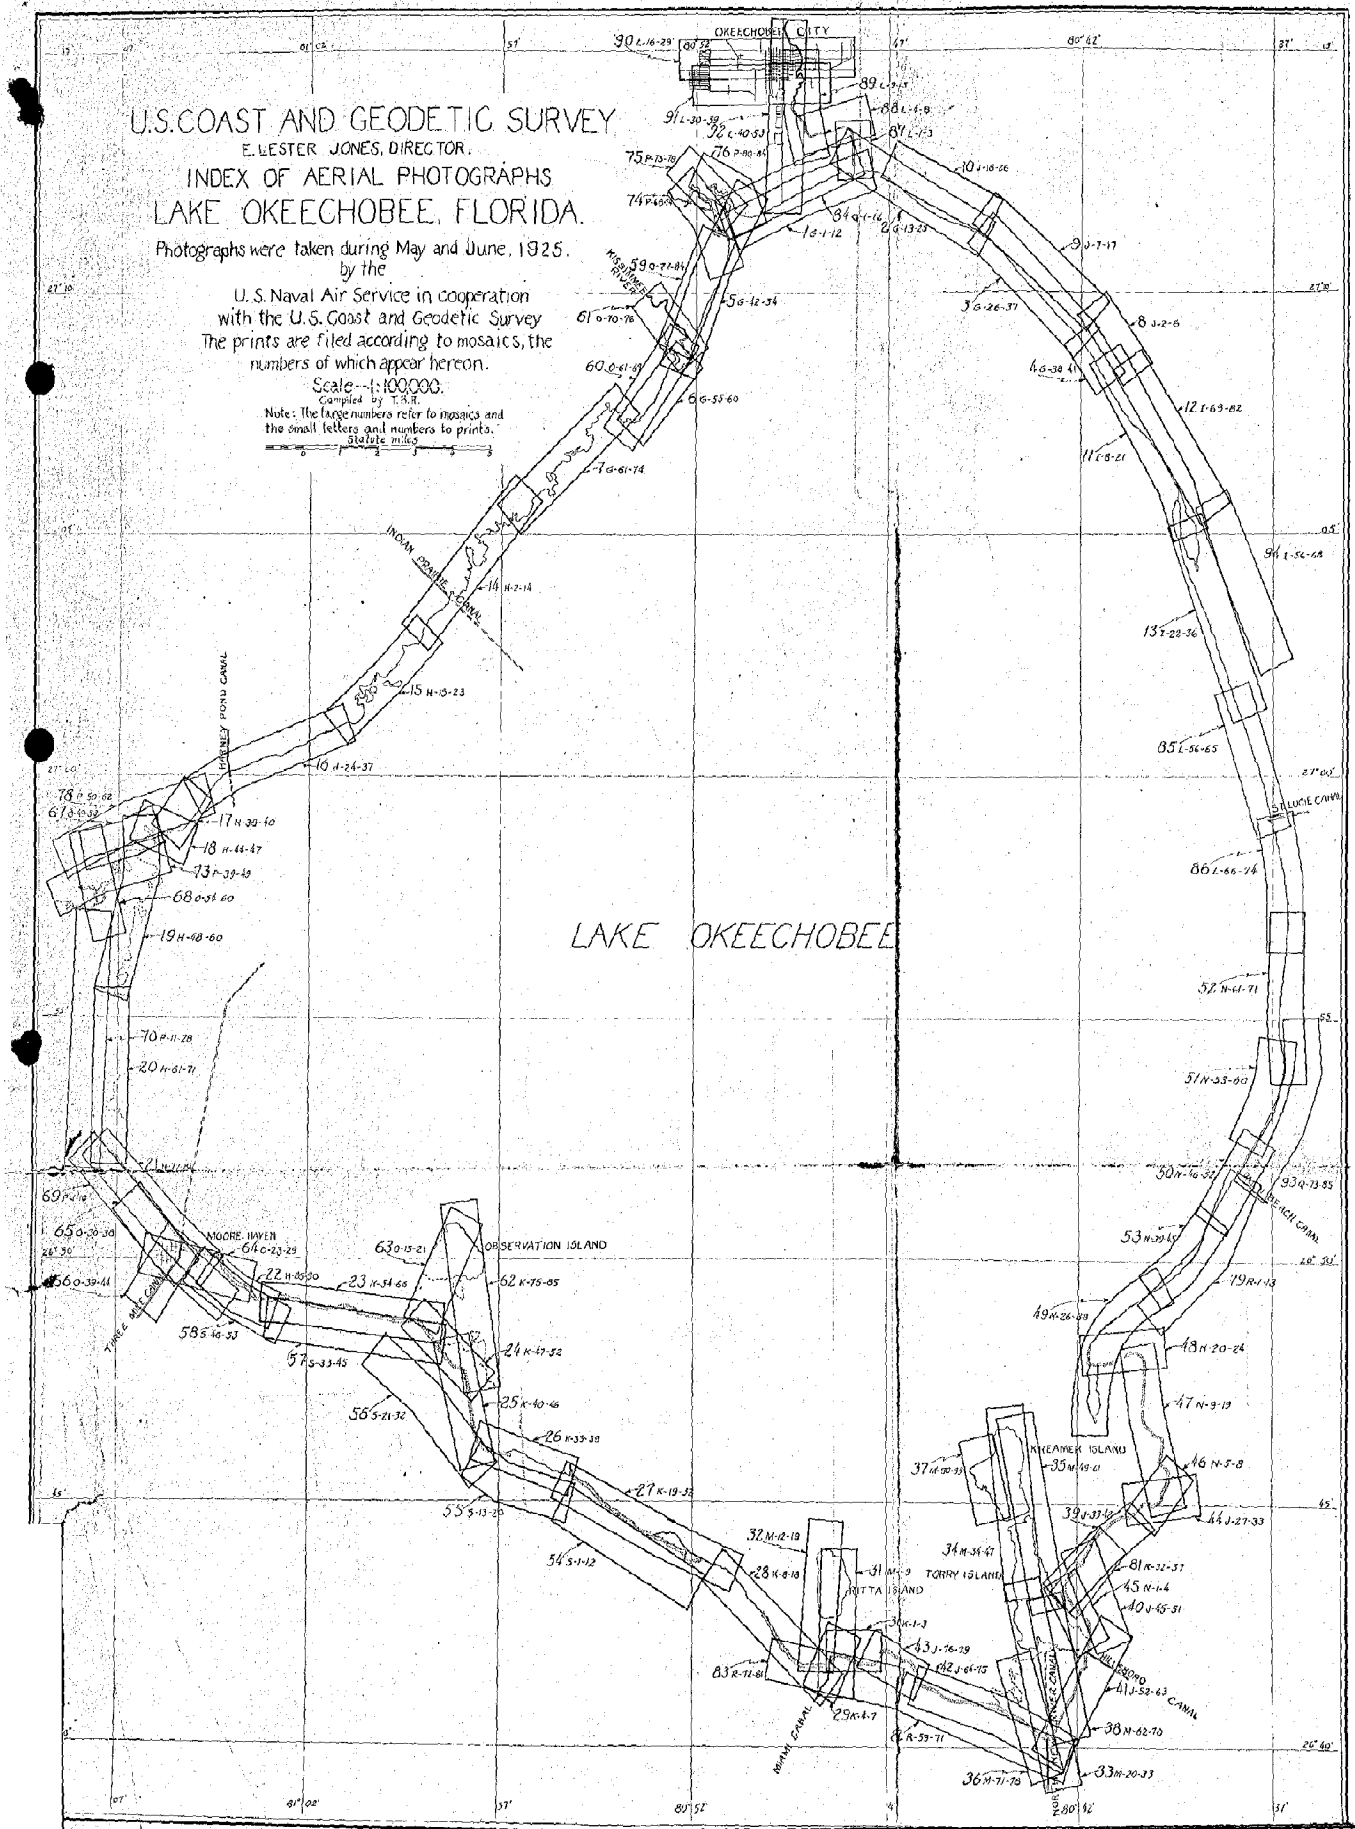
U.S. COAST AND GEODETIC SURVEY
 E. LESTER JONES, DIRECTOR.
 INDEX OF AERIAL PHOTOGRAPHS
 LAKE OKEECHOBEE, FLORIDA.

Photographs were taken during May and June, 1925.
 by the

U. S. Naval Air Service in cooperation
 with the U. S. Coast and Geodetic Survey
 The prints are filed according to mosaics, the
 numbers of which appear hereon.

Scale - 1:100,000.

Note: The large numbers refer to mosaics and
 the small letters and numbers to prints.
 State miles

The survey was executed by aerial photographs taken from a height of six thousand feet by photographers of the U. S. Naval Air Service. An index chart showing the area covered by the photographs is included as page 106 of this report.
