DESCRIPTIVE REPORT

Lake Okeechobee

4124 to 4130

DESCRIPTIVE REPORT
A TOPOGRAPHICAL SURVEY OF
LAKE OKEECHOBEE FLORIDA

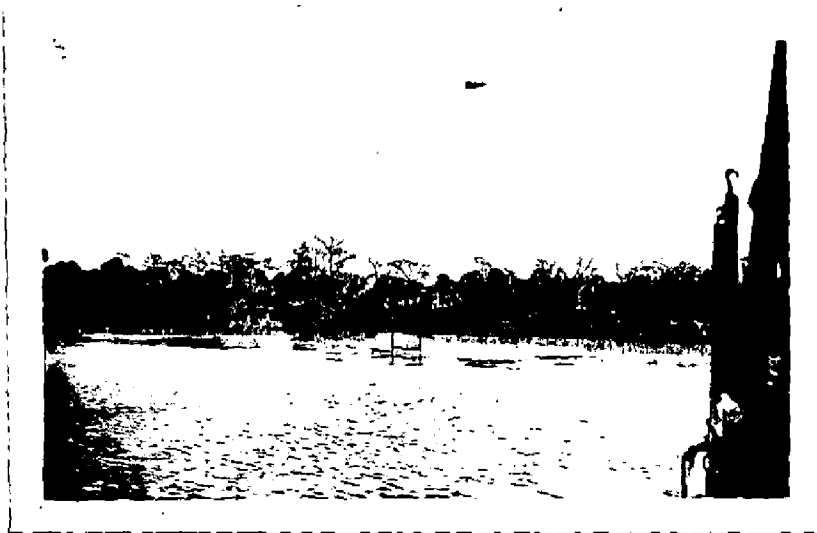
Typical high trees along northern and eastern shores

Around the greater part of the northern and eastern shores of the lake from Eagle Bay to Bacom Point there runs a narrow, comparatively high sandy ridge which is covered with high trees.

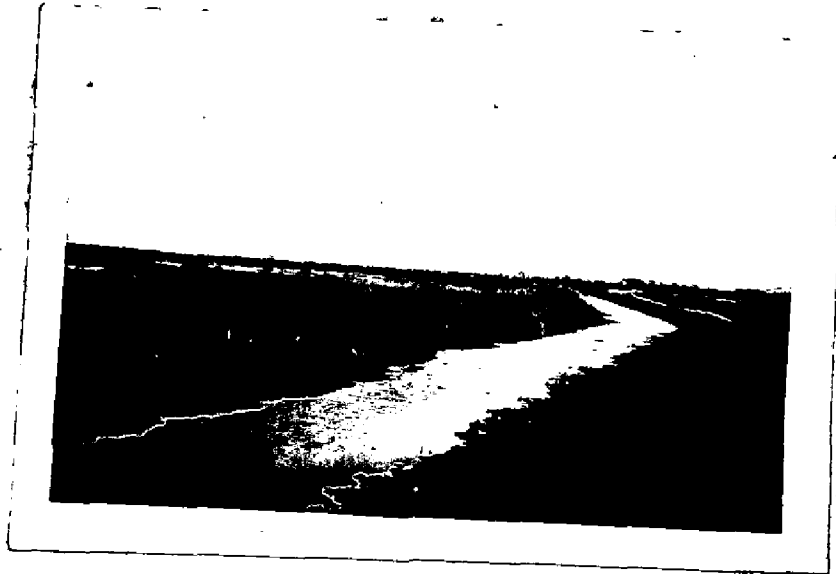
Typical view of earth dike along south shore of lake showing boat channel alongside and profusion of vegetation in water. The lake is on the left.

The land in this vicinity is a very rich muck and the cultivated areas are covered with small truck farms. Starting at Bacom Point is an earth dike which continues along most of the south shore of the lake and holds the water of the lake back from the land behind it, most of which was at the time of the survey below the level of the water in the lake.

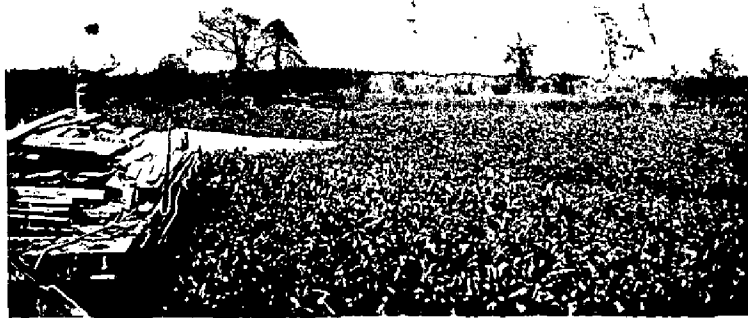
Water hyacinths along shore at Signal Kiss.

The shallow waters along the shore furnish an abundant growth of water hyacinths which float about with the wind and greatly obstruct navigation along some sections of the shore and in various streams. These hyacinths also grow in the streams and float downstream into the lake.

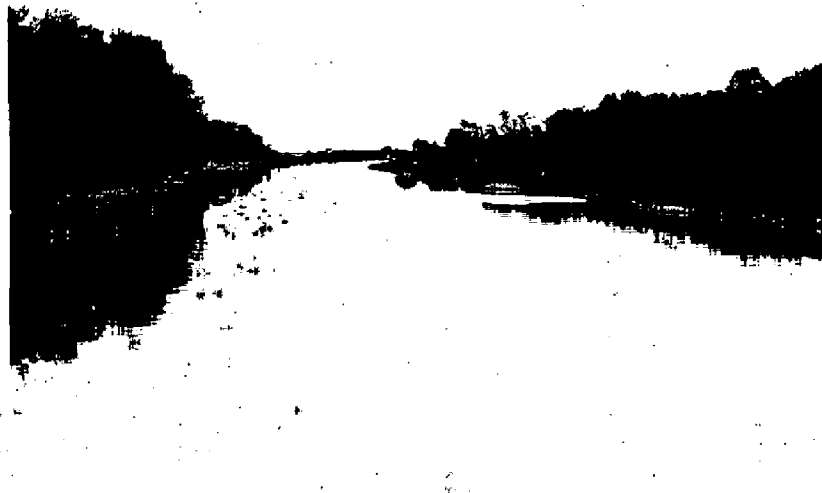
Taylor creek near mouth looking toward lake.
