Form 504 U. S. DEPARTMENT OF COMMERCE COAST AND GEODETIC SURVEY DESCRIPTIVE REPORT	
<i>Type of Survey</i>	SHORELINE
<i>Field No.</i>	<i>Office No.</i> T-9534
LOCALITY	
<i>State</i>	ALASKA
<i>General locality</i>	PRINCE WILLIAM SOUND
<i>Locality</i>	KNIGHT ISLAND PASSAGE
<u>1950-54</u>	
CHIEF OF PARTY	
Field:	G. A. Nelson
Office:	L. W. Swanson
LIBRARY & ARCHIVES	
DATE

This shoreline manuscript, scale 1:10,000, is one of 43 maps comprising Project PH-152, which is in the western part of Prince William Sound. T-9534 is on the west side of Knight Island Passage at the north east end of Chenega Island.

COMPILATION REPORT
Shoreline Survey T-9534

REVIEW REPORT T-9534

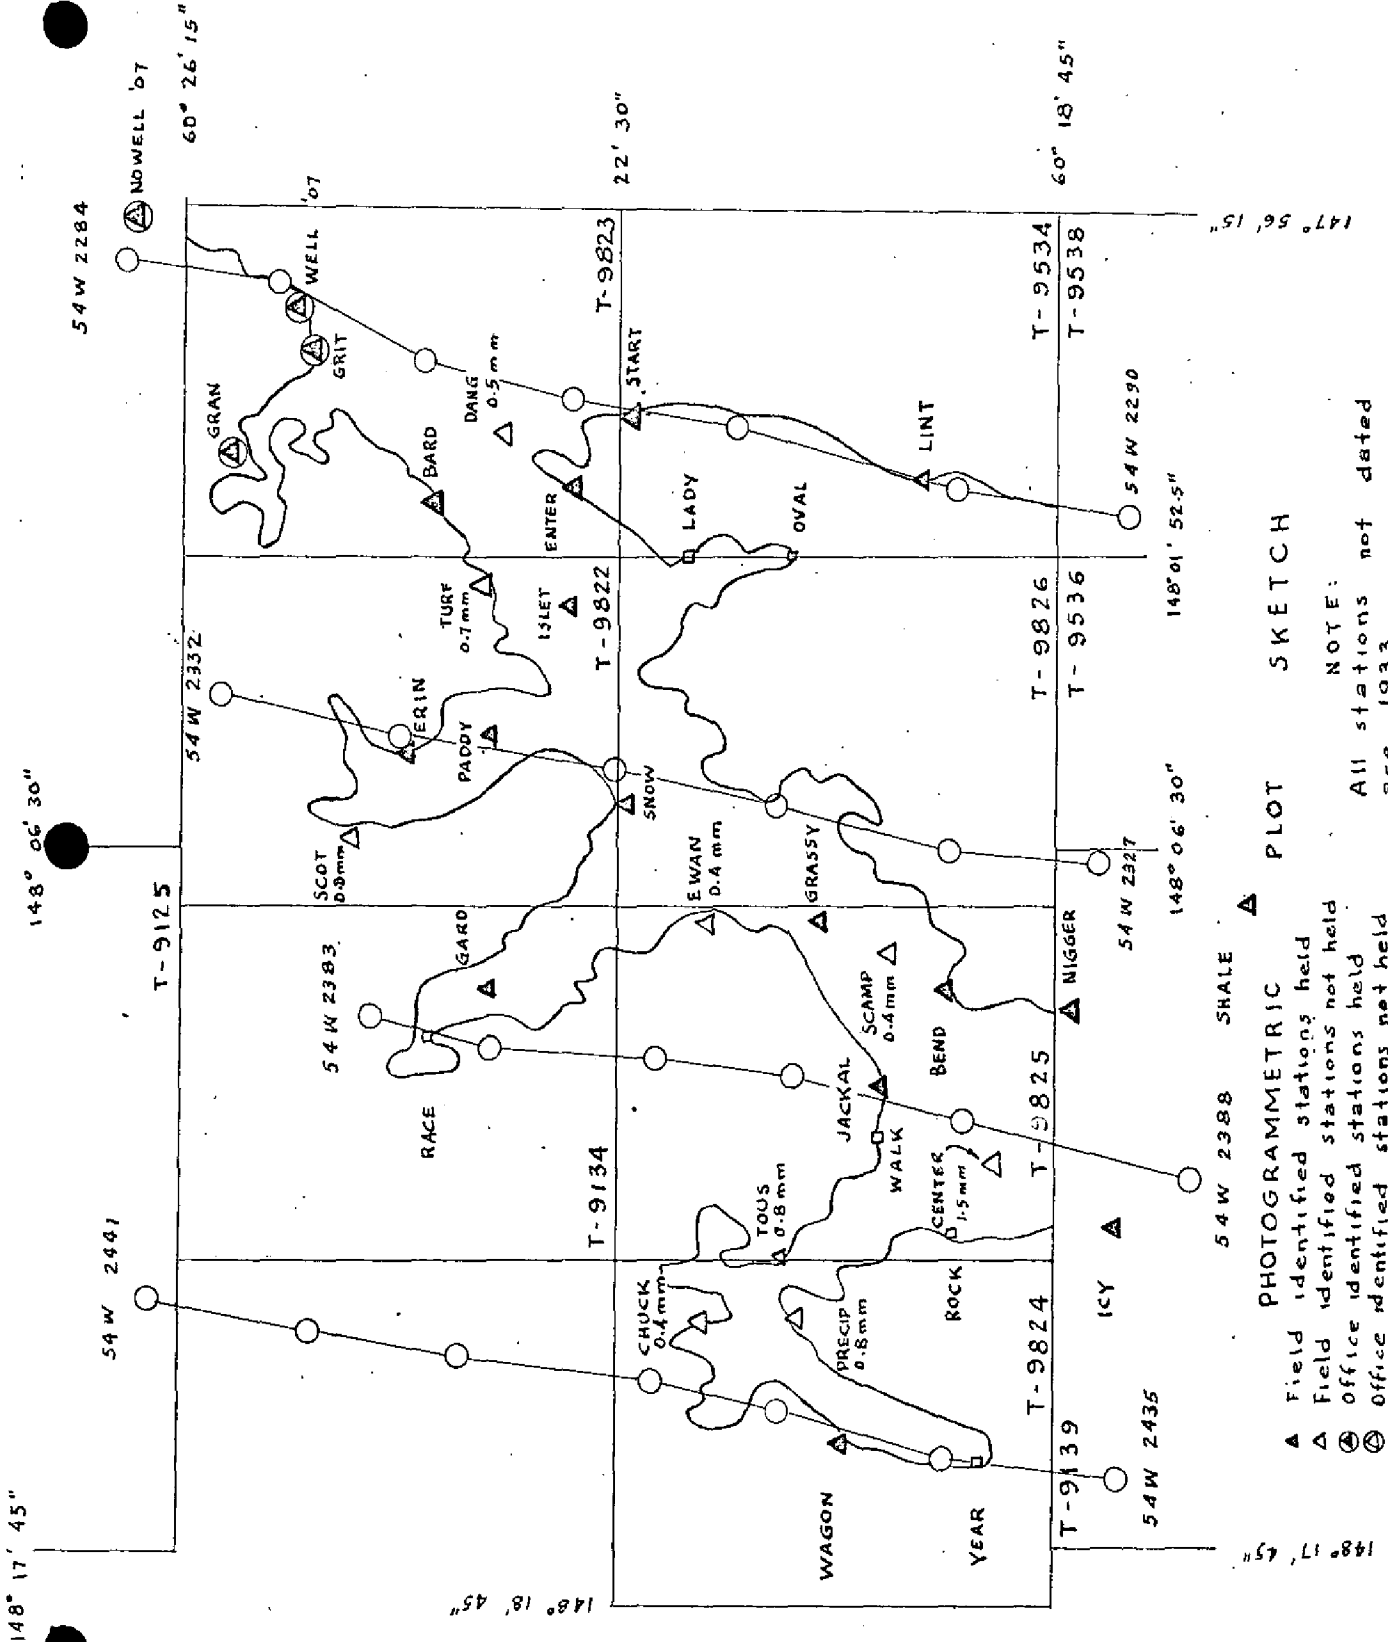
PHOTOGRAMMETRIC PLOT SKETCH

This radial plot comprises seven manuscripts covering the area of Dangerous Passage and including the northern part of Chenega Island. The surveys included are T-9134, T-9822 thru T-9826 and T-9534.

▲ Field identified stations held
 △ Field identified stations not held
 ⊙ Office identified stations held
 ⊚ Office identified stations not held
 □ Topographic stations located by plot

The control throughout most of the area was adequate. Of the 29 stations used, 20 of them held. (within 0.3mm). Three of them were held within 0.4mm. Those stations missed by larger amounts were SCOT (0.8mm N.E.) TURF (0.7mm N. W.) PRECIP (0.8mm N.E.) TOUS (0.8mm N) CENTER (1.5mm N.W.). All of these stations which were missed by large amounts were field-identified as questionable except CENTER 1933 which was due to erroneous identification on the field photograph. Plot positions for station DANG, 0.5mm difference and CHUCK, 0.4 mm. difference were formed by only two radials. Discrepancies thus are unchecked. Station CHUCK could easily have been misidentified by this amount.

Control stations in the area of T-9534 fall very close to the flight lines with conditions such that they could not be identified on the adjacent flights. There was also difficulty in identification because of shadow and overhang of shoreline features. Positions thus may be weak in a north-south direction.

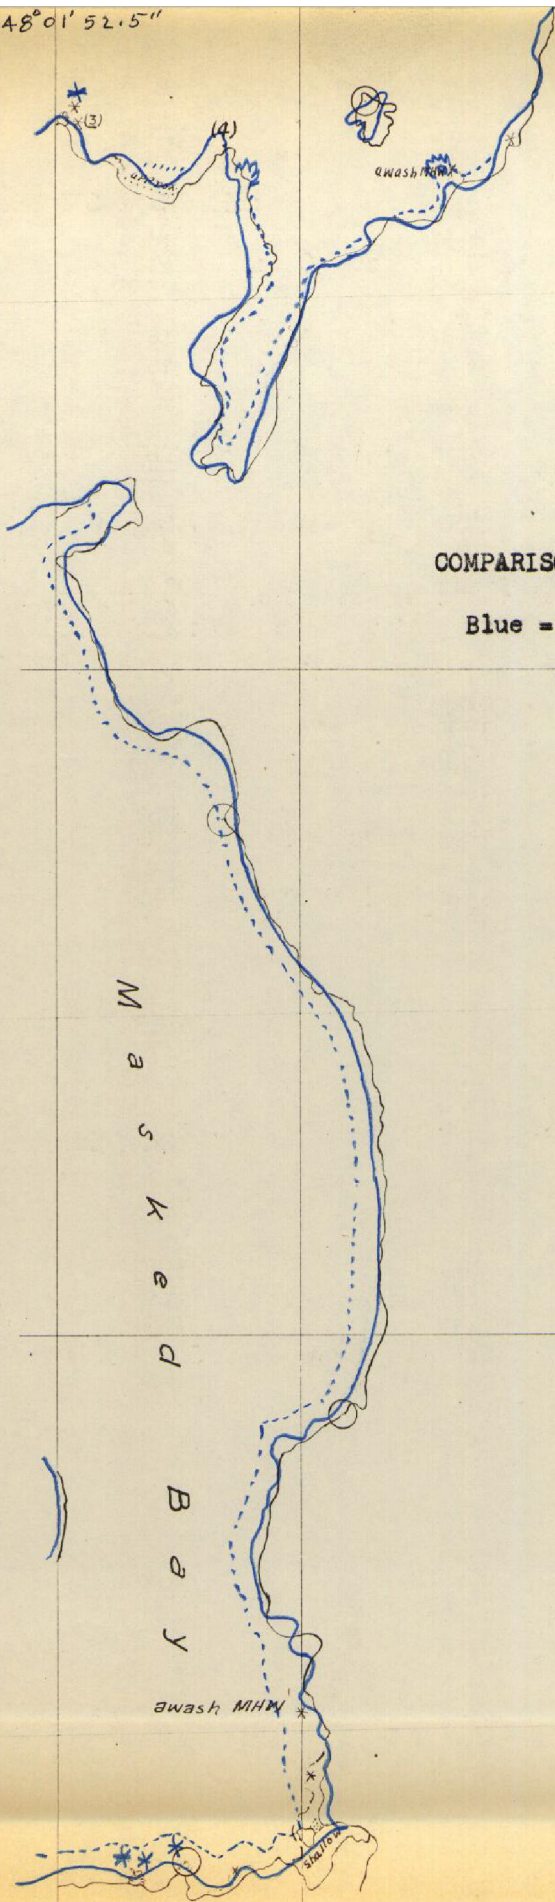
COMPARISON PRINT

Blue = T-4808

An ozalid comparison print, (pages 25 through 28), with differences noted in Items 62 through 65, is bound with the original of this report.

A comparison was made with Survey T-4808, scale 1:20,000, dated May - June 1933, using triangulation stations common to both maps and projection intersections as control. Differences between T-4808 and T-9534 are shown in blue on the comparison print.

In general, the shoreline compared well. Some rocks are shown on T-4808 that could not be identified on the photographs and, therefore, do not appear on T-9534. These are noted on the comparison print.

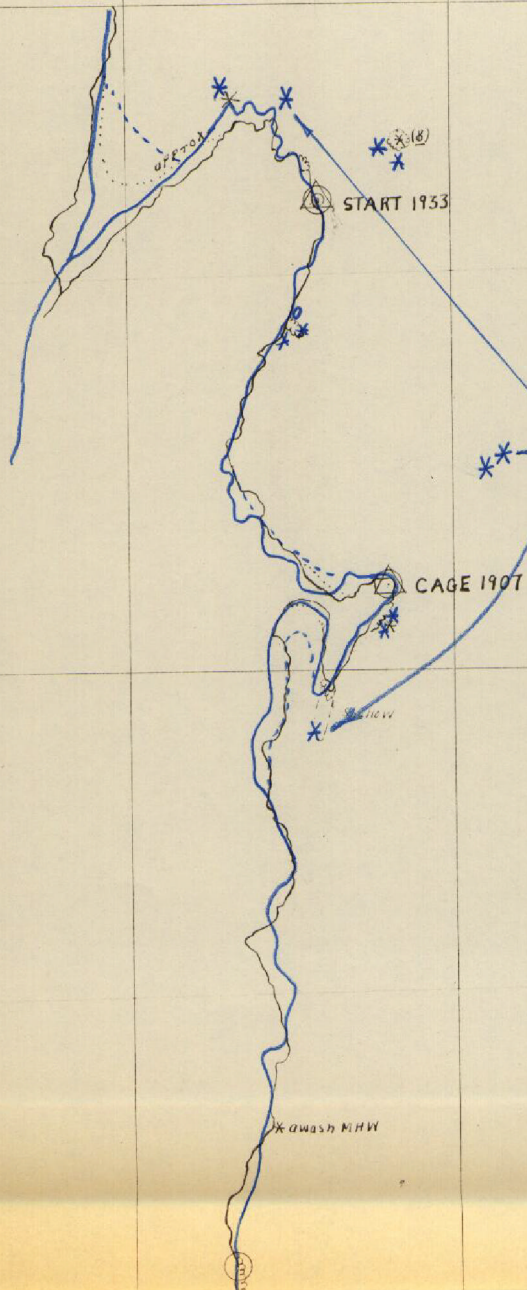
COMPARISON PRINT

- Blue = T-4808
- Brown = SEWARD (B-3)
- Red = Chart 8515

Not visible on photos
 Also on SEWARD (B-3)
 Also on Chart 8515

A visual comparison was made with U.S.G.S. Quadrangle SEWARD (B-3), ALASKA, scale 1:63,360, dated 1950. No significant shoreline differences were noted. Rock differences are noted on the comparison print in brown.

A visual comparison was made with Chart 8515, scale 1:80,000, 10th edition, dated October 25, 1969. No significant shoreline differences were noted. Rock differences are noted in red on the comparison print.

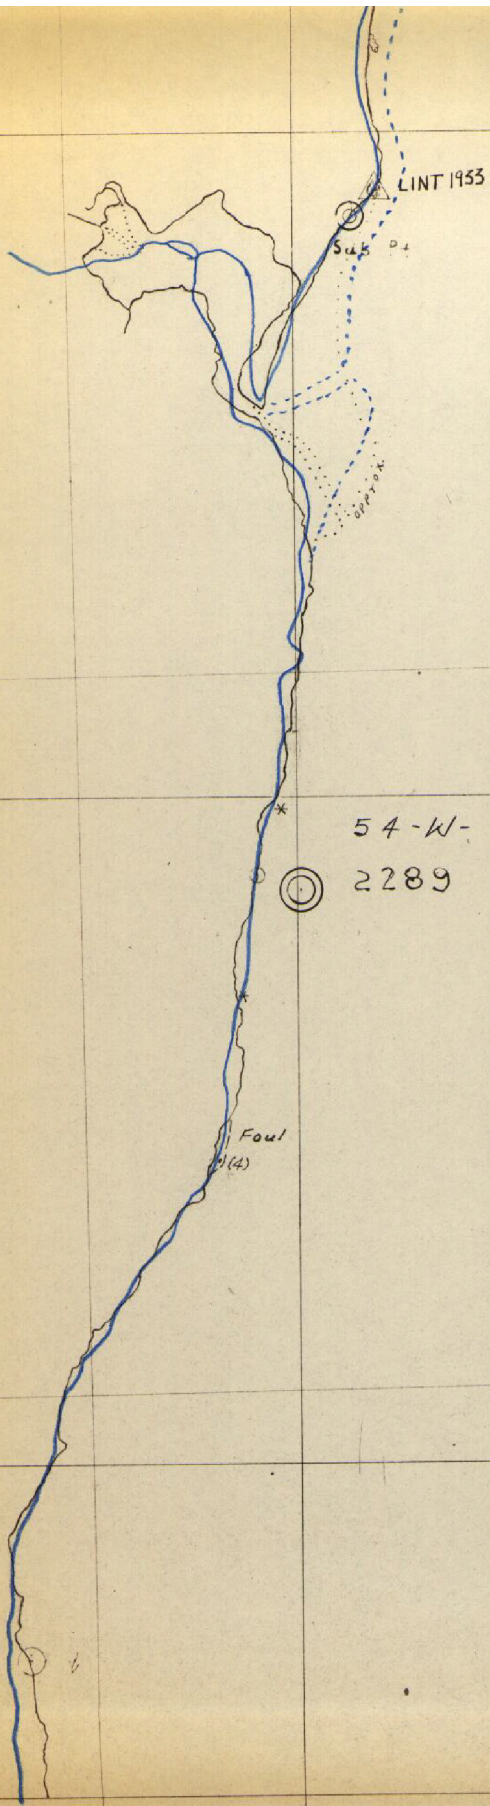
COMPARISON PRINT

Blue = T-4808
Brown = SEWARD (B-3)
Red = Chart 8515

Rks awash
Not visible on photos
Also shown on SEWARD (B-3)
Also shown on Chart 8515

It is pointed out here that rock differences are the same on T-4808, SEWARD (B-3), and Chart 8515.
