<p>Form 504</p> <p>U. S. DEPARTMENT OF COMMERCE</p> <p>COAST AND GEODETIC SURVEY</p> <p>DESCRIPTIVE REPORT</p>	
<i>Type of Survey</i>	SHORELINE
<i>Field No.</i>	<i>Office No.</i> T-9822
LOCALITY	
<i>State</i>	ALASKA
<i>General locality</i>	PRINCE WILLIAM SOUND
<i>Locality</i>	PADDY BAY
<p><u>1950-54</u></p> <p>CHIEF OF PARTY</p> <p>Field: G. A. Nelson</p> <p>Office: L. W. Swanson</p>	
LIBRARY & ARCHIVES	
DATE _____

SUMMARY TO ACCOMPANY
DESCRIPTIVE REPORT T-9822

This shoreline manuscript, scale 1:10,000, is one of 43 maps that comprise Project PH-152, which is in the western part of Prince William Sound. T-9822 includes Paddy Bay and part of Dangerous Passage.

PHOTOGRAMMETRIC PLOT REPORT
PRINCE WILLIAM SOUND, ALASKA
PH-152
July 1959

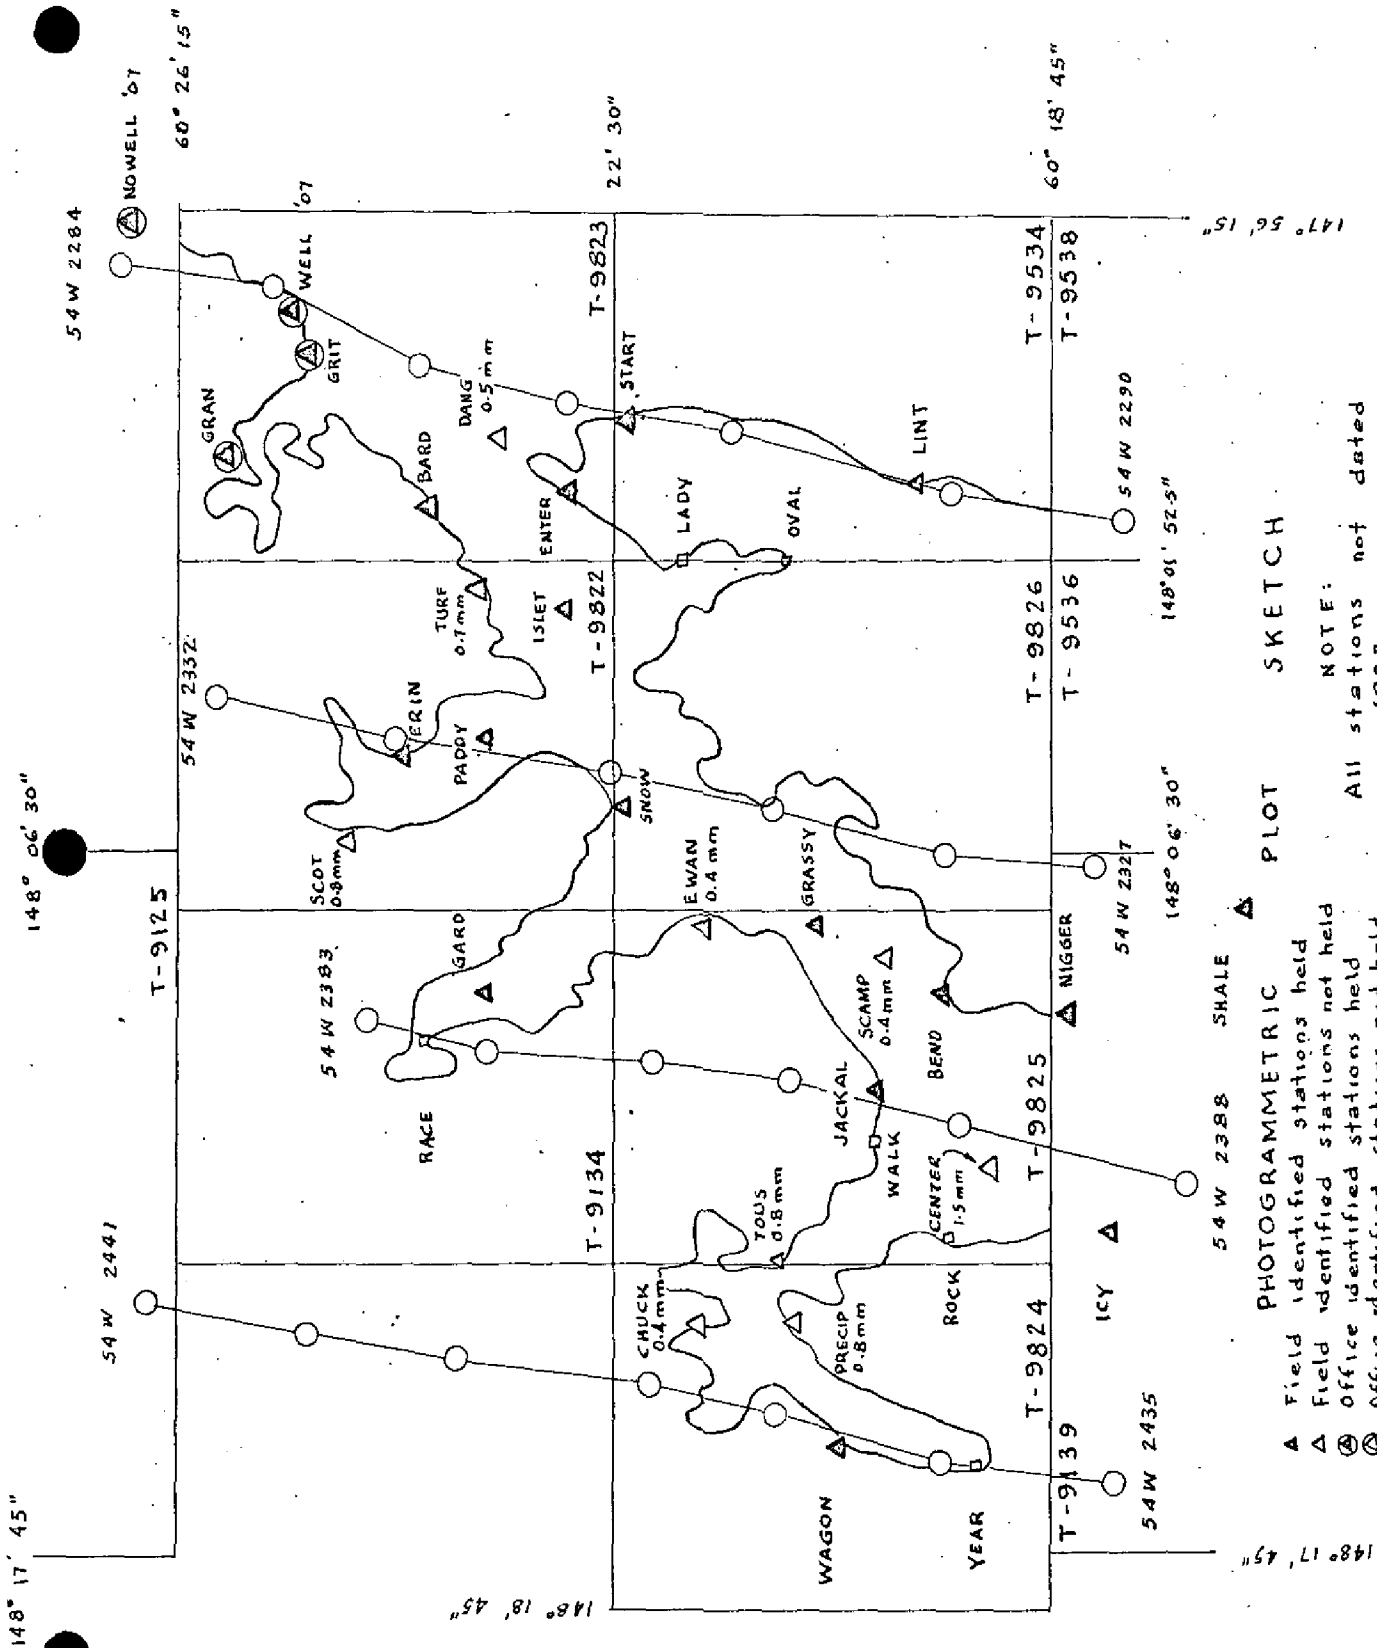
PLOT SKETCH

This radial plot comprises seven manuscripts covering the area of Dangerous Passage and including the northern part of Chenega Island. The surveys included are T-9134, T-9822 thru T-9826 and T-9534.

Those positions obtained by intersections of three or more templet rays were circled on the back of the manuscript with red plastic ink, and those formed by two rays in green.

The control throughout most of the area was adequate. Of the 29 stations used, 20 of them held (within 0.3mm). Three of them were held within 0.4mm. Those stations missed by larger amounts were SCOT (0.8mm N.E.) TURF (0.7mm N.W.) PRECIP (0.8mm N.E.) TOUS (0.8mm N) CENTER (1.5mm N.W.). All of these stations which were missed by large amounts were field-identified as questionable except CENTER 1933 which was due to erroneous identification on the field photograph. Plot positions for station DANG, 0.5mm difference and CHUCK, 0.4 mm. difference were formed by only two radials. Discrepancies thus are unchecked. Station CHUCK could easily have been misidentified by this amount.

PHOTOGRAMMETRIC
 ▲ Field identified stations held
 △ Field identified stations not held
 ⊙ Office identified stations held
 ⊚ Office identified stations not held
 □ Topographic stations located by plot

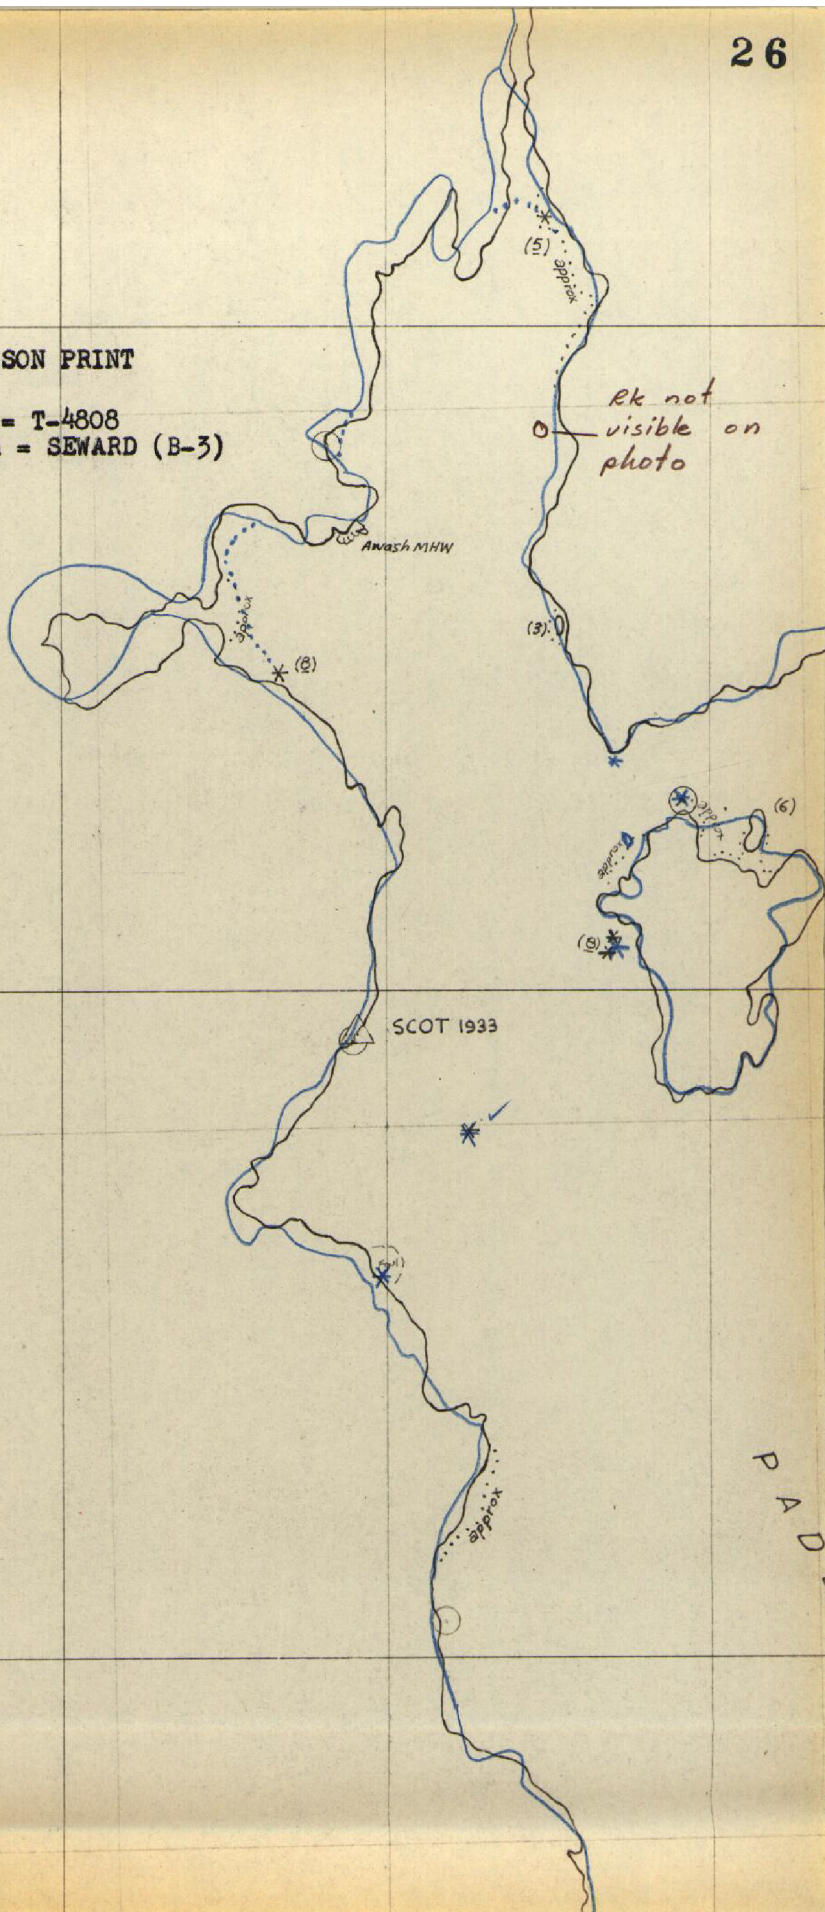
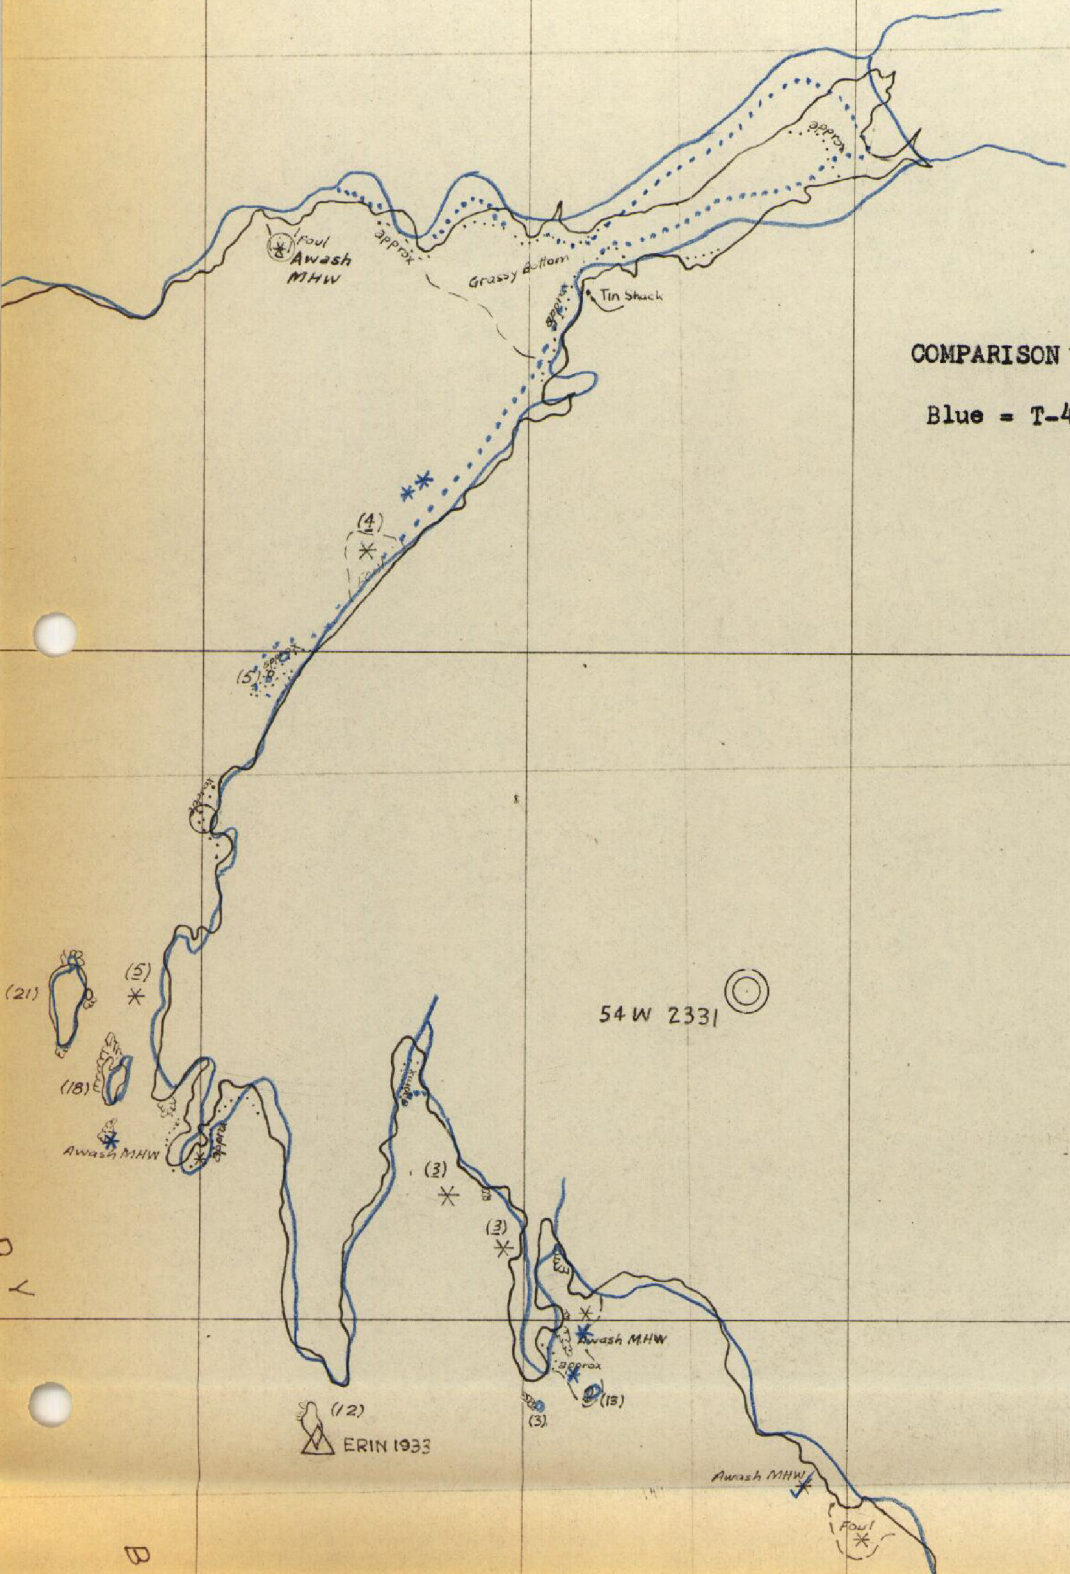
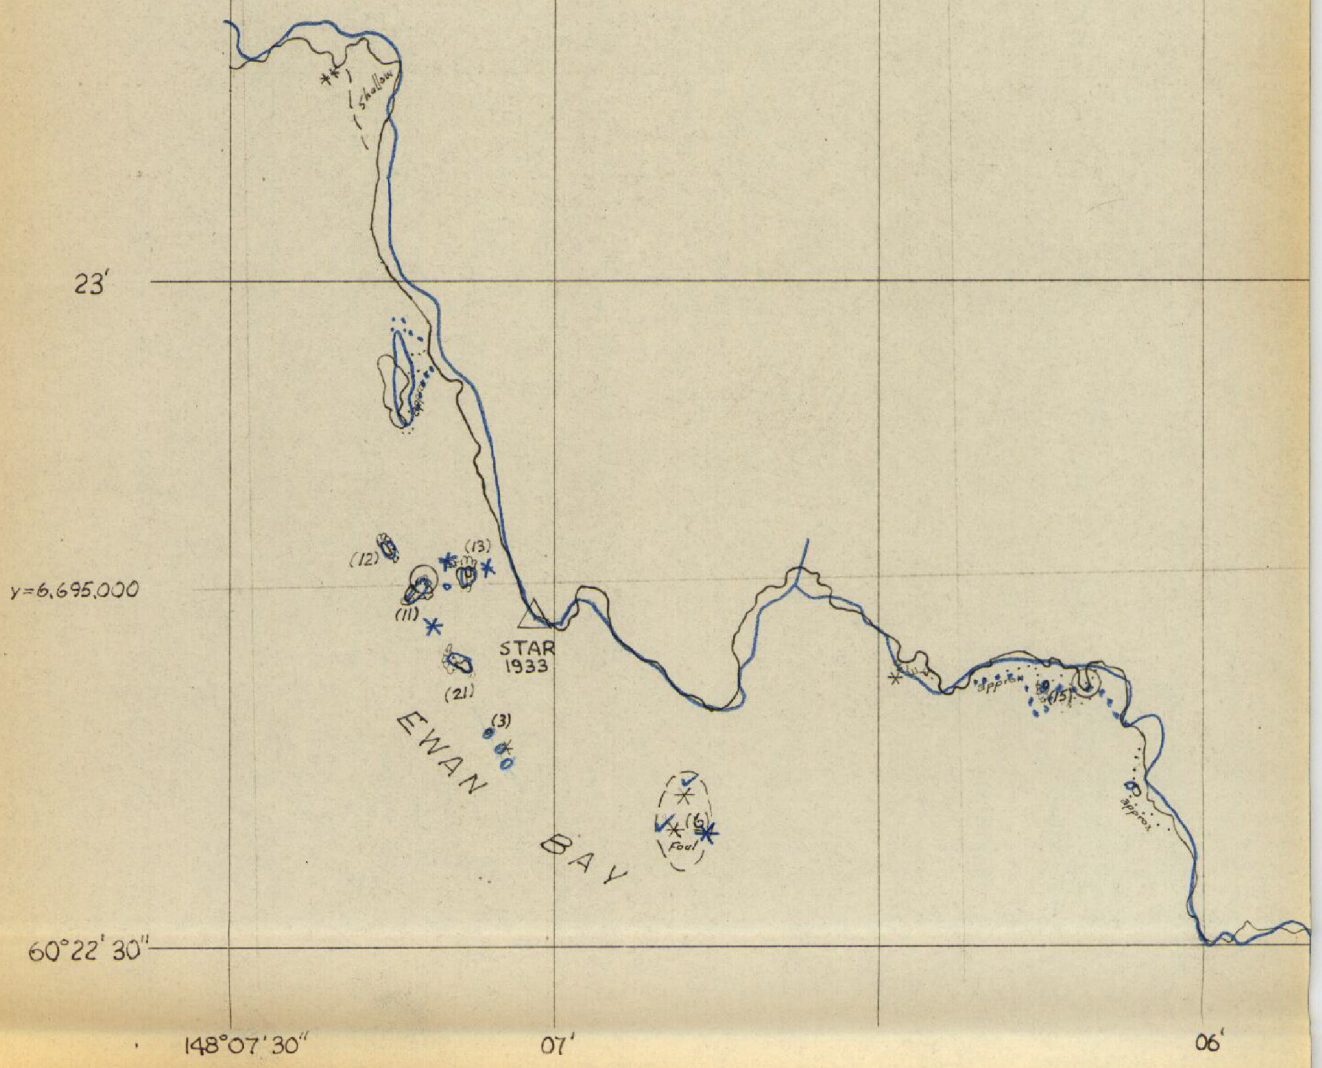
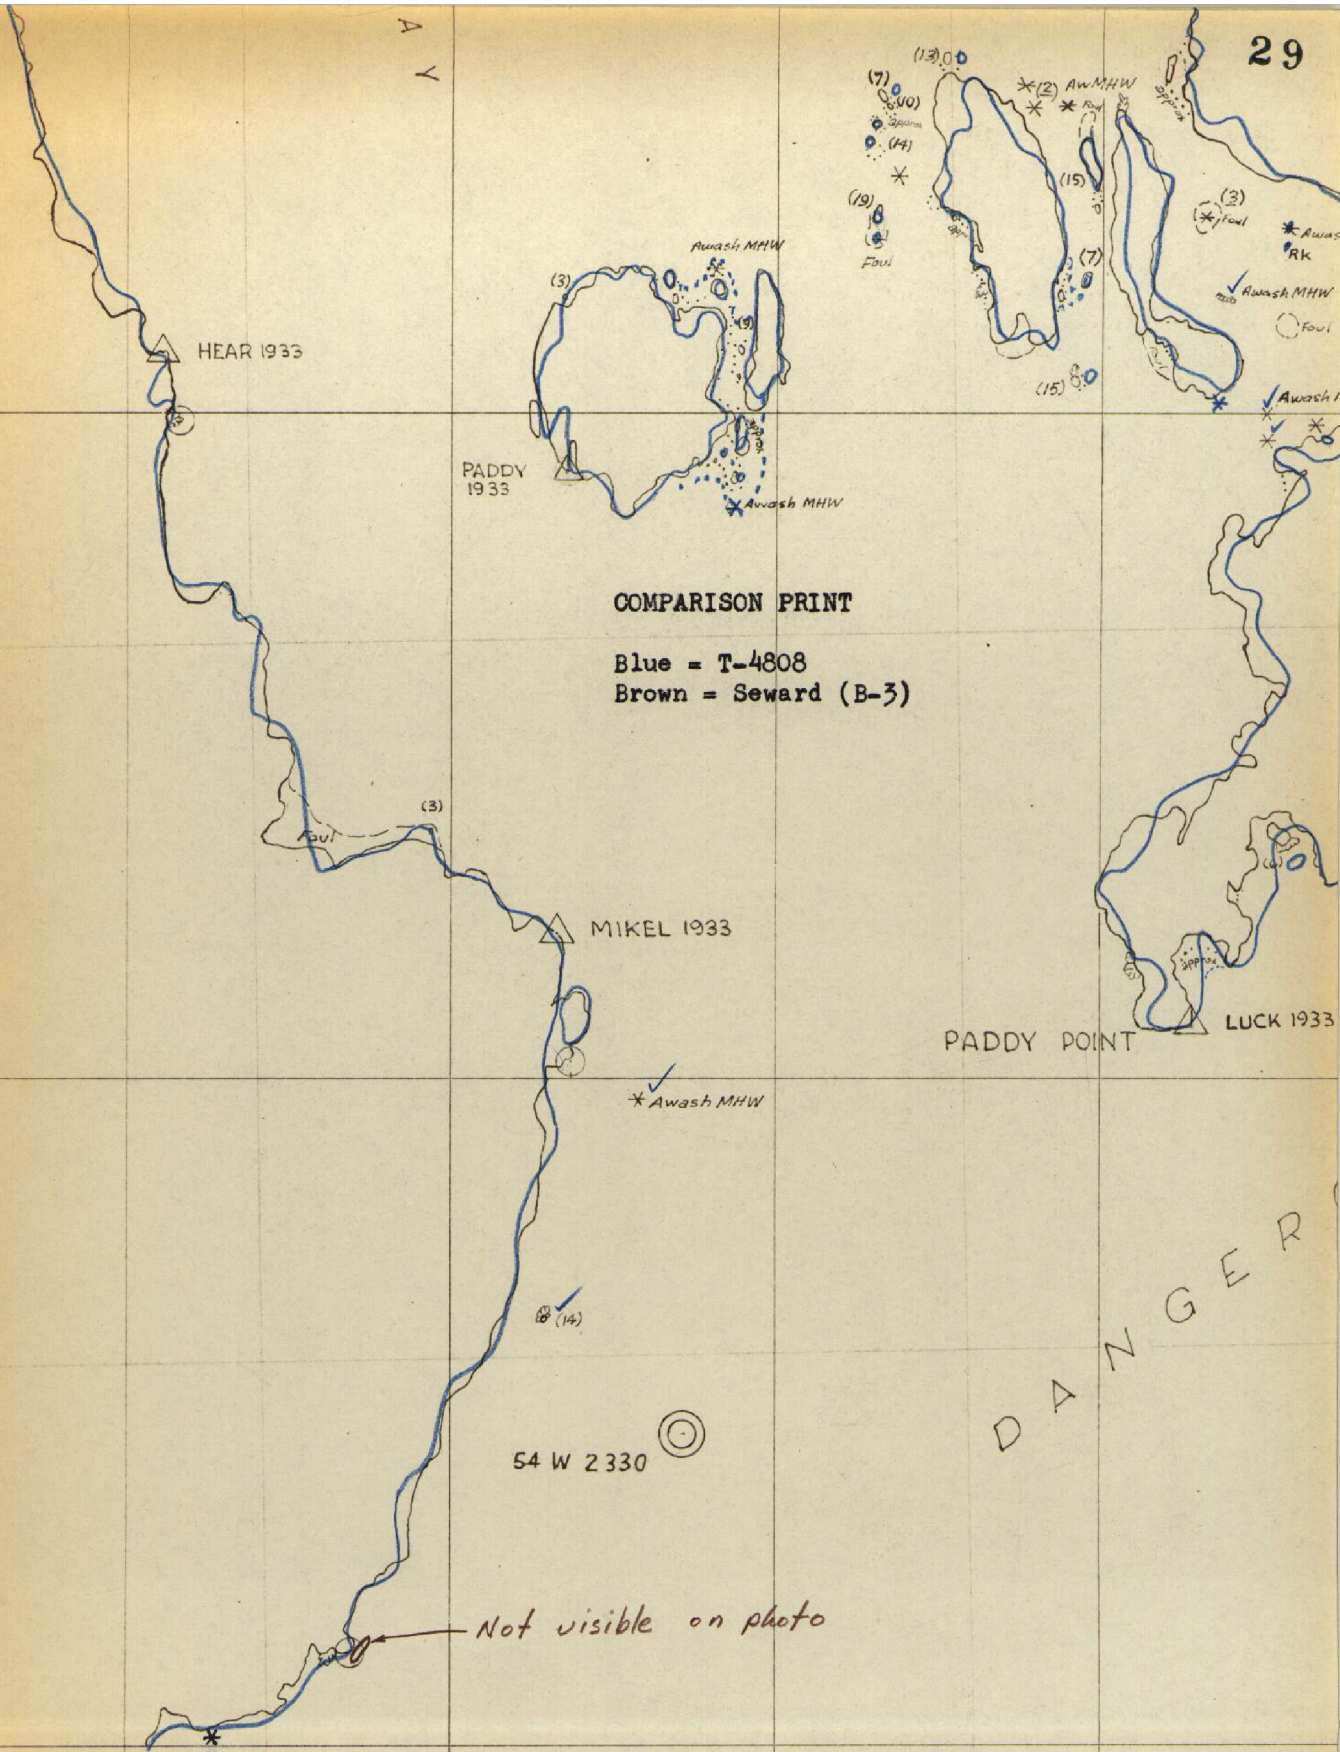
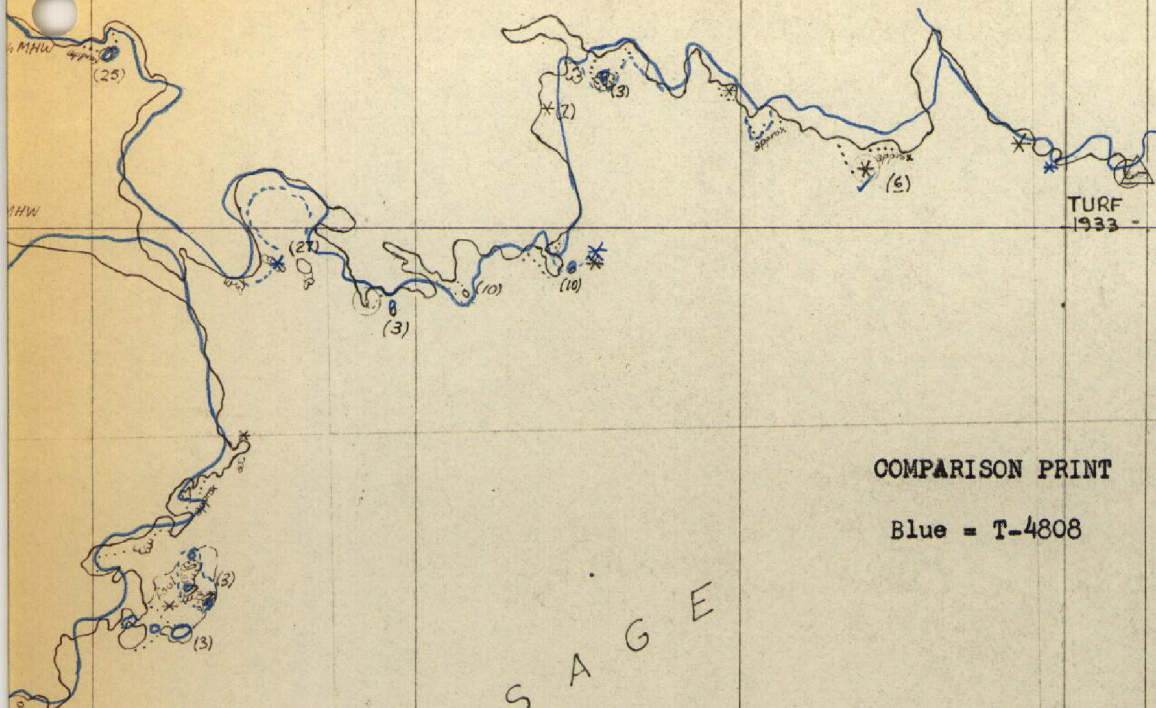
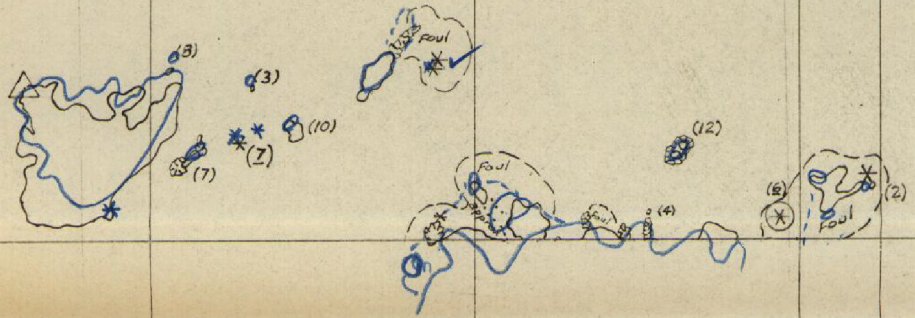
COMPARISON PRINT

A comparison was made with Survey T-4808, scale 1:20,000, dated May, June 1933. Differences between T-4808 and T-9822 are shown in blue on the comparison ozalid, and are evident without further discussion.

A visual comparison was made with U.S.G.S. Quadrangle SEWARD (B-3), ALASKA, scale 1:63,360, dated 1950. A detailed comparison was not made because of the small scale of the quadrangle, but two differences are shown in brown on the comparison ozalid.

A bare rock at latitude $60^{\circ}24.9'$, longitude $148^{\circ}05.8'$ is not visible on the photographs.

An islet or large bare rock at latitude $60^{\circ}22.6'$, longitude $148^{\circ}05.2'$ is not visible on the photographs.

Blue = T-4808
Brown = SEWARD (B-3)

Rk not visible on photo

An ozalid comparison print, (pages 26 through 30), with differences noted in Items 62 through 65, is bound with the original of this report.
