Form 504 U. S. DEPARTMENT OF COMMERCE COAST AND GEODETIC SURVEY DESCRIPTIVE REPORT	
<i>Type of Survey</i>	SHORELINE
<i>Field No.</i>	<i>Office No.</i> T-9824
LOCALITY	
<i>State</i>	ALASKA
<i>General locality</i>	PRINCE WILLIAM SOUND
<i>Locality</i>	JACKPOT BAY
<hr/> 19 50-54 <hr/>	
CHIEF OF PARTY	
Field:	G. A. Nelson
Office:	L. W. Swanson
LIBRARY & ARCHIVES	
DATE

SHORELINE MAPPING PROJECT PH - 152

Prince William Sound, Alaska

SUMMARY TO ACCOMPANY
DESCRIPTIVE REPORT T-9824

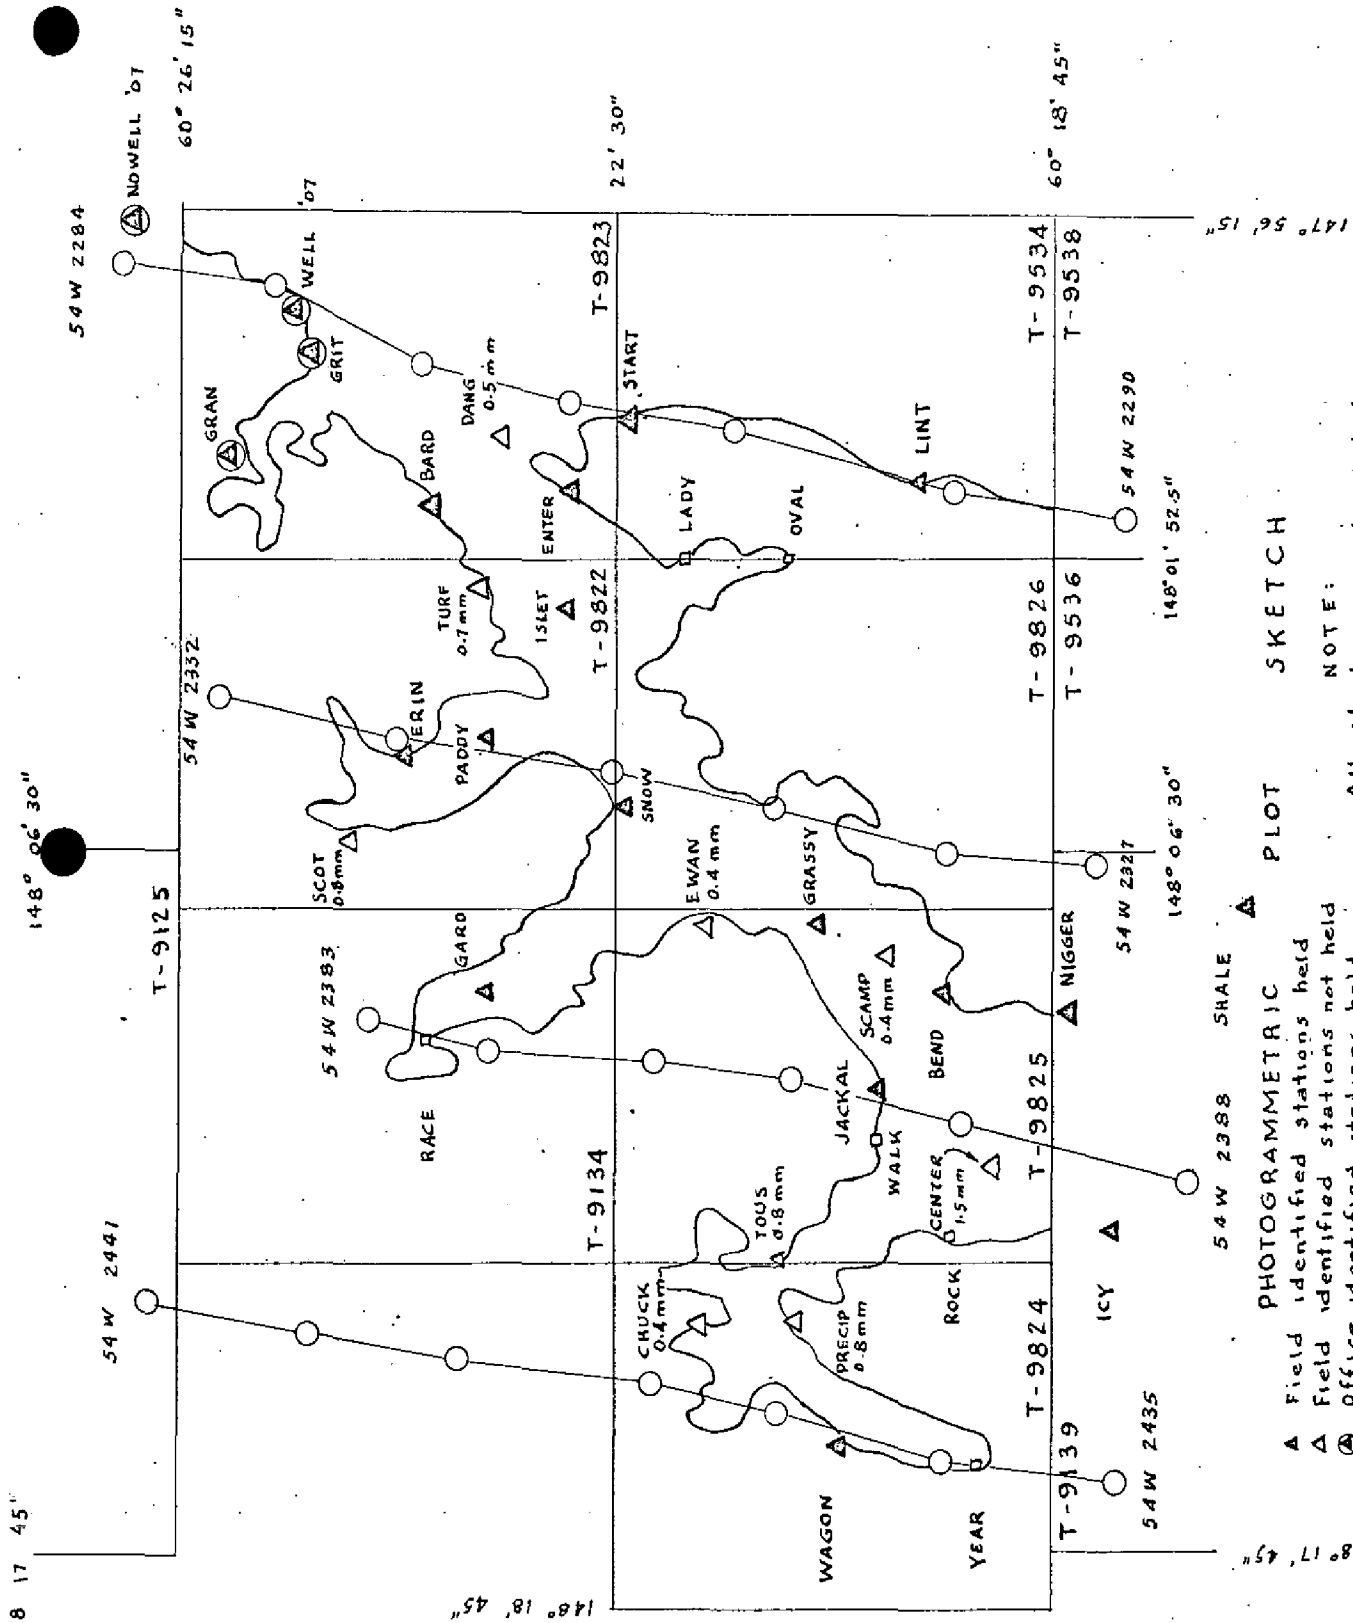
PHOTOGRAMMETRIC PLOT SKETCH

- ▲ Field identified stations held
- △ Field identified stations not held
- ⊙ Office identified stations held
- Office identified stations not held
- ⊠ Topographic stations located by plot

NOTE: All stations not dated are 1933

The control throughout most of the area was adequate. Of the 29 stations used, 20 of them held. (within 0.3mm). Three of them were held within 0.4mm. Those stations missed by larger amounts were SCOT (0.8mm N.E.) TURF (0.7mm N. W.) PRECIP (0.8mm N.E.) TOUS (0.8mm N) CENTER (1.5mm N.W.). All of these stations which were missed by large amounts were field-identified as questionable except CENTER 1933 which was due to erroneous identification on the field photograph. Plot positions for station DANG, 0.5mm difference and CHUCK, 0.4 mm. difference were formed by only two radials. Discrepancies thus are unchecked. Station CHUCK could easily have been misidentified by this amount.

Survey T-9824 had three control stations which did not hold. These discrepancies are explained above and do not signify an error in datum. Positions in this area were also verified by comparing with prior planetable surveys.

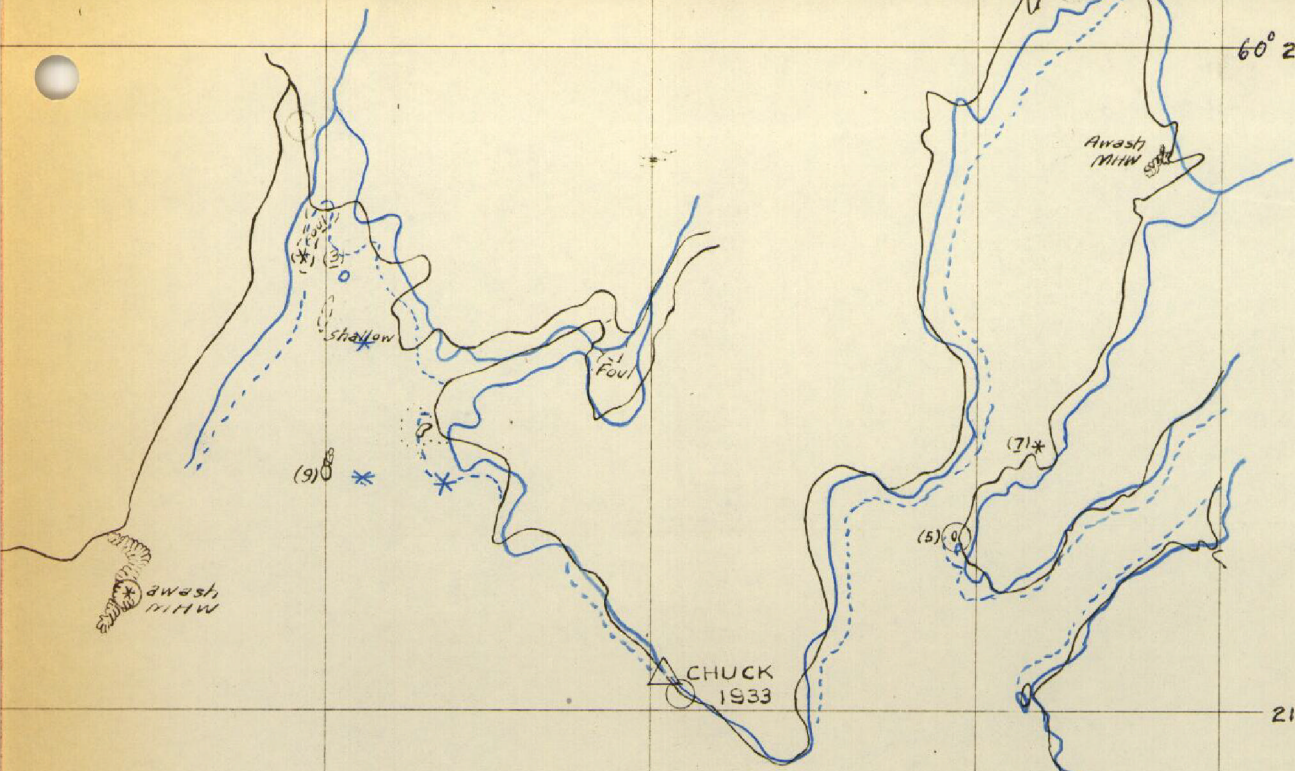
COMPARISON PRINT

Blue = T-4808

A comparison was made with Survey No. T-4808, scale 1:20,000, dated May, June 1933. Differences between T-4808 and T-9824 are shown in blue on the comparison print.

The general trend of the shoreline compares well, as do relative positions of alongshore features. Differences in position of the shoreline vary. At the north side of Jackpot Bay, the T-9824 shoreline is considerably west of the T-4808 shoreline.

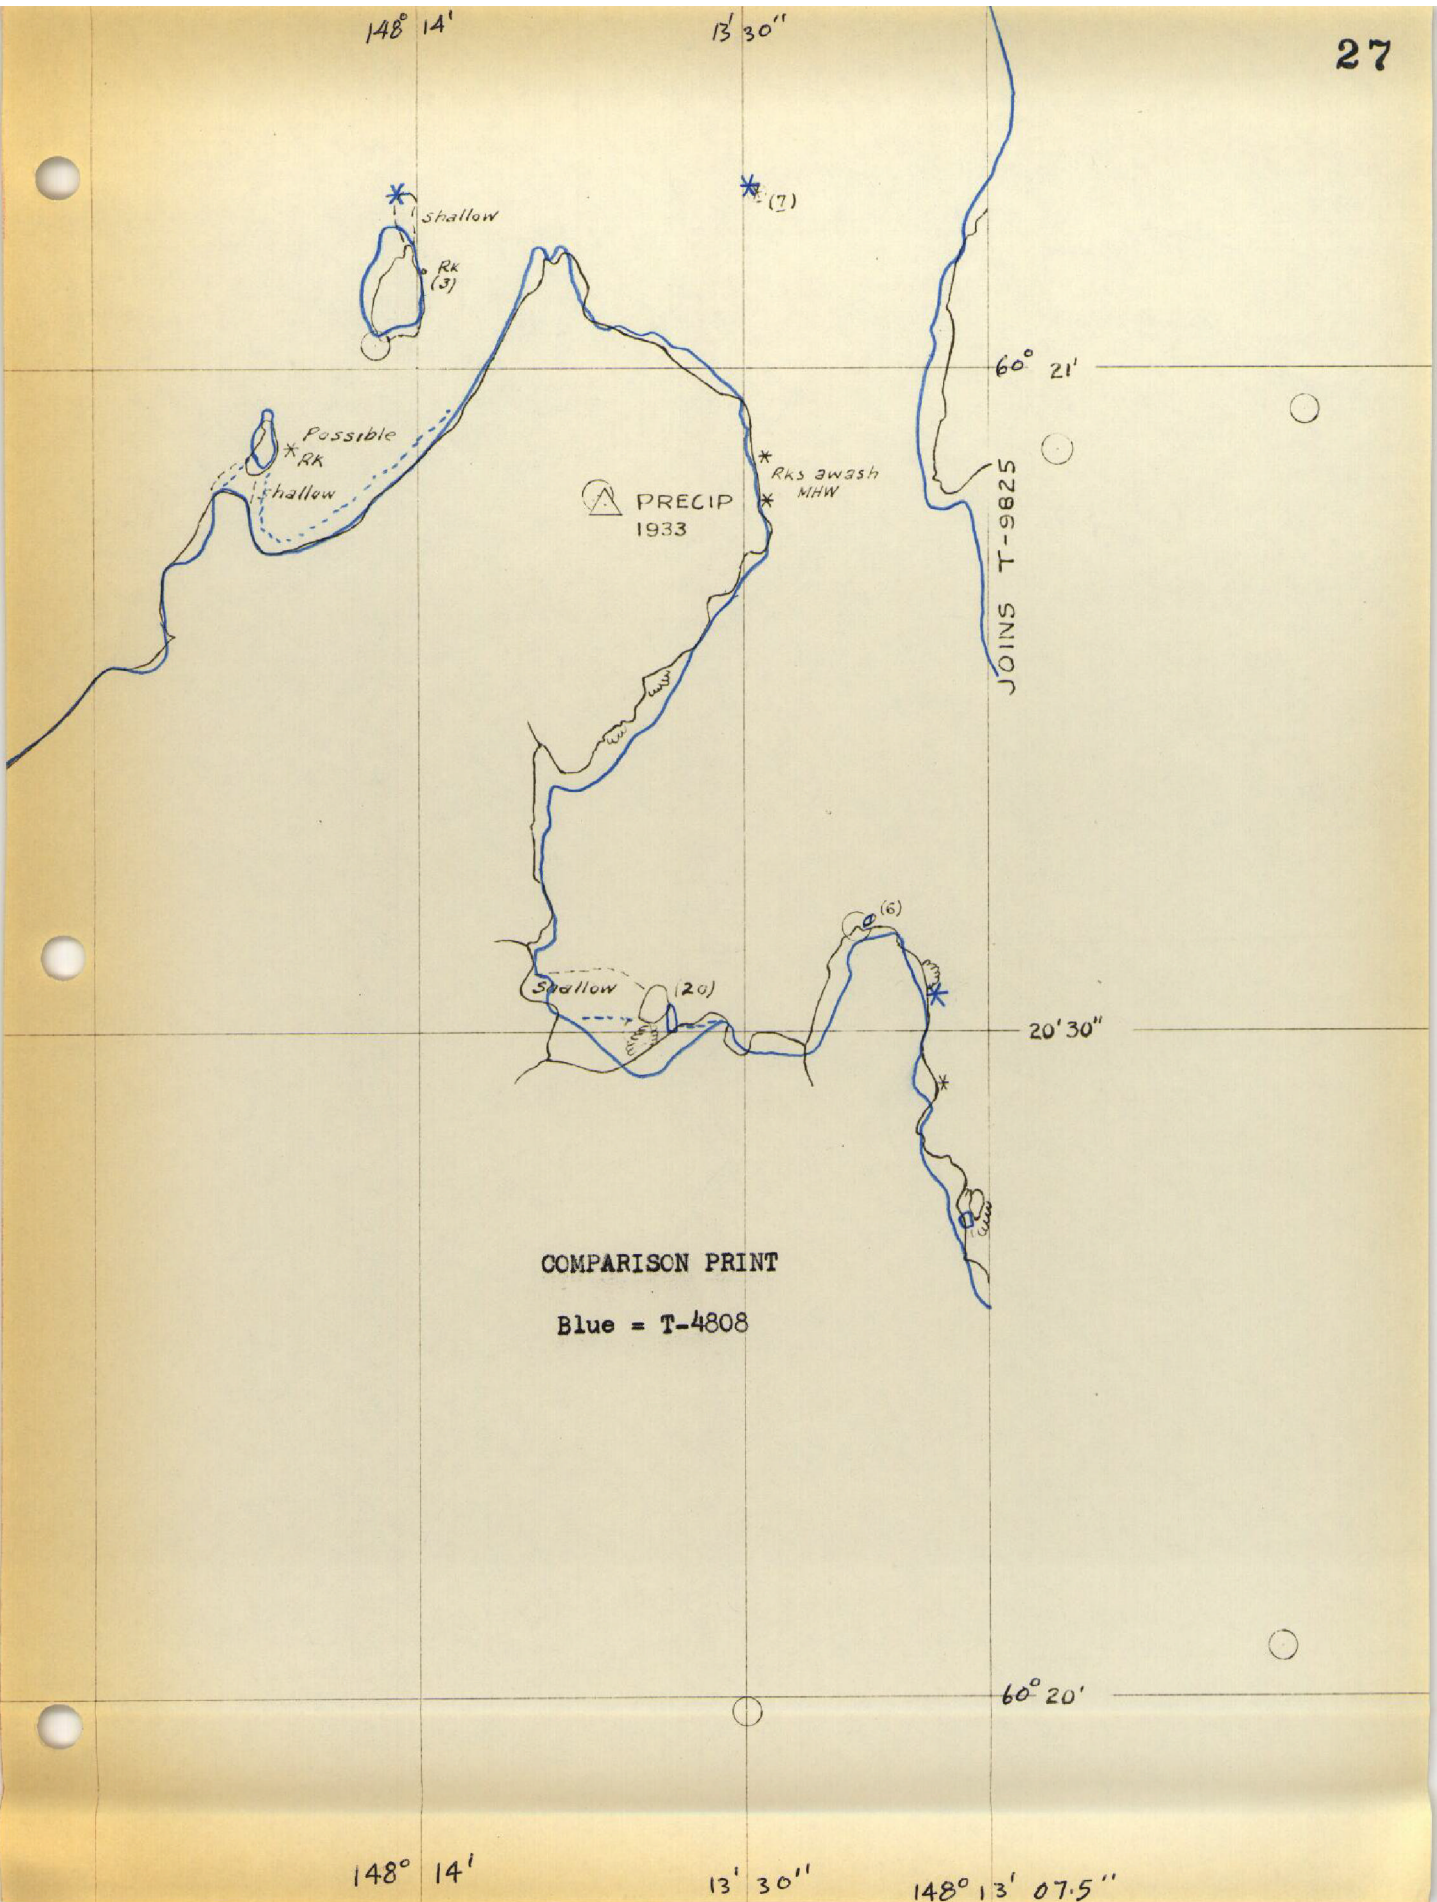
COMPARISON PRINT

Blue = T-4808

A visual comparison was made with U.S.G.S. Quadrangle SEWARD (B-4), ALASKA, scale 1:63,360, dated 1951. Differences between this map and T-9824 are shown in brown on the comparison print.

A bare rock or islet at approximate latitude $60^{\circ}20.8'$, longitude $148^{\circ}15.5'$ is not visible on the photographs. The charted depth at this point is over 50 fathoms.

A bare rock at approximate latitude $60^{\circ}20.5'$, longitude $148^{\circ}14.9'$ is not visible on the photographs and was not mapped on T-9824.
