Form 504 U. S. DEPARTMENT OF COMMERCE COAST AND GEODETIC SURVEY DESCRIPTIVE REPORT	
<i>Type of Survey</i>	SHORELINE
<i>Field No.</i>	<i>Office No.</i> T-9825
LOCALITY	
<i>State</i>	ALASKA
<i>General locality</i>	PRINCE WILLIAM SOUND
<i>Locality</i>	JACKPOT ISLAND
<hr/> 1950-54	
CHIEF OF PARTY	
Field:	G. A. Nelson
Office:	L. W. Swanson
LIBRARY & ARCHIVES	
DATE

SHORELINE MAPPING PROJECT PH - 152

Prince William Sound, Alaska

SUMMARY TO ACCOMPANY
DESCRIPTIVE REPORT T-9825

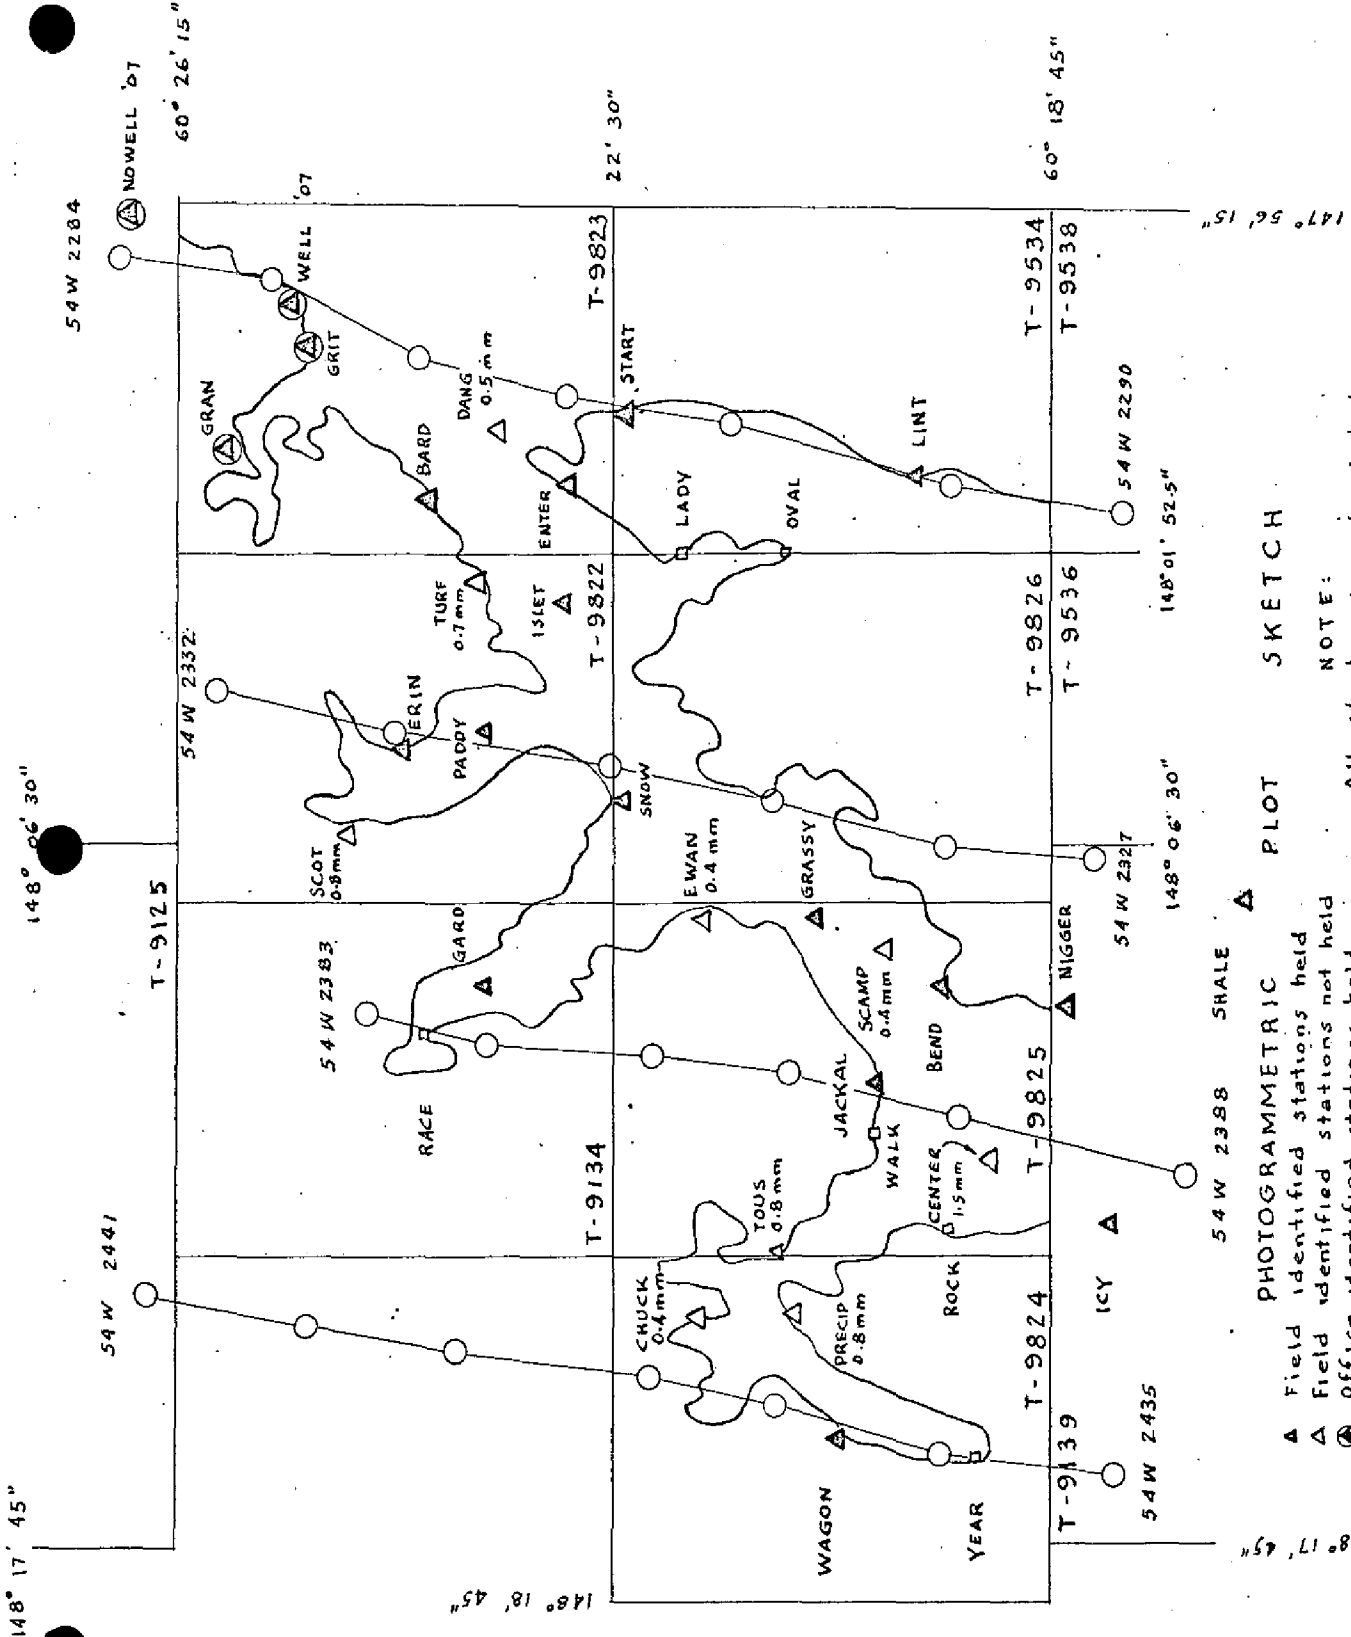
PHOTOGRAMMETRIC PLOT SKETCH

- ▲ Field identified stations held
- △ Field identified stations not held
- ⊙ Office identified stations held
- ⊚ Office identified stations not held
- Topographic stations located by plot

NOTE:
All stations not dated
are 1933

The plot was begun on T-9825 which was thought to be strongest controlled, junctioning with positions and control on T-9139. The plot was continued up Dangerous Passage with the best controlled templets. The weaker controlled templets were then added and the plot was re-adjusted to fit control and improve pass point intersections.

The control throughout most of the area was adequate. Of the 29 stations used, 20 of them held. (within 0.3mm). Three of them were held within 0.4mm. Those stations missed by larger amounts were SCOT (0.8mm N.E.) TURF (0.7mm N. W.) PRECIP (0.8mm N.E.) TOUS (0.8mm N) CENTER (1.5mm N.W.). All of these stations which were missed by large amounts were field-identified as questionable except CENTER 1933 which was due to erroneous identification on the field photograph. Plot positions for station DANG, 0.5mm difference and CHUCK, 0.4 mm. difference were formed by only two radials. Discrepancies thus are unchecked. Station CHUCK could easily have been misidentified by this amount.

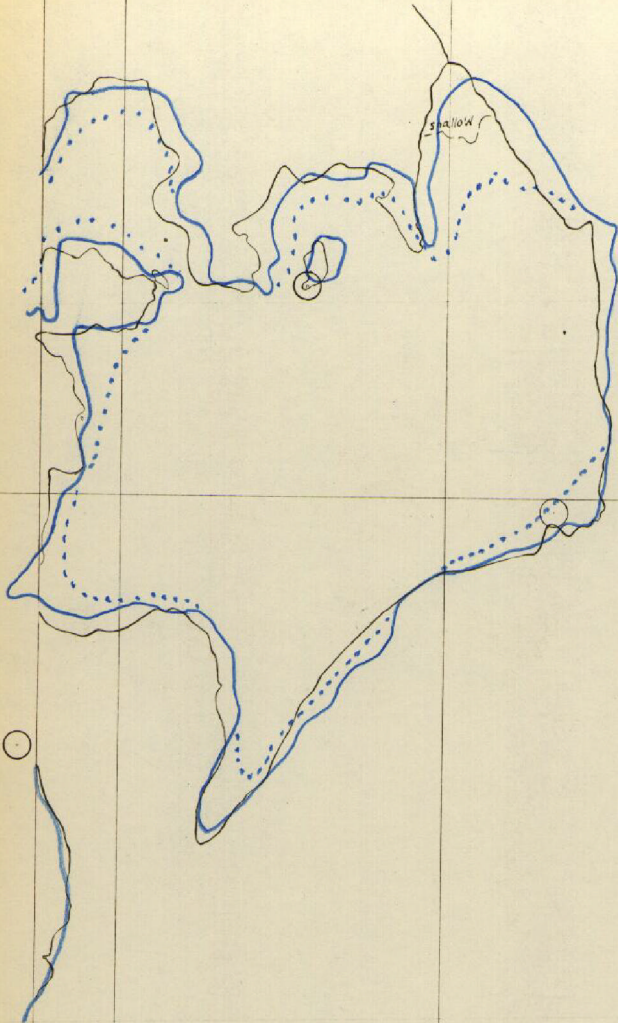
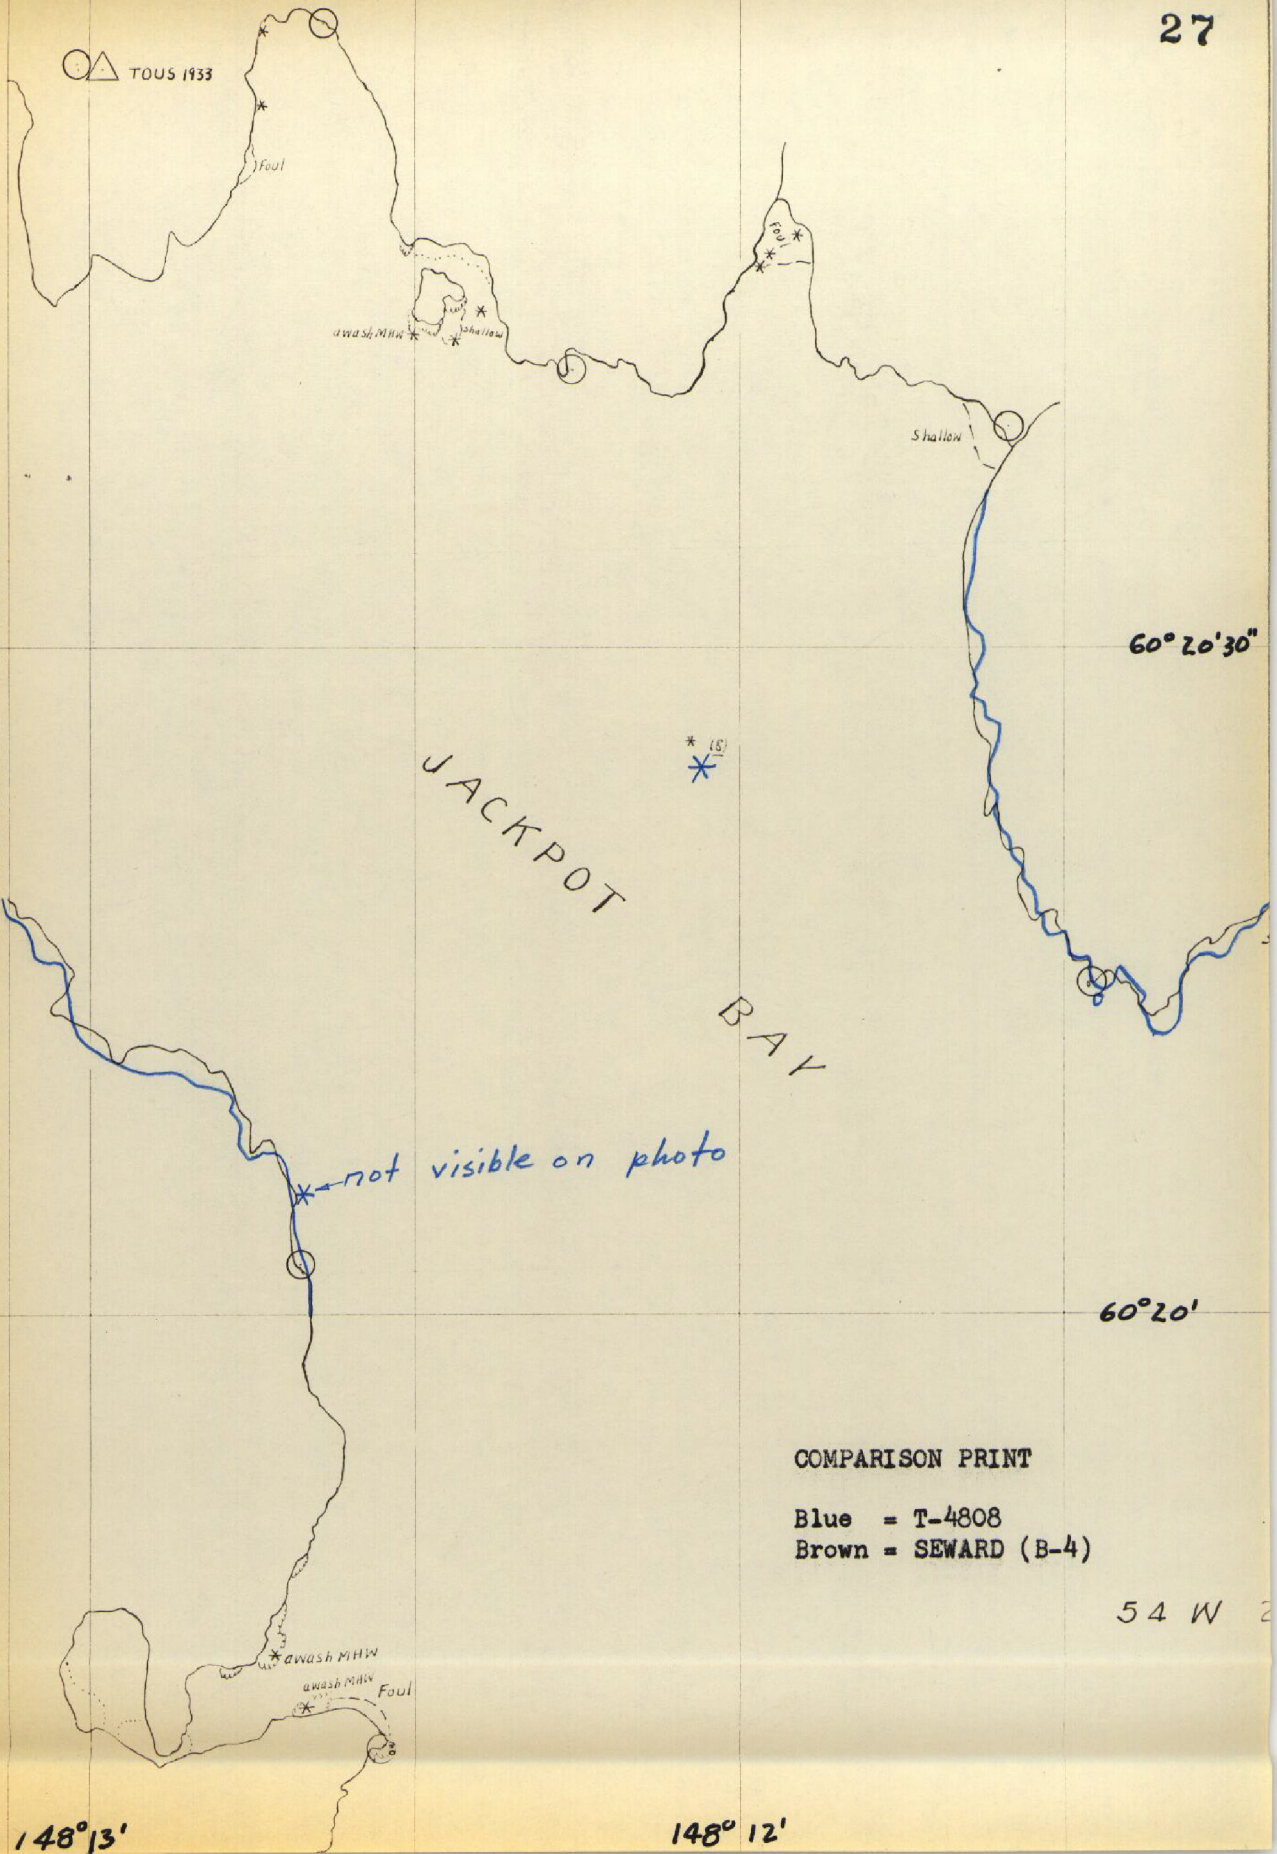
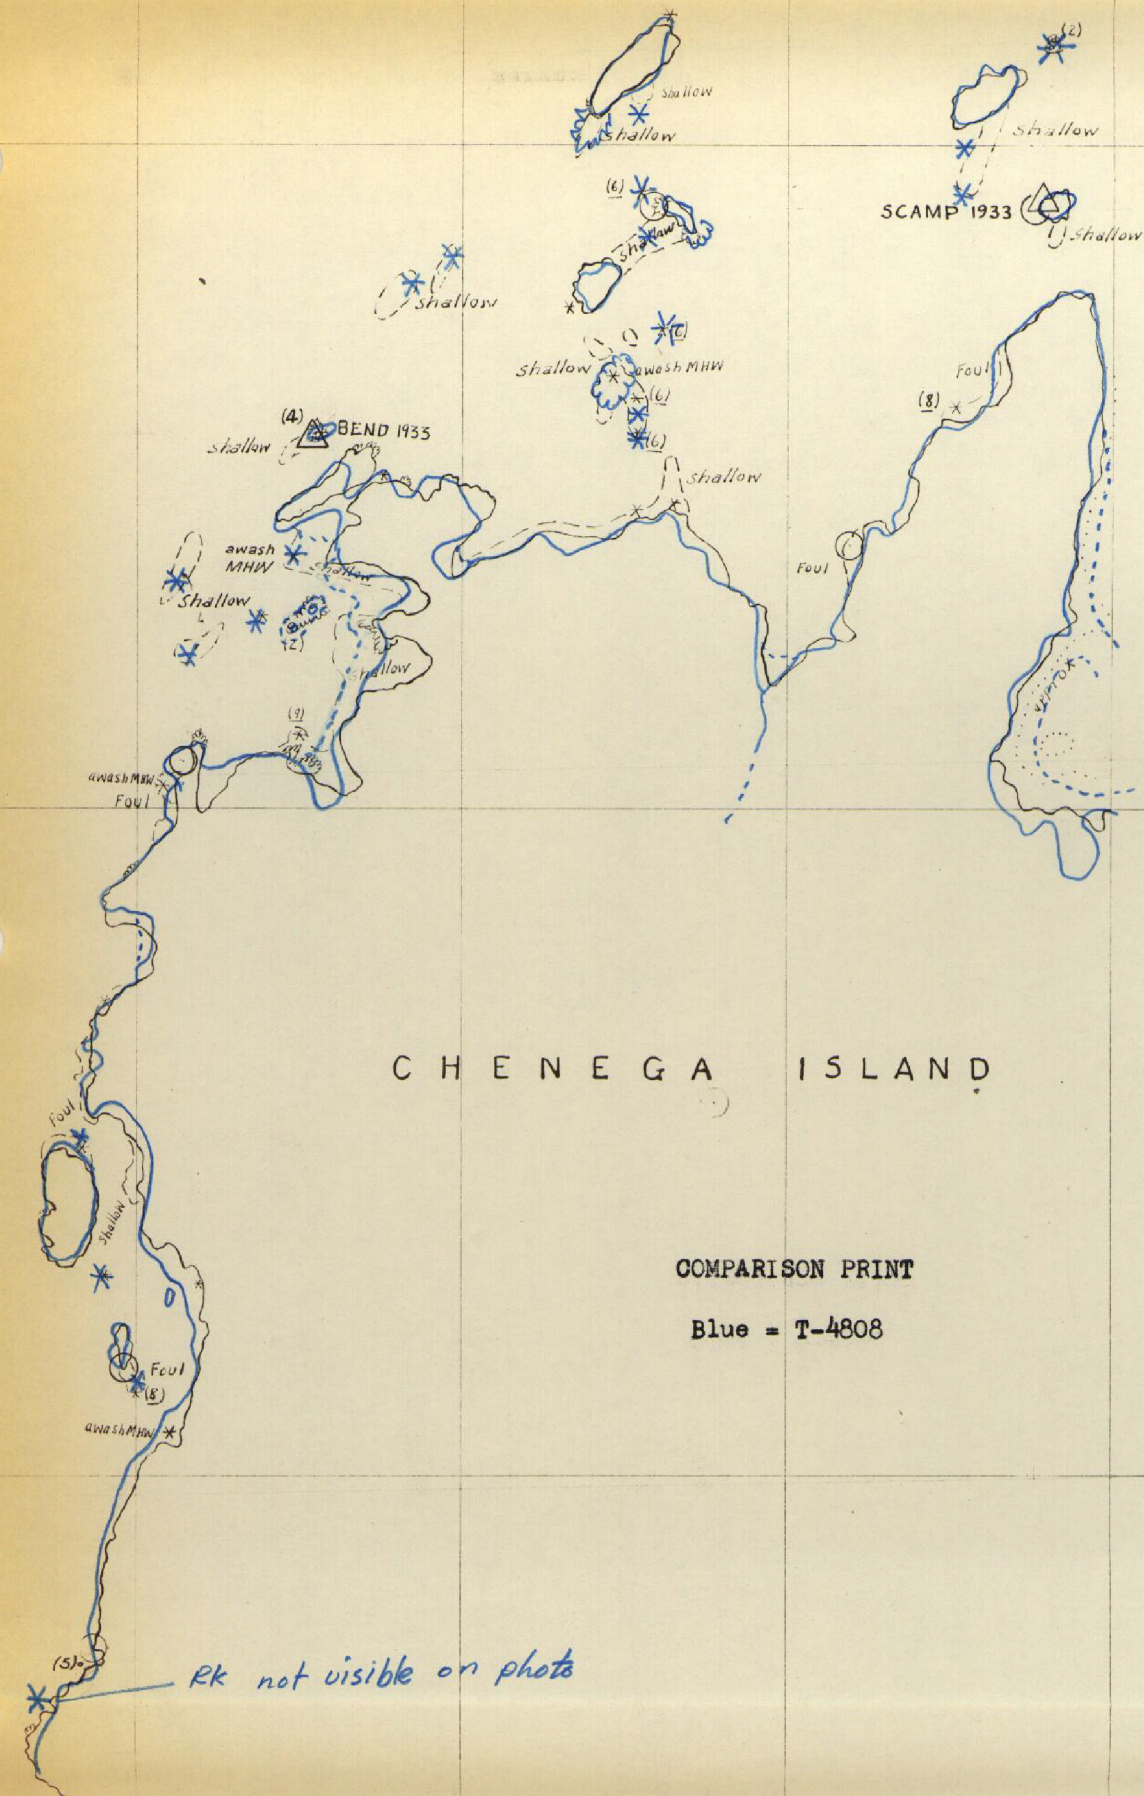
COMPARISON PRINT

Blue = T-4808

Brown = SEWARD (B-4)

An ozalid comparison print, (pages 26 through 32), with differences noted in Items 62 through 65, is bound with the original of this report.

A comparison was made with Survey No. T-4808, scale 1:10,000, dated May, June 1933. Differences between T-4808 and T-9824 are shown in blue on the comparison print.

A visual comparison was made with U.S.G.S. Quadrangle SEWARD (B-4), ALASKA, scale 1:63,360, dated 1951. Differences between the quadrangle T-9825 are shown in brown on the comparison print.
