DESCRIPTIVE REPORT

Type of Survey Shoreline (Photogrammetric)

Field No. ^{PH} 6117 Office No. T-11293

Locality Kasook Inlet to Grass Island

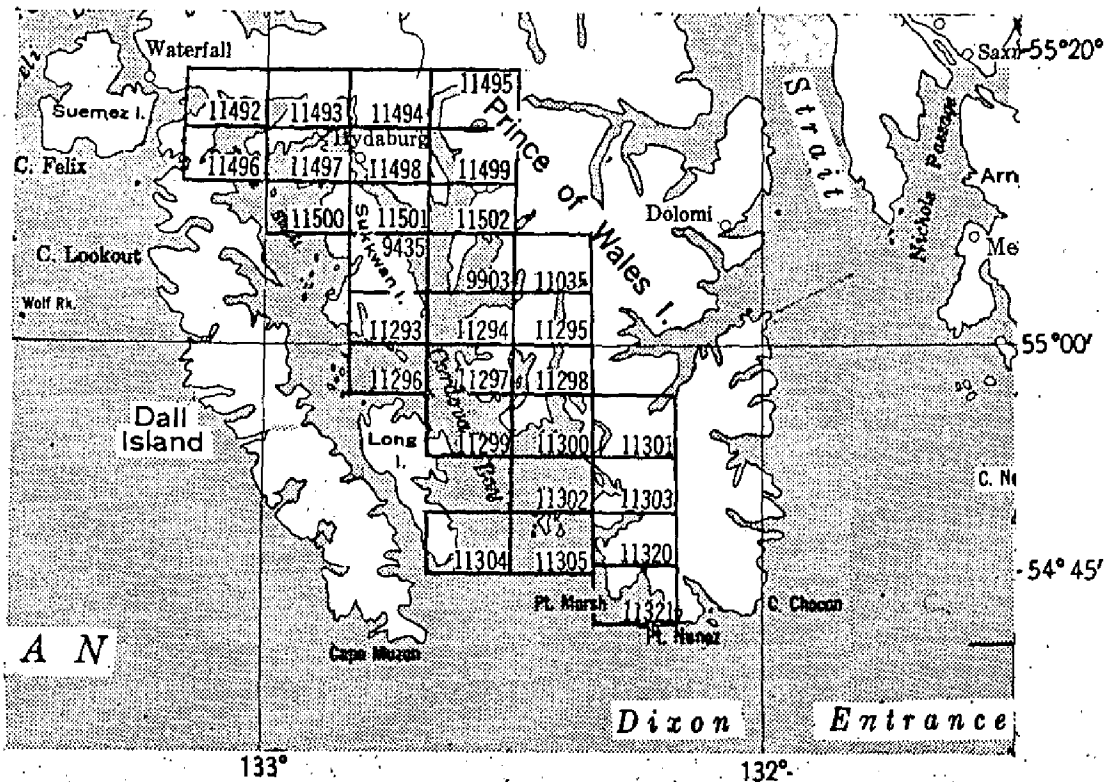
SHORELINE MAPPING PROJECT PH-117

Cordova Bay & Vicinity of S.E. Alaska

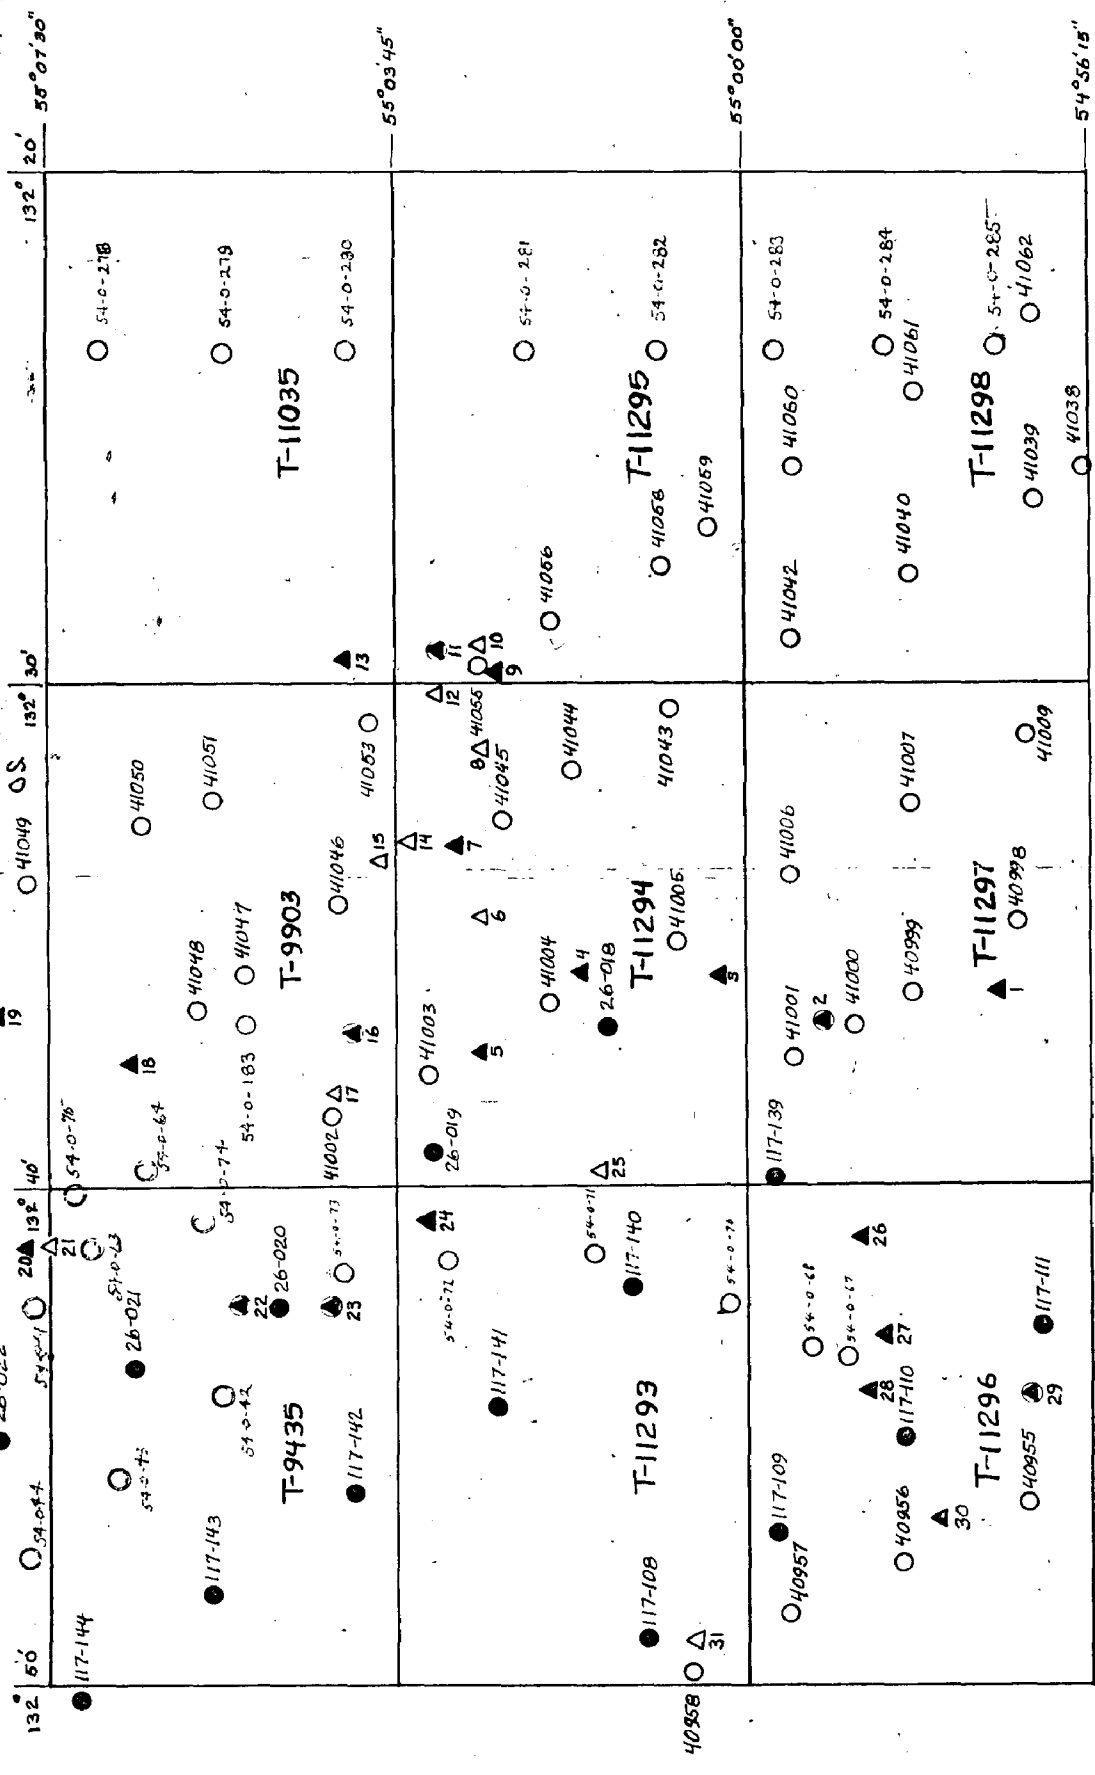
LAYOUT SKETCH
PH-117

SURVEYS NOS T-9435, T-9903, T-11035 and
T-11293 to T-11298 inclusive

A small plot was laid using fourteen (14) single lens ratioed photographs flown in June 1954. This was done so that the shoreline, which could only be approximately delineated in March 1954 because of inadequate photography, could be redelineated.
