DESCRIPTIVE REPORT

Type of Survey Shoreline (Photogrammetric)

Field No. ^{PH}6117 Office No. T-11296

Locality Jackson Island

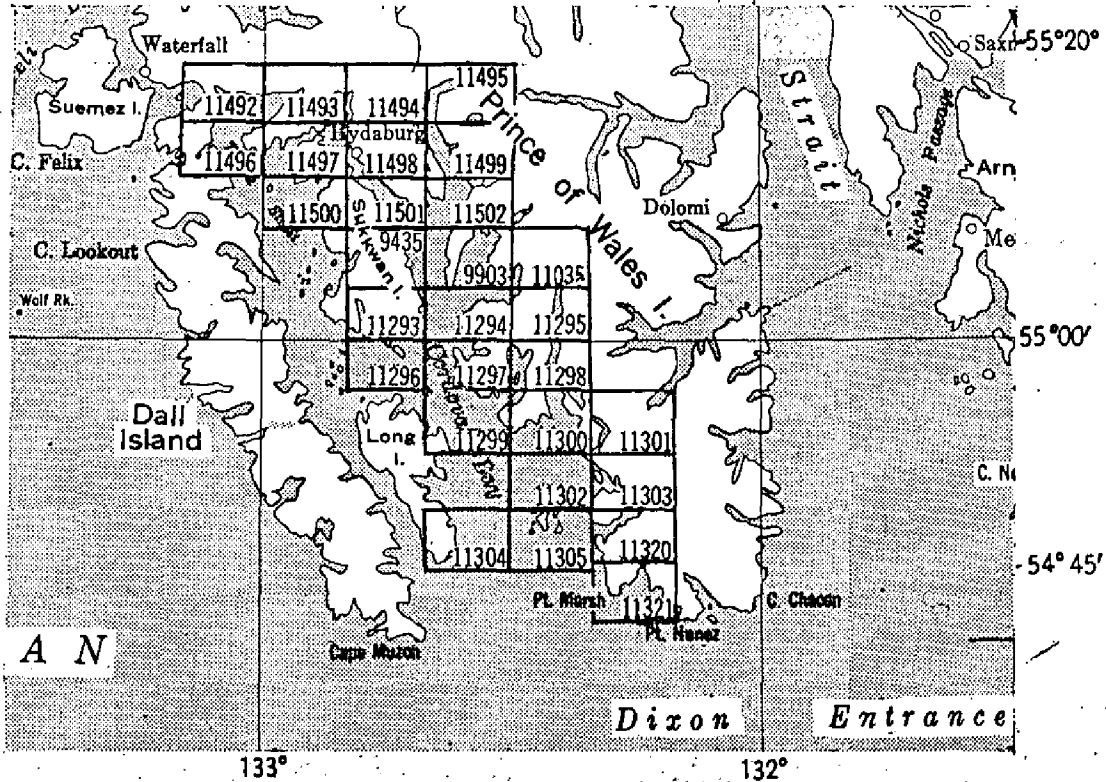
SHORELINE MAPPING PROJECT PH - 117

Cordova Bay & Vicinity of S.E. Alaska

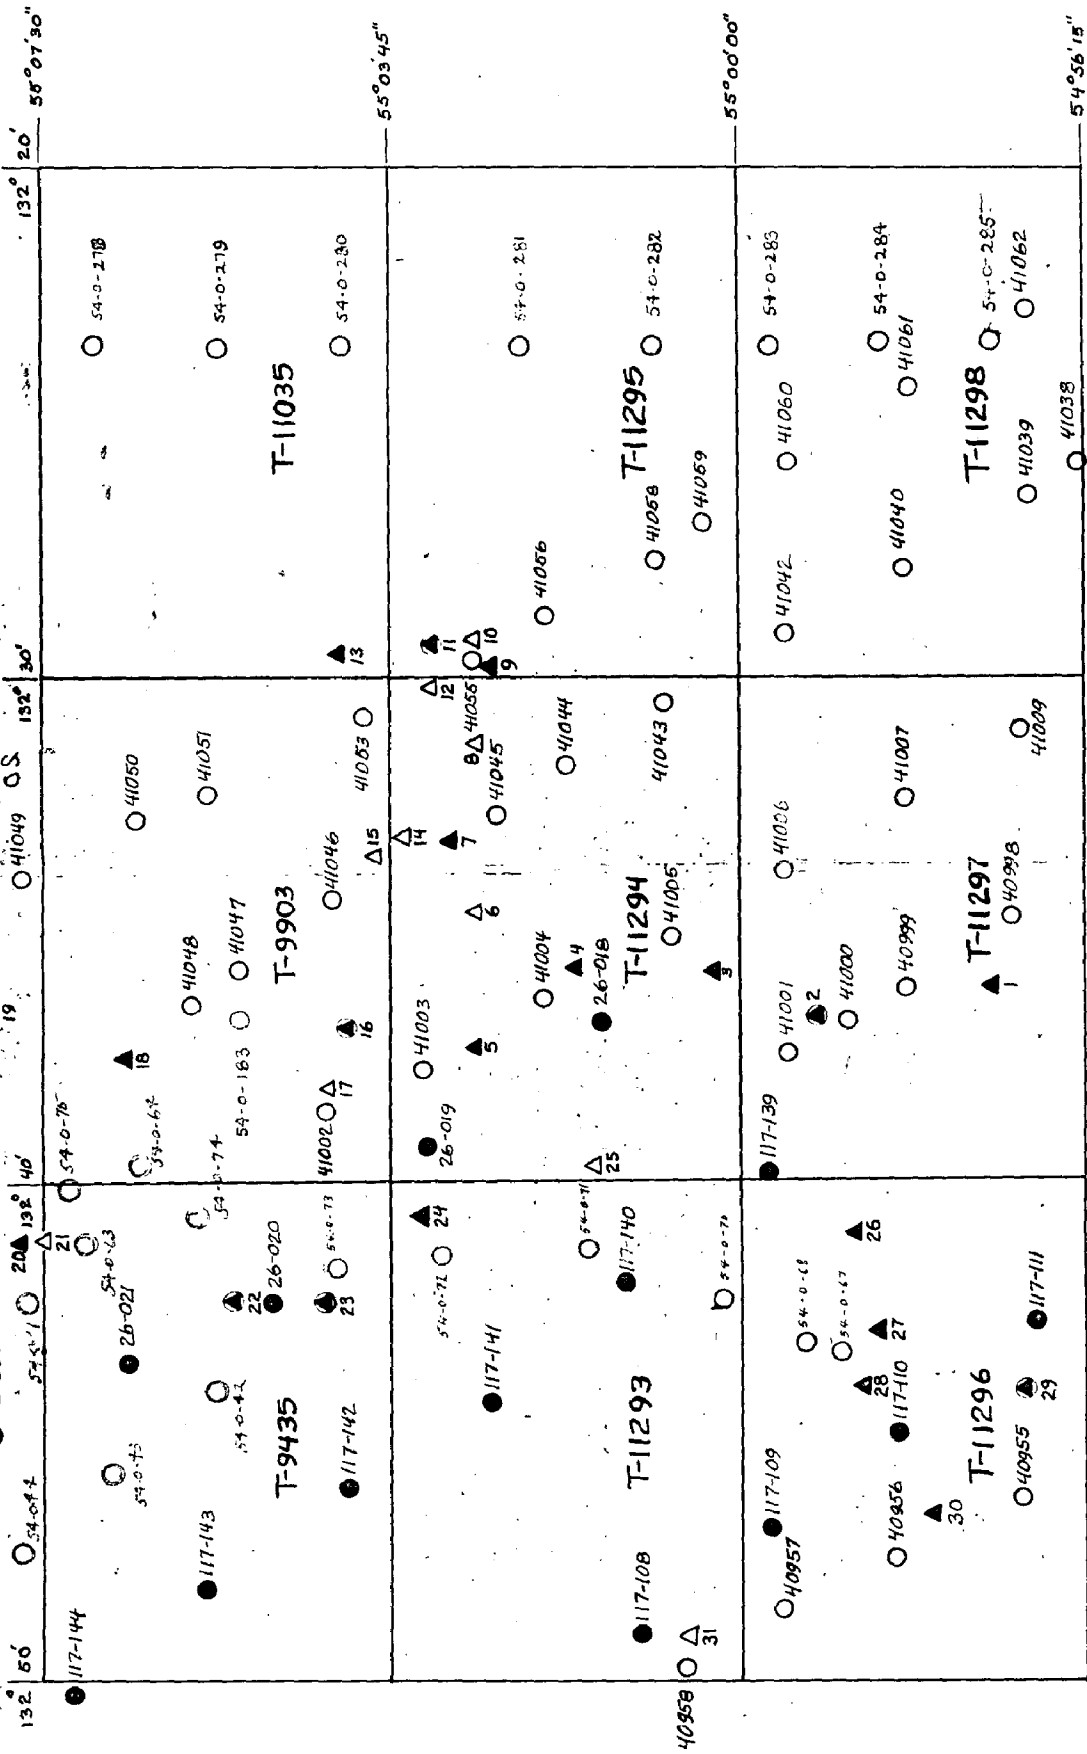
LAYOUT SKETCH
 PH-117
 SURVEYS NOS T-9435, T-9903, T-11035 and
 T-11293 to T-11298 inclusive
 ○ NINE LENS PHOTOGRAPHS
 ● SINGLE LENS PHOTOGRAPHS
 ▲ CONTROL STATIONS (identified)
 ○ CONTROL STATIONS (not held in plot)
 ▲ CONTROL STATIONS (not identified)
 ○ 1954 SINGLE LENS PHOTOGRAPHS
