Form 504	
U. S. DEPARTMENT OF COMMERCE COAST AND GEODETIC SURVEY	
DESCRIPTIVE REPORT	
Type of Survey	Shereline (Photogrammetric) T-11301, T-11303 T-11320 and T-11321 *
Field No.	Ph-117 Office No. T-11321 *
LOCALITY	
State	Alaska
General locality	Cordeva Bay
Locality	POINT Marsh, Hessa Inlet & Hunter Bay
1953-1954	
CHIEF OF PARTY F. R. Gessett, Chief of FIELD PARTY E. H. Kirsch, Baltimore Photo. Office	
LIBRARY & ARCHIVES	
DATE

SHORELINE MAPPING PROJECT PH-117
Cordova Bay & Vicinity of S.E. Alaska

Summary to Accompany
Descriptive Report
All T-Numbers
PH-117

LAYOUT SKETCH
PH-117

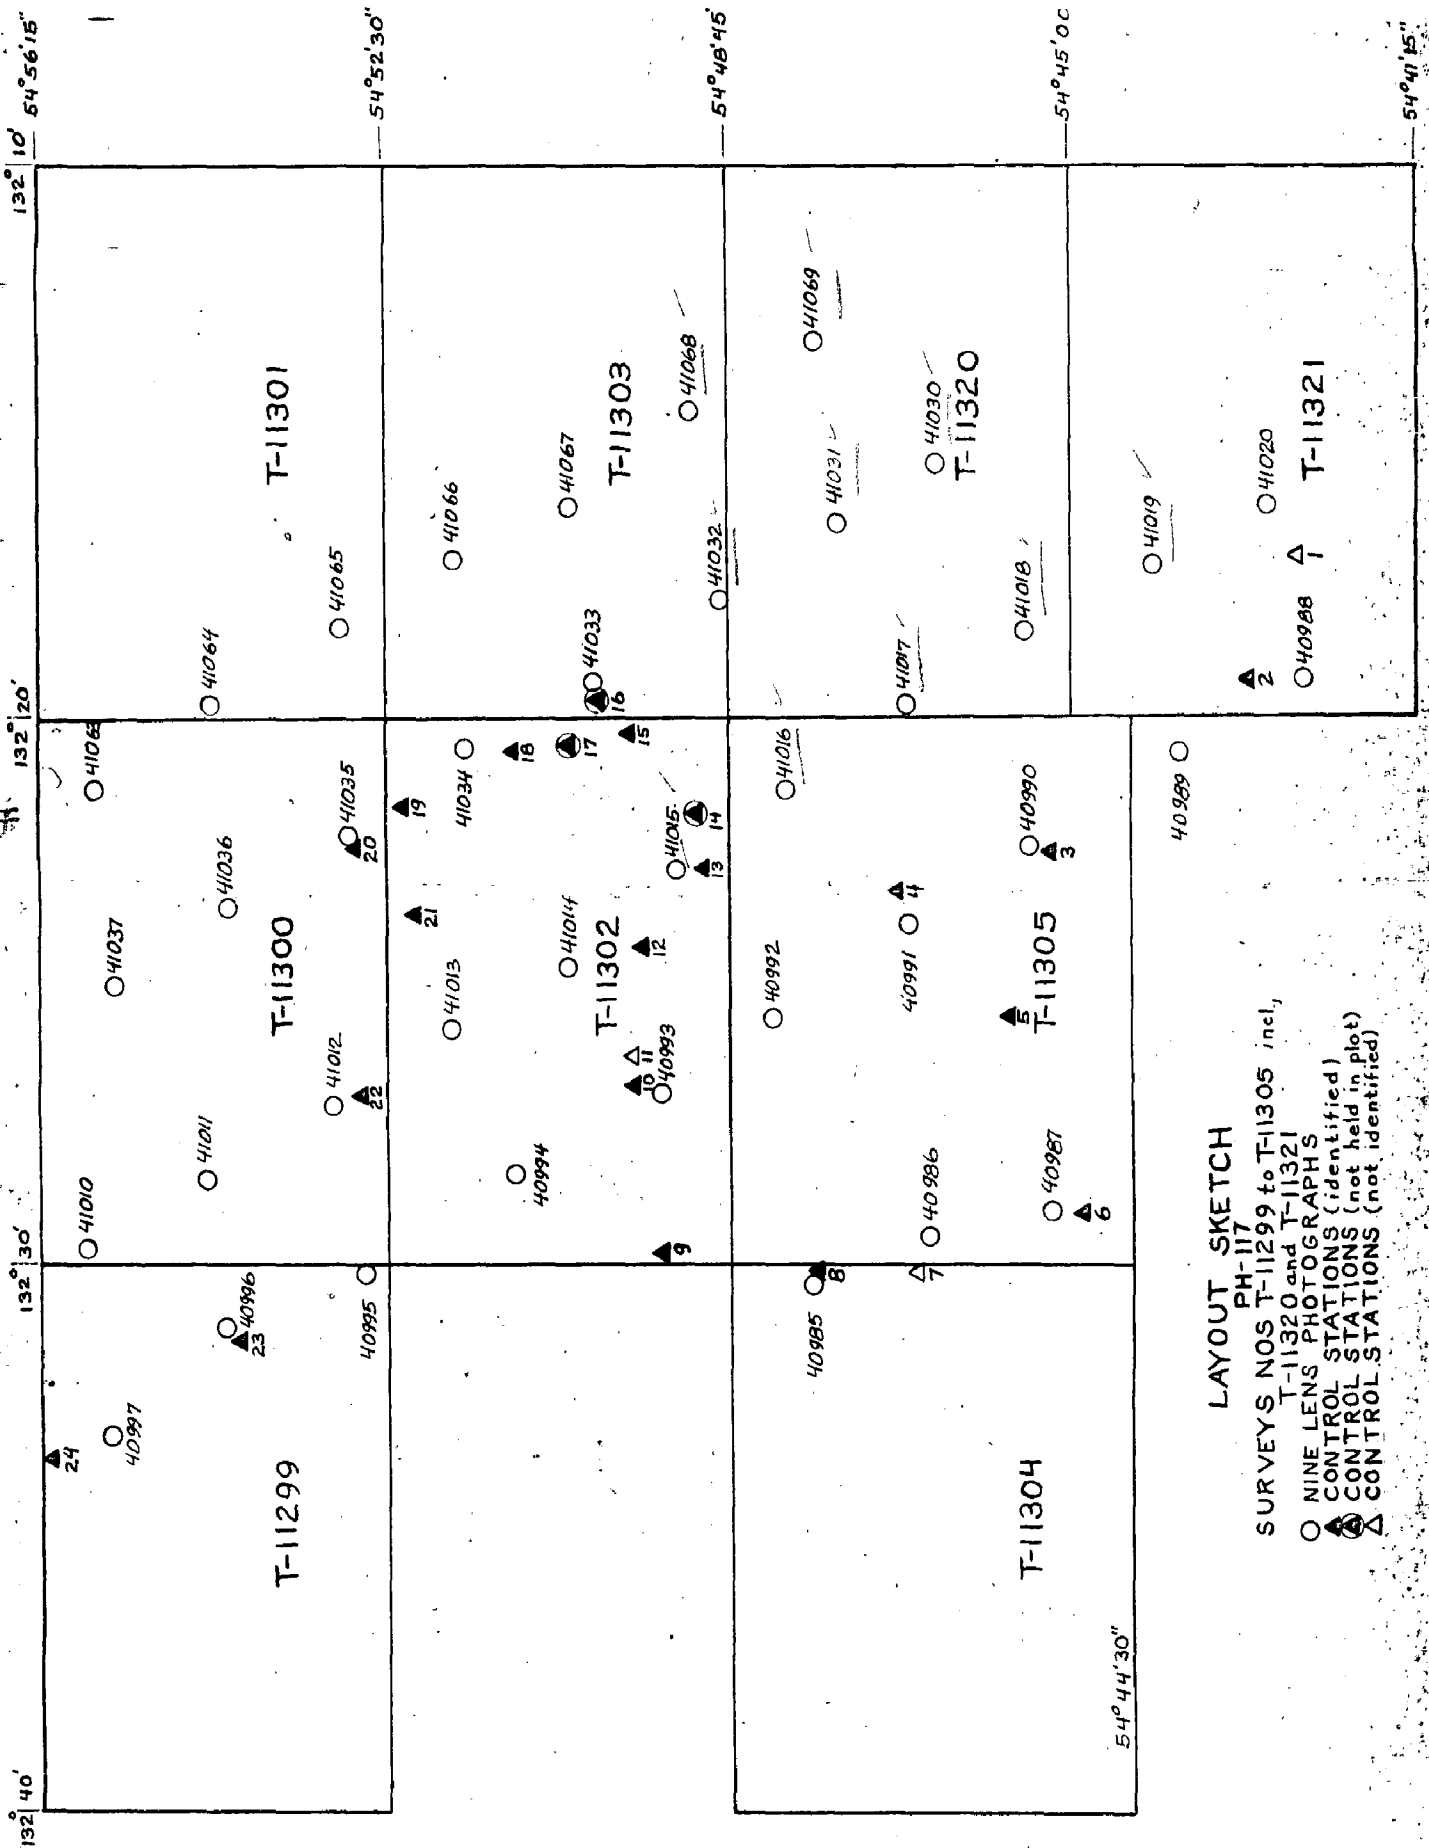
SURVEYS NOS T-11299 to T-11305 incl,
T-11320 and T-11321
O NINE LENS PHOTOGRAPHS
▲ CONTROL STATIONS (identified)
△ CONTROL STATIONS (not held in plot)
