FORM C&GS-504 U.S. DEPARTMENT OF COMMERCE ENVIRONMENTAL SCIENCE SERVICES ADMINISTRATION COAST AND GEODETIC SURVEY	
<h2>DESCRIPTIVE REPORT</h2>	
Type of Survey	SHORELINE (PHOTOGRAMMETRIC)
Field No.	Office No. T-12191
LOCALITY	
State	Alaska
General locality	Keku Strait
Locality	Keku Islands, S. E.
<u>1961-1969</u>	
CHIEF OF PARTY	
Alfred C. Holmes, Director, AMC	
LIBRARY & ARCHIVES	
DATE

T - 12191

SHORELINE MAPPING PROJECT

KEKU STRAITS, ALASKA

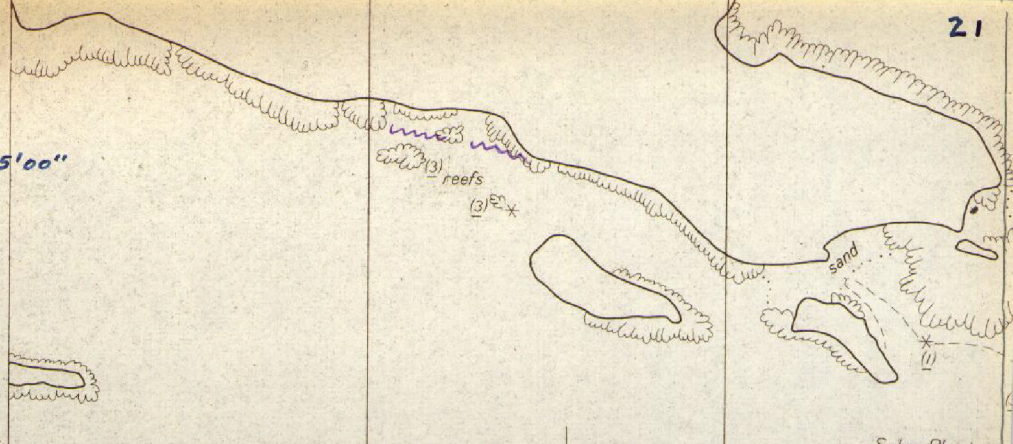
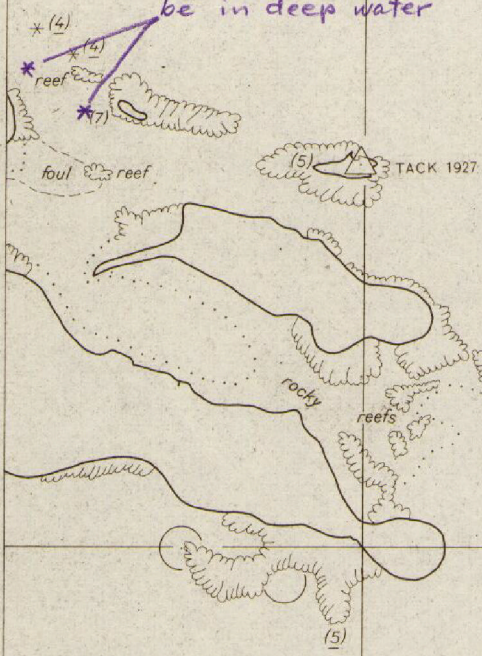
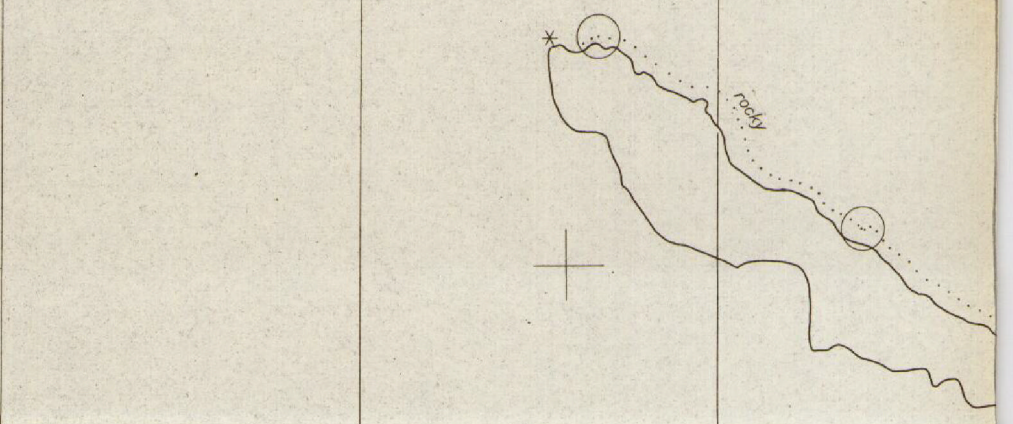
COMPARISON PRINT

Not on Photos GIW
9410, 11, 12. These
positions appear to
be in deep water

Purple = H-9040

Discrepancies that exist between the boat sheets and T-12191 have been indicated on the comparison print in purple.

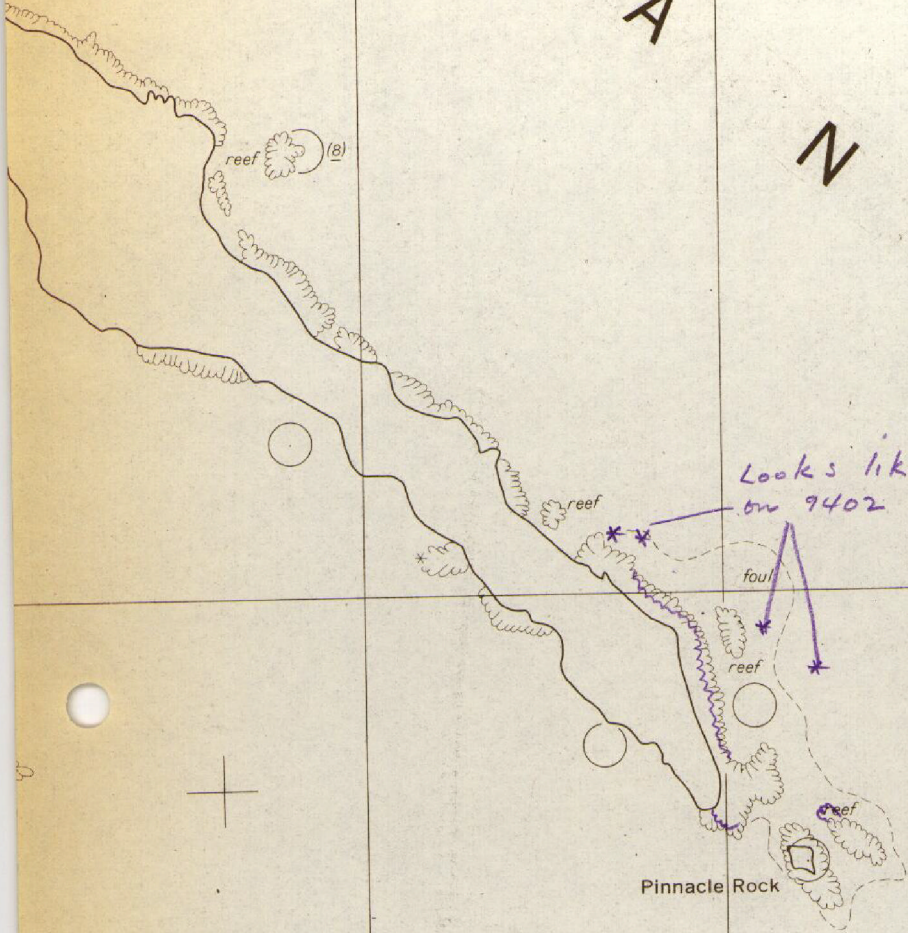
COMPARISON PRINT

Looks like kelp on 9402

Purple = H-9040

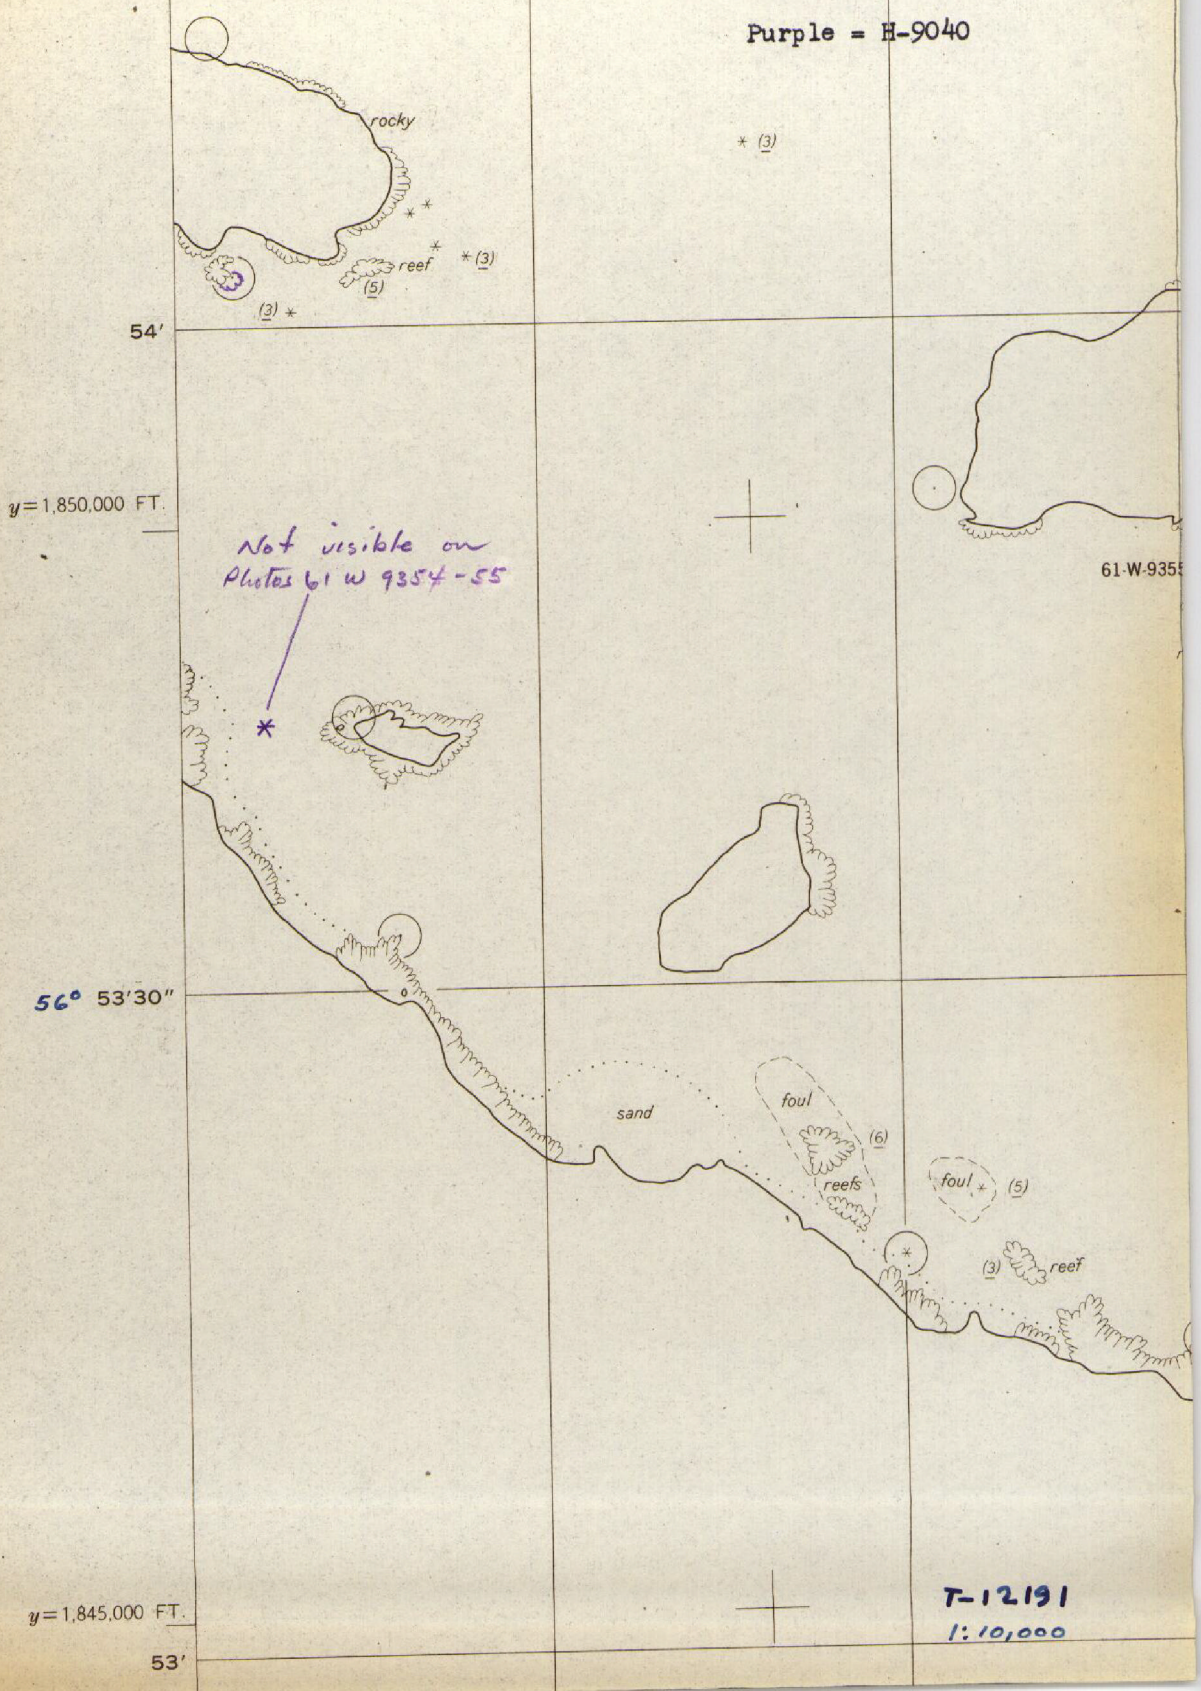
COMPARISON PRINT

Purple = H-9040
