T-13314

DESCRIPTIVE REPORT

SUMMARY TO ACCOMPANY  
DESCRIPTIVE REPORTS T-13314,  
T-13315 and T-13316

PHOTOGRAMMETRIC PLOT REPORT  
HILO BAY, HAWAII  
Job PH-6703  
November 14, 1975

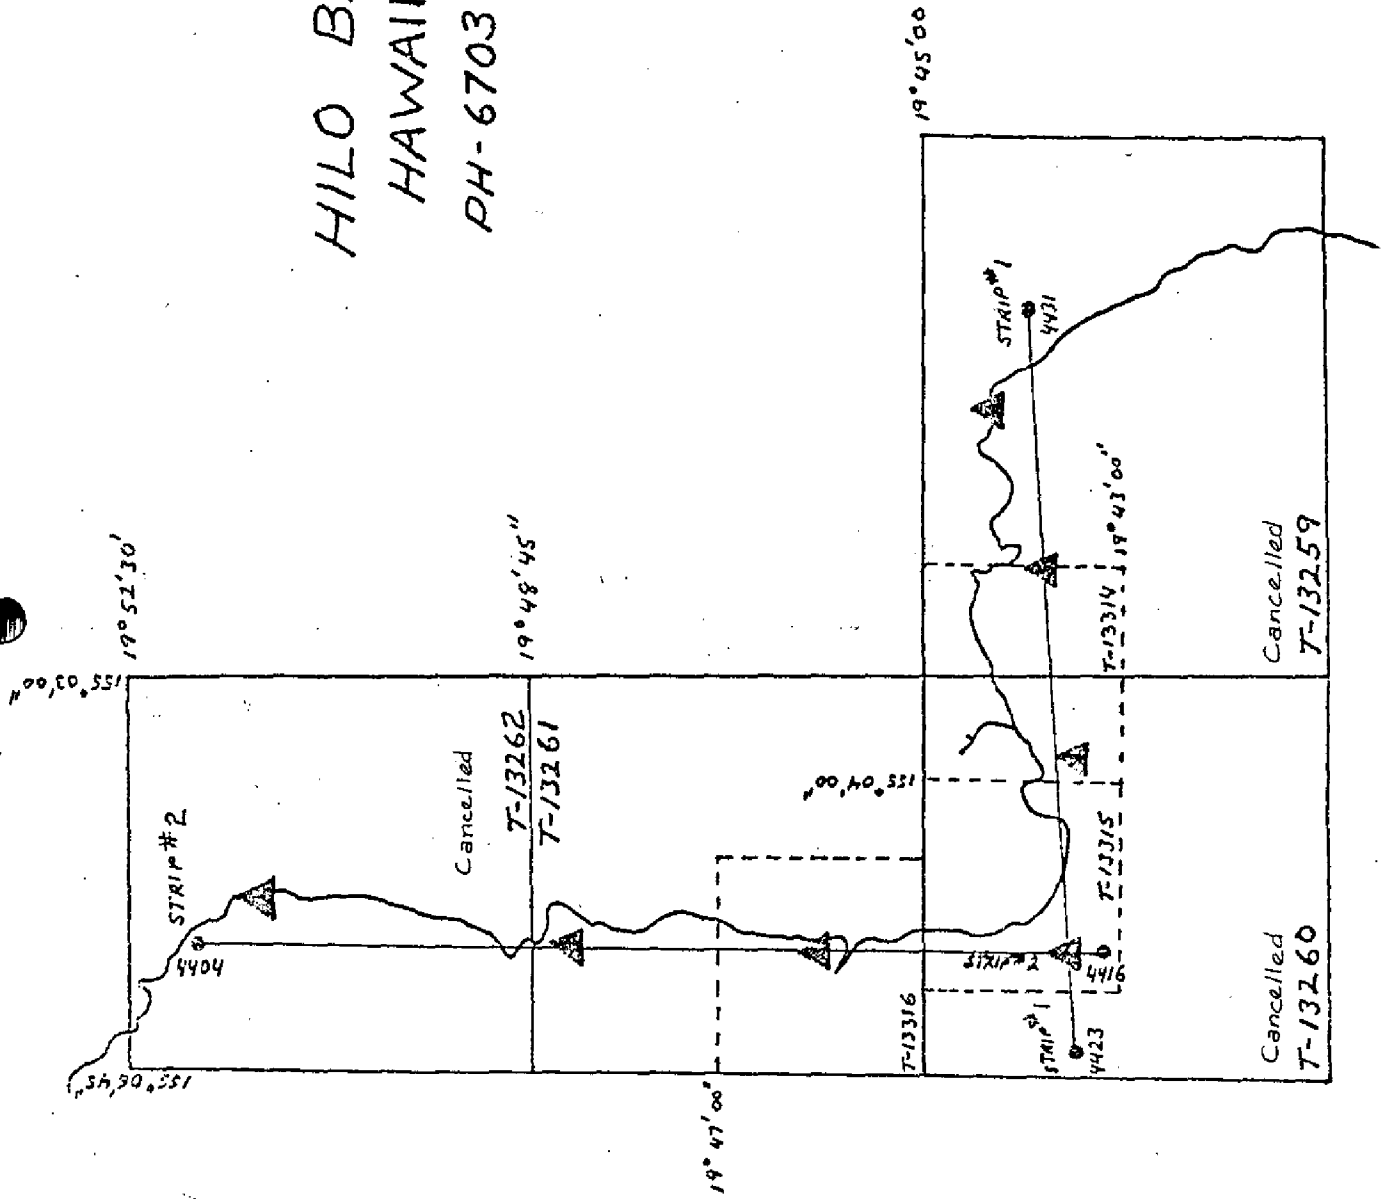
# HILO BAY HAWAII PH-6703

Area Covered: The area covered in this project <sup>is</sup> ~~the~~ the east coast area of the island Hawaii. This area is covered by four 1:10,000-scale sheets, T~~13~~-13259 thru T~~13~~-13262 and three 1:5,000-scale sheets, T~~13~~-13314 thru T~~13~~-13316. Note: T-13259, T-13260 + T-13262 are cancelled. A.L.S. 5/24/78

Method: Two strips of 1:15,000 scale black-and-white photography were bridged by analytic aerotriangulation methods. The two strips of bridging photography were controlled by field-identified control.

Common points were located on the bridging photography for ratio purposes. Tie points were used to insure an adequate junction of the strips during the adjustment.

# List & Accuracy of Control Used In Strip Adjustment
