TOPOGRAPHIC TITLE SHEET

General locality South Shore of Long Island

Locality Outer Coast between Header Creek and Tiana Beach

FIELD REPORT
for
AIR PHOTO TOPOGRAPHIC SHEET FIELD (NO. 30)

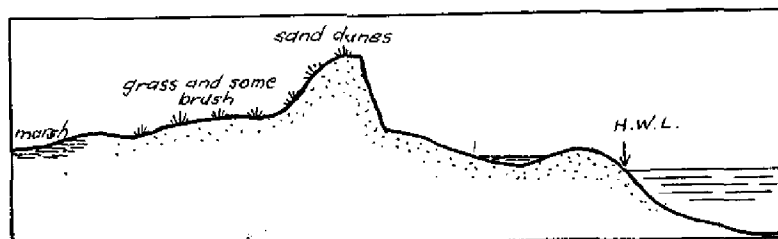
A characteristic of the beach along the south coast of Long Island is the built up sand ridge along the high water line with a slight depression inland just in front of the dunes. This depression is often filled with water from the wash of high waves over the ridge (at H. W.) and in many cases some of the darker colored top soil is blown from the inland area and is retained in this depression. Although the contrast in coloring is not marked it can sometimes be identified on the photographs. It must be noted that the high water line is really at the outer boundary of the ridge and not at the foot of the dunes. Beyond the high water line the beach drops off fast so the stage of tide would have little influence on interpretation of high water line.

Nearby dwellers have stated that a heavy sea may destroy this characteristic feature but after a time the ridge is again built up by wave action.

* The H.W. line as shown on this sheet is considered correct as of the date of the photographs. The low ridge of island at H.W. line as shown in the sketch on page 1 may have washed out prior to the date of the planotable survey several months after the photographs were taken. It seems probable from the discussion

The high water line as shown on the aluminum control sheet does not agree with the high water line as shown on this air-photo topographic sheet. As explained in the preceeding field report, there is a slight depression inland from the high water line and this may have been interpreted as the high water line by the topographic party. In some localities the high water line (as shown by the field topographic party) passes through the outer edge of sand dunes which can be readily identified on the photos (photo V-38 about 150 meters S. W. of signal Let; photo V-48 about 200 meters S. W. of signal Gob). **See opposite page.*
