DESCRIPTIVE REPORT

Type of Survey Topographic

T-9430

General locality Kotzebue Sound, North.

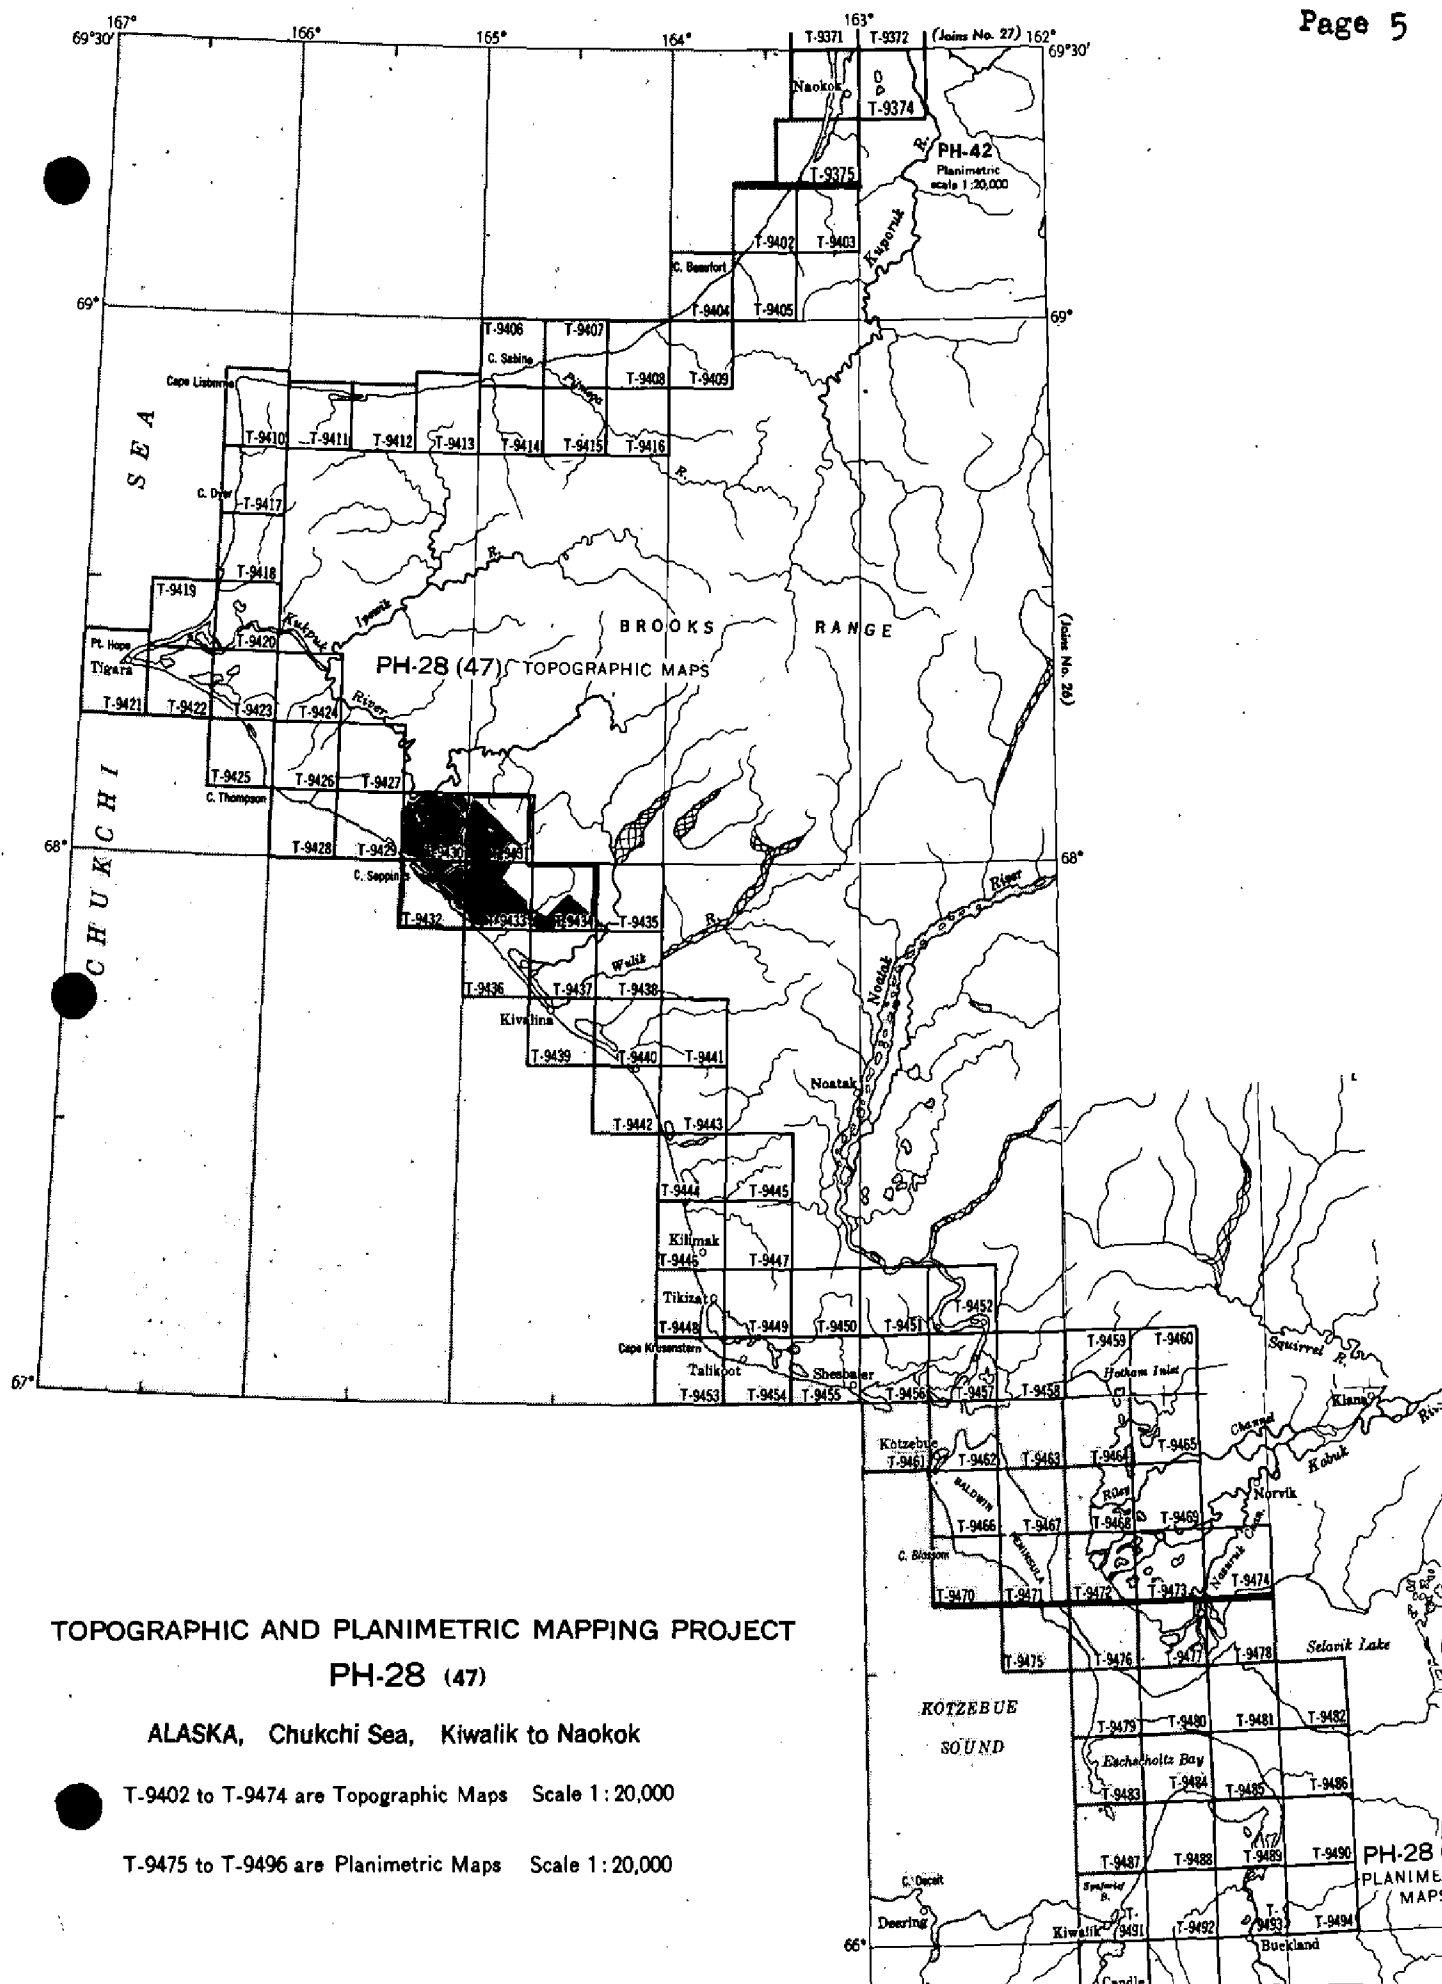
Contours and cultural features were delineated simultaneously on the Reading Plotter, model B. Of the five quads being reported herein, only one has its land area completely mapped; it is T-9432. The other four, in general, are not mapped in their back limits, in the area away from the coastline. This was caused by mapping photos having been flown generally parallel to the shoreline, and the inshore flight having two gaps in it, one extending across T-9433 northward into T-9431 and southward into T-9434, and the other gap\* being in the NW corner of T-9430. The map outline diagram on page 5 also outlines the back limits of compilation, showing the area mapped in red.
