## DESCRIPTIVE REPORT

Type of Survey Topographic

Field No. **Ph-28 (47)** Office No. **T-9143** **T-9439 thru**

Locality Coastal area north of Cape

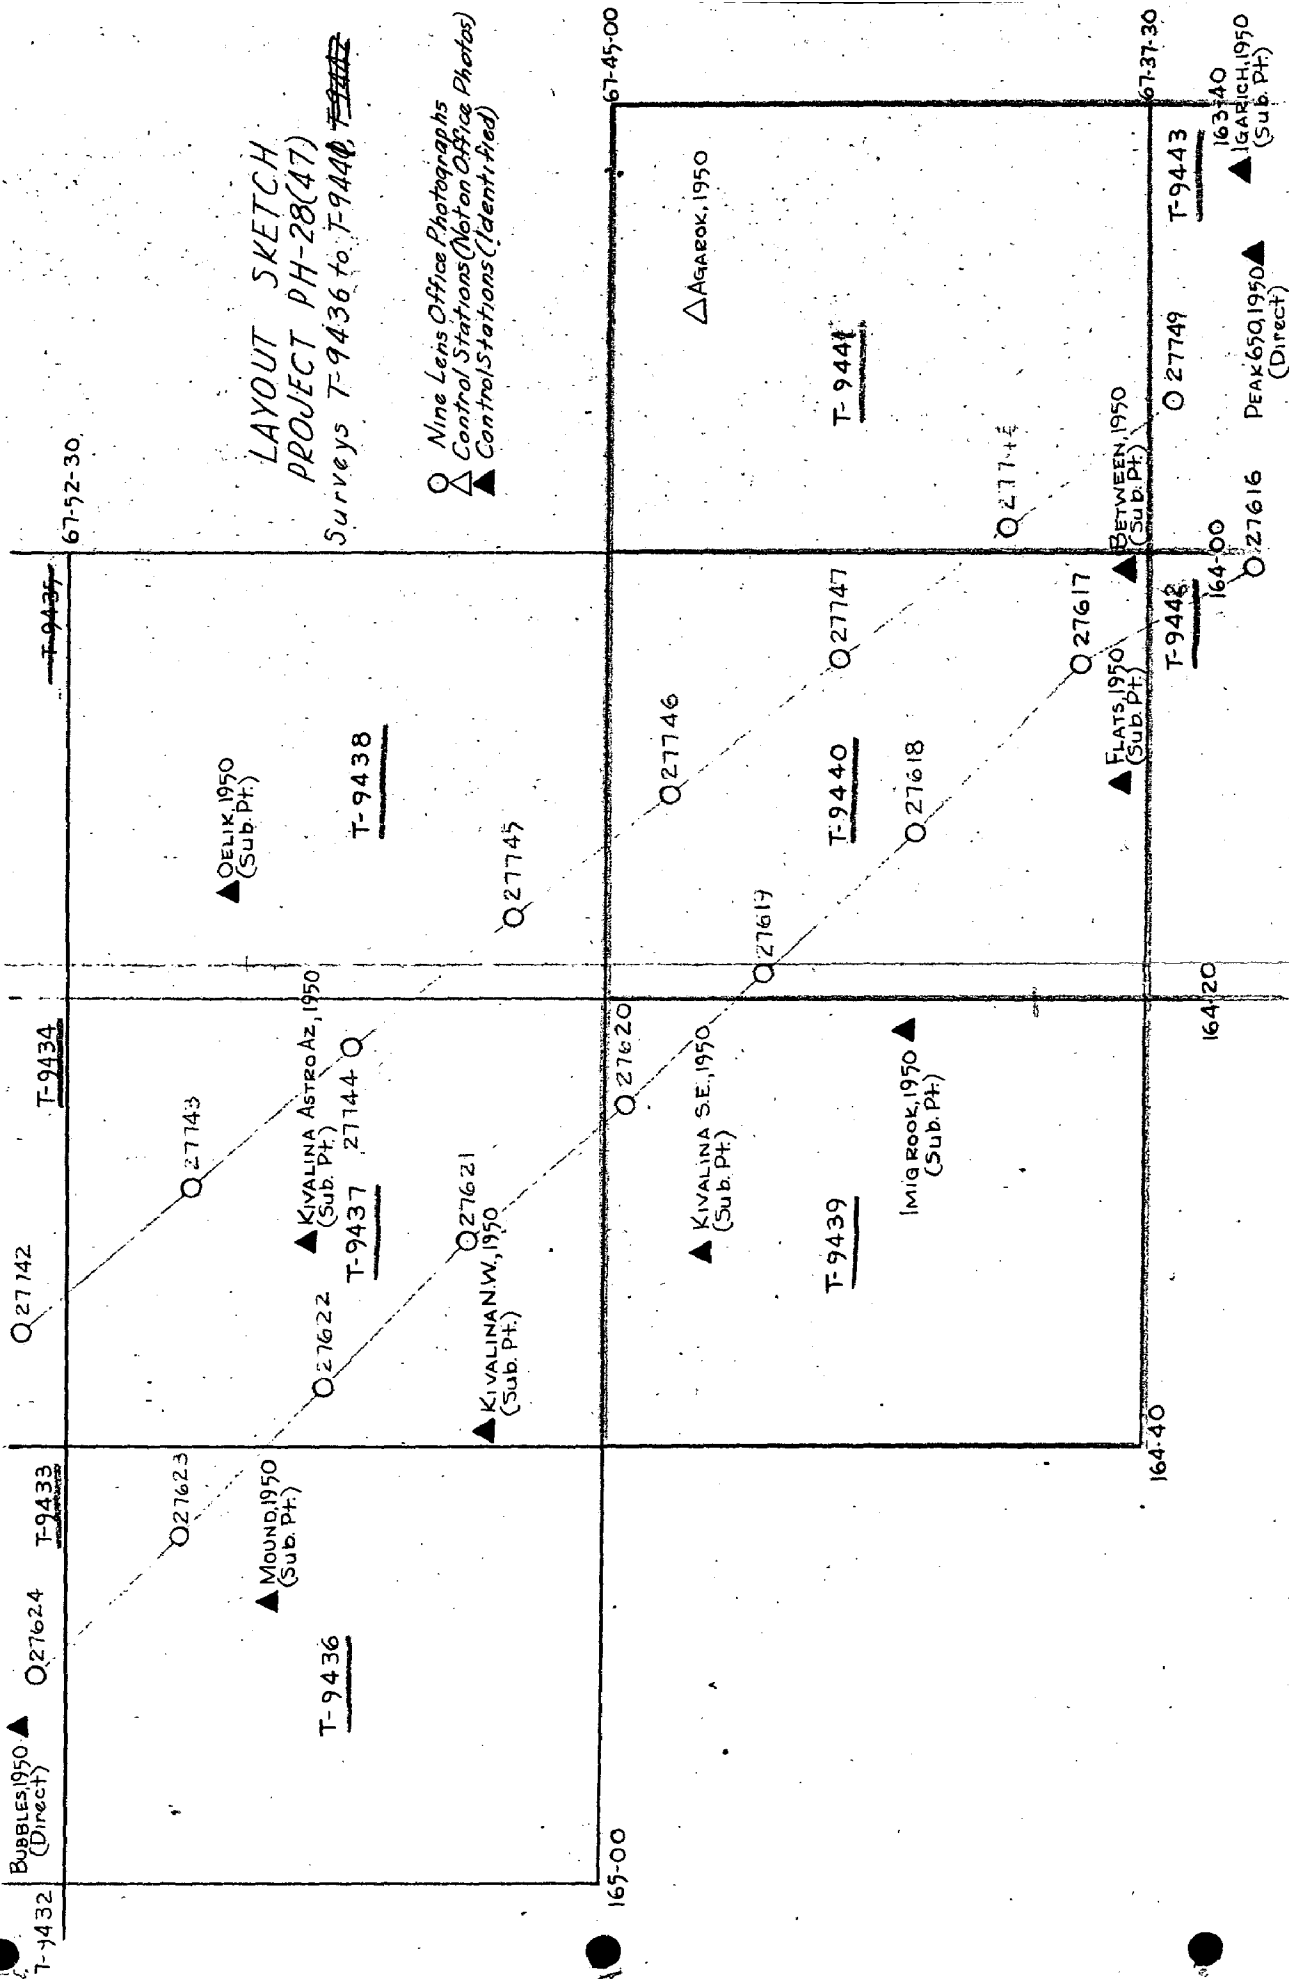
A sketch showing the layout of these surveys and the distribution of photograph centers and control is attached to this report.

○ Nine Lens Office Photographs  
△ Control Stations (Not on Office Photos)  
▲ Control Stations (Identified)
