DESCRIPTIVE REPORT

Type of Survey Topographic

T-9479, 9480

Locality Lower Baldwin Sound

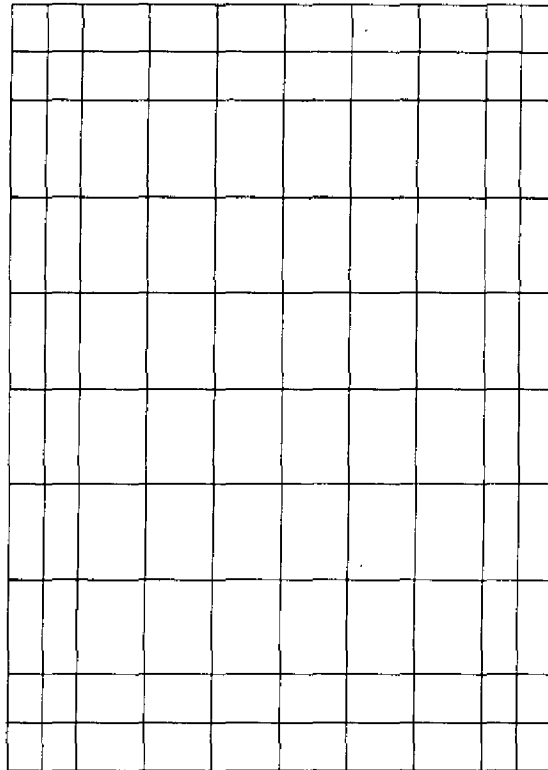
Areas contoured by various personnel

100% compiled on the Reading Plotter, model "B",  
by the team of:

Louis Levin and  
Orvis N. Dalbey
