## DESCRIPTIVE REPORT

Type of Survey Topographic  
Field No. Ph-28 (47) Office No. T-9484  
thru  
T-9486

State Alaska  
General locality Kotzebue Sound  
Locality Eschscholtz Bay

SURVEYS T-9482, T-9484 to T-9496, inclusive

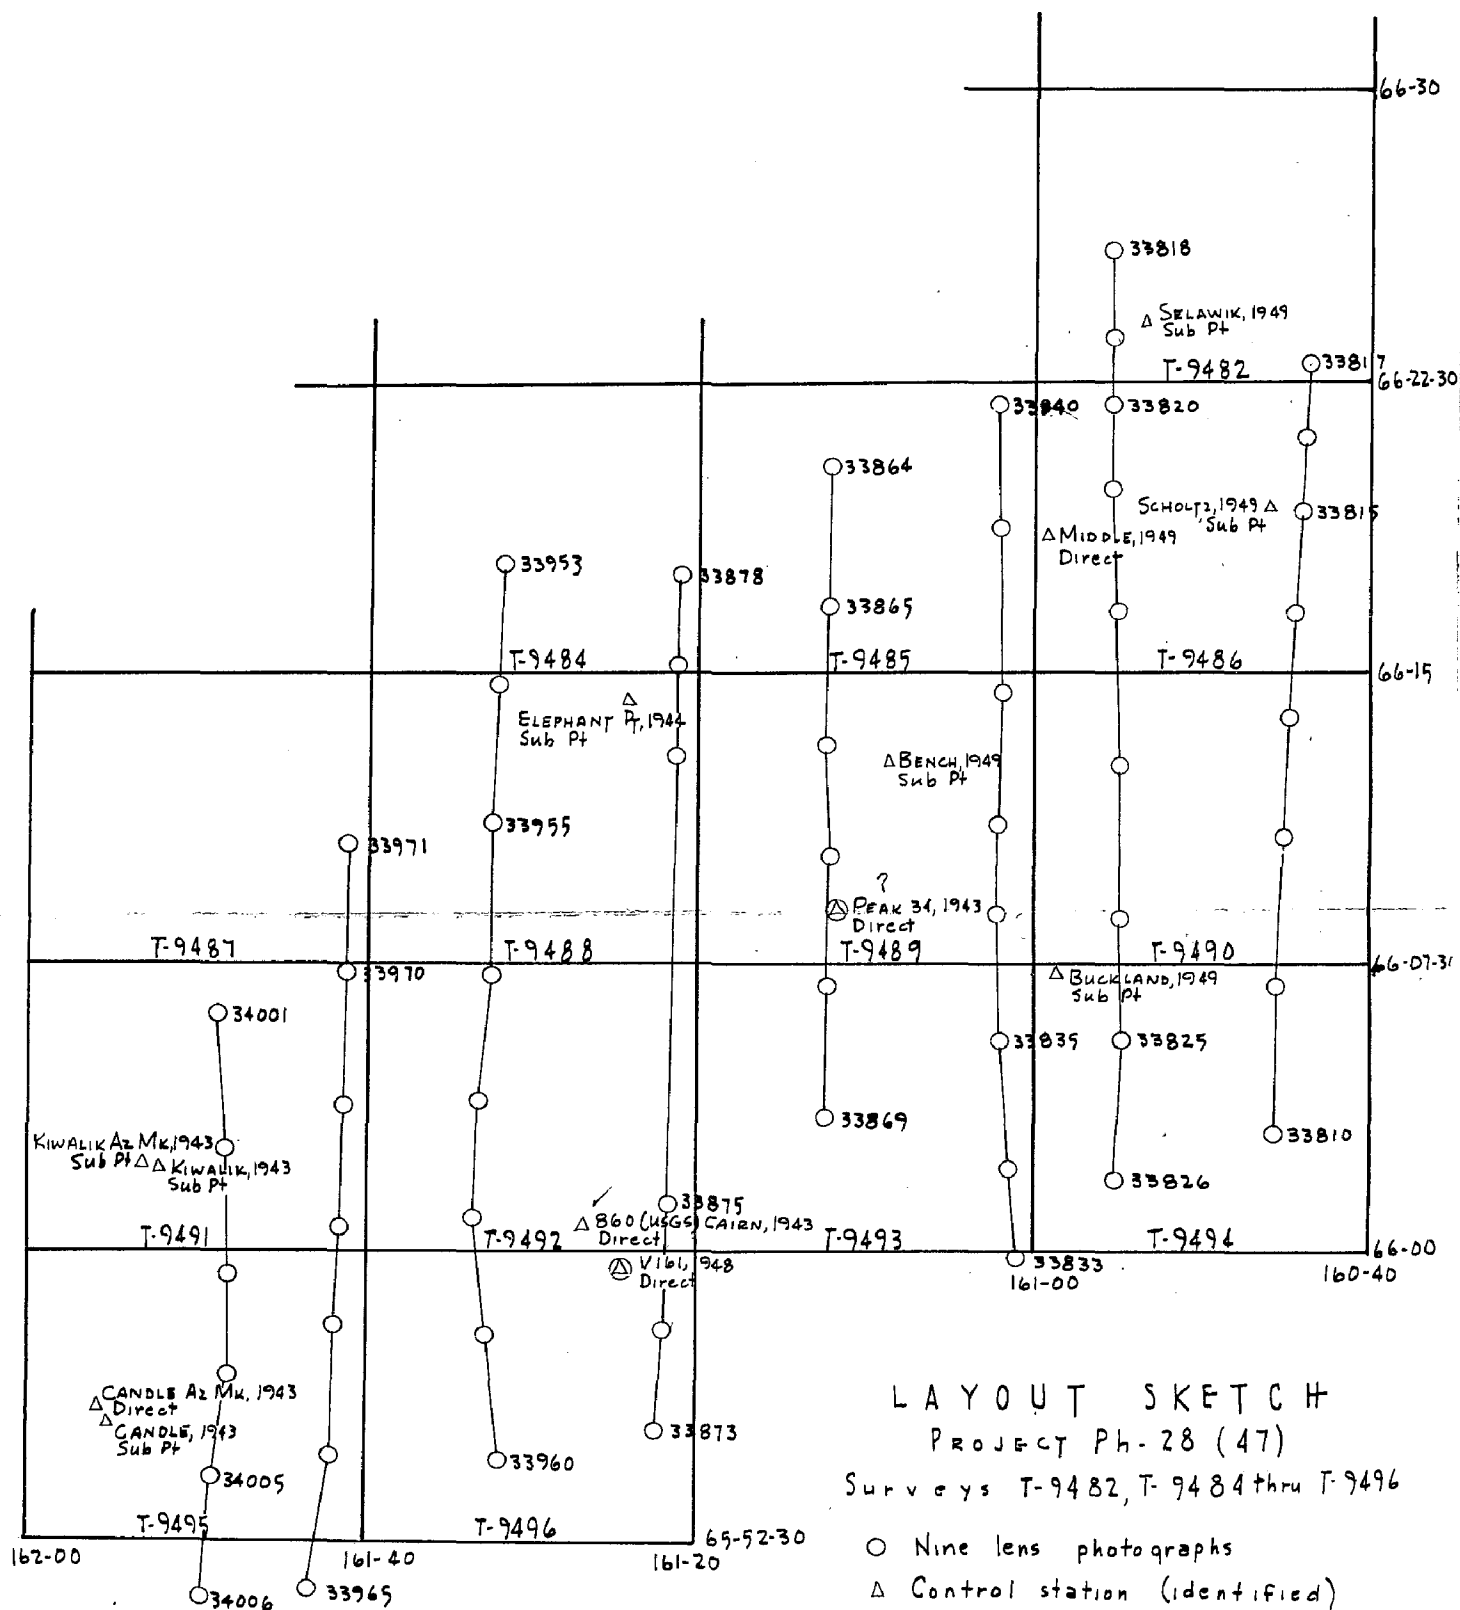
A sketch, showing the layout of surveys in this plot and the distribution of control and photograph centers, is attached to this report.
