## DESCRIPTIVE REPORT

Type of Survey ..Coastal..Zone..Map.....

Job No. PH-7113..... Map No. TP-00429.....

Locality ..Cutler..Ridge..to..Fender..Point.....

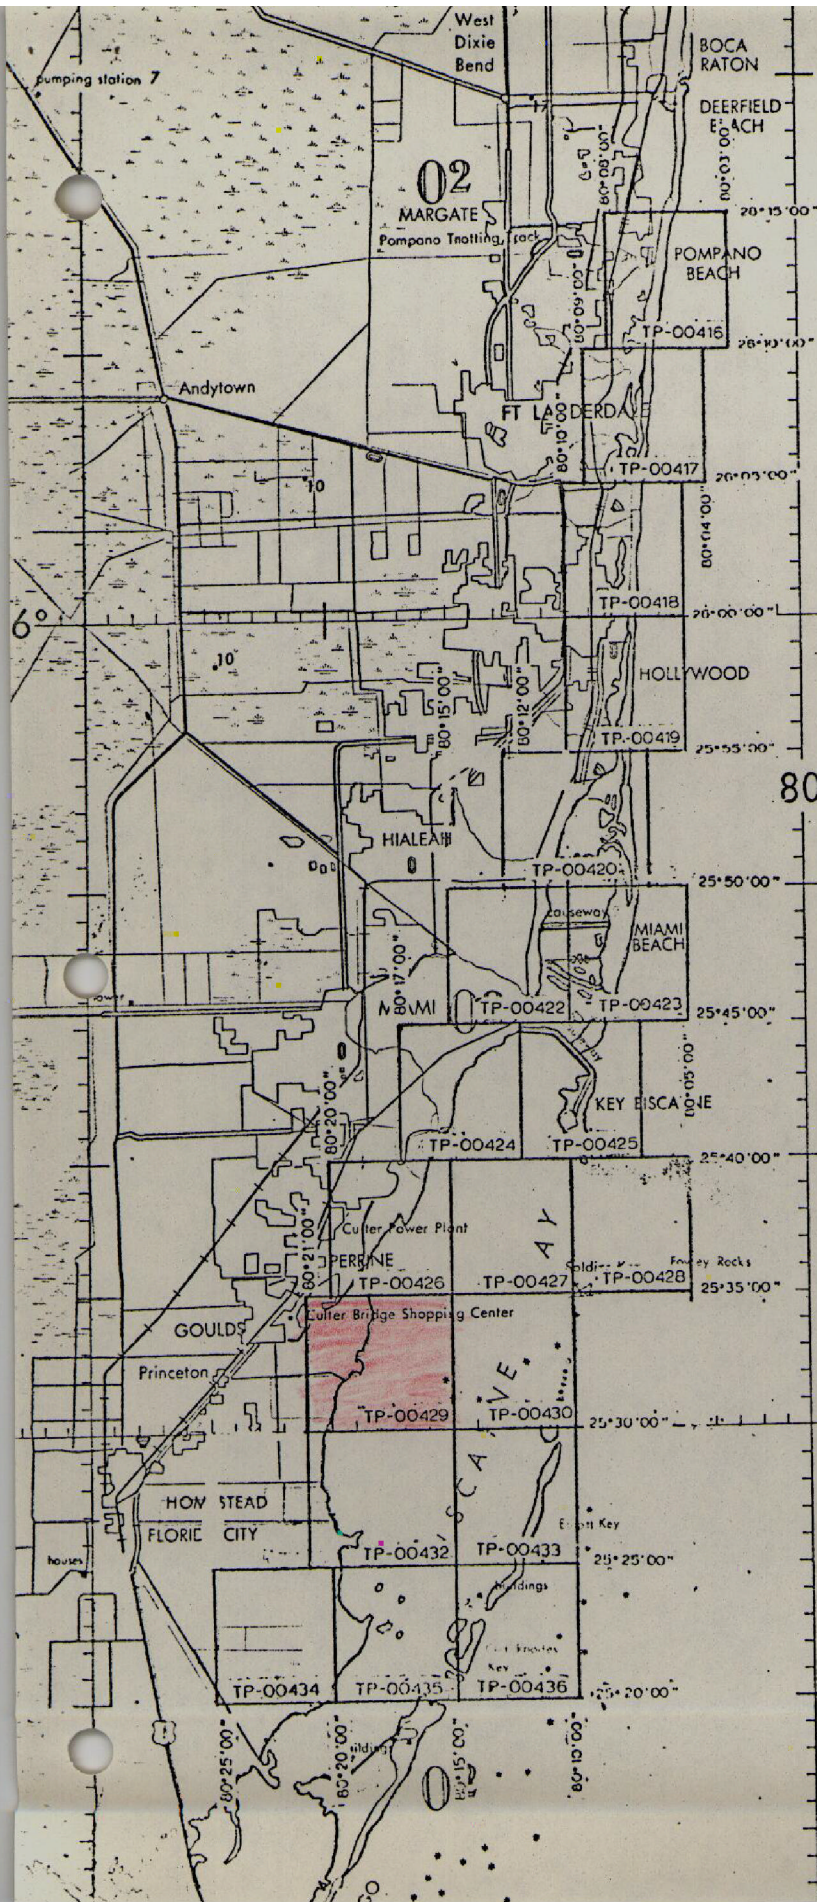
JOB PH-7113  
HILLSBORO INLET to CARD SOUND  
FLORIDA  
SHORELINE MAPPING  
SCALE 1:10,000

A layout for Job PH-7113 (revised since the aerotriangulation operation) will show the location of individual maps. A copy of this layout is included in this Descriptive Report.

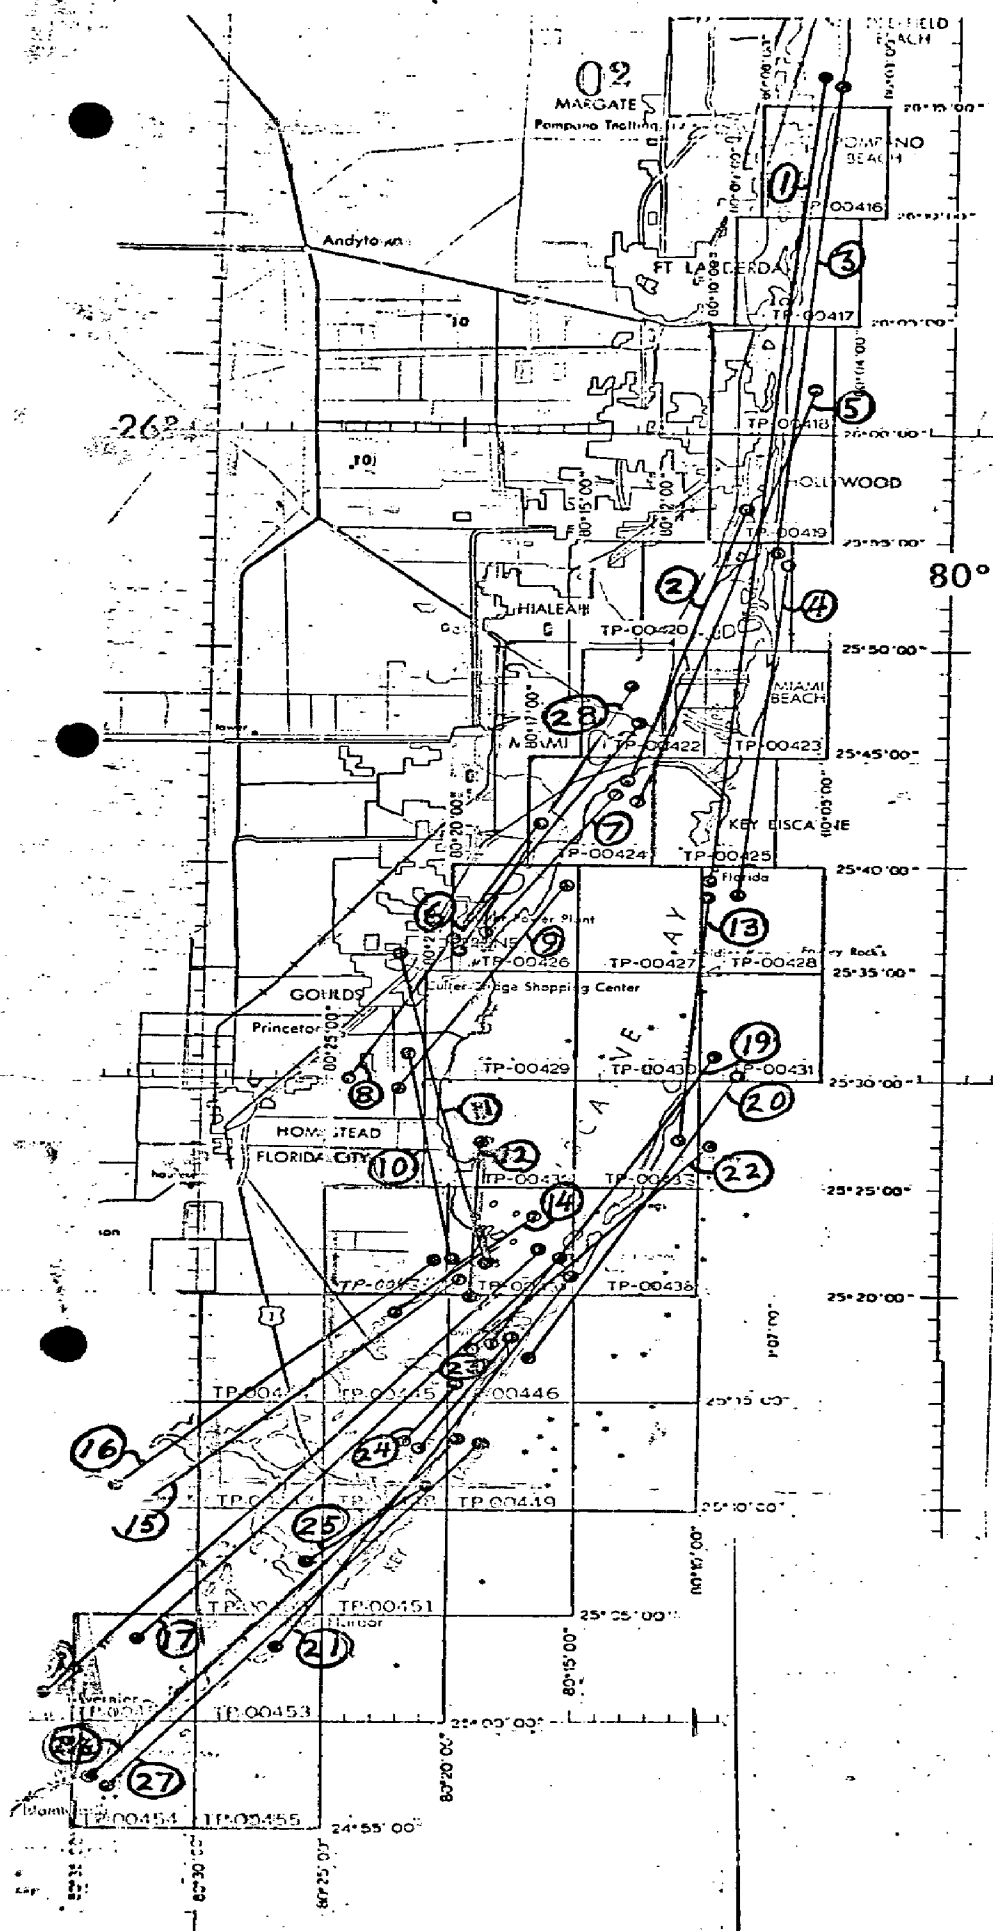
INFRA-RED CONTACT  
PRINTS RATIOED FOR  
COMPILATION

## INFRA-RED CONTACT PRINTS

1. 71K 5632R - 5660R MLW
2. 71K 5662R - 5672R MLW
3. 71K 5750R - 5766R MHW
4. 71K 5795R - 5806R MHW
5. 71K 5815R - 5829R MHW
6. 71L 8501R - 8509R MLW
7. 71L 8512R - 8520R MLW
8. 71L 8571R - 8580R MHW
9. 71L 8523R - 8530R MLW
10. 71L 8783R - 8791R MHW
11. 71L 8584R - 8593R MHW
12. 71L 8532R - 8537R MLW
13. 71L 9067R - 9080R MLW
14. 71L 8337R - 8341R MHW
15. 72K 6287R - 6298R MHW
16. 72K 6572R - 6584R MLW
17. 72K 6546R - 6563R MLW
18. 72K 6311R - 6330R MHW
19. 71L 8544R - 8559R MLW
20. 71L 8648R - 8662R MLW
21. 72K 6480R - 6499R MHW
22. 71L 8697R - 8705R MHW
23. 72K 6344R - 6350R MLW
24. 72K 6253R - 6255R MLW
25. 72K 6420R - 6423R MHW
26. 72K 6501R - 6515R MHW
27. 72K 6368R - 6382R MLW
28. 71K 5847R - 5856R MHW

Ratio points were located on twenty-eight (28) strips of infrared contact prints. Additional ratio points were located on contact prints which have a large portion of water coverage so that they could be individually enlarged to scale. A sketch showing the location of the infrared photographs is attached.
