TP-00971

NOAA FORM 76-35 (3-76) U.S. DEPARTMENT OF COMMERCE NATIONAL OCEANIC AND ATMOSPHERIC ADMINISTRATION NATIONAL OCEAN SURVEY	
<h2>DESCRIPTIVE REPORT</h2>	
<b>Map No.</b> TP-00971	<b>Edition No.</b> 1
<b>Job No.</b> CM-7715	
<b>Map Classification</b> Final Field Edited	
<b>Type of Survey</b> Shoreline	
<b>LOCALITY</b>	
<b>State</b> Florida	
<b>General Locality</b> Tampa Bay	
<b>Locality</b> Double Branch to Sweetwater Creek	
<div style="border: 1px solid black; padding: 5px; display: inline-block;">           1977 TO 1978         </div>	
<b>REGISTRY IN ARCHIVES</b>	
<b>DATE</b>

Coastal Zone Map TP-00971 is one of fourteen 1:10,000 scale and one 1:20,000 scale shoreline maps in Project CM-7715. These maps are intended for planning purposes for the state of Florida and for the construction and maintenance of NOS Nautical Charts.

CM-7715

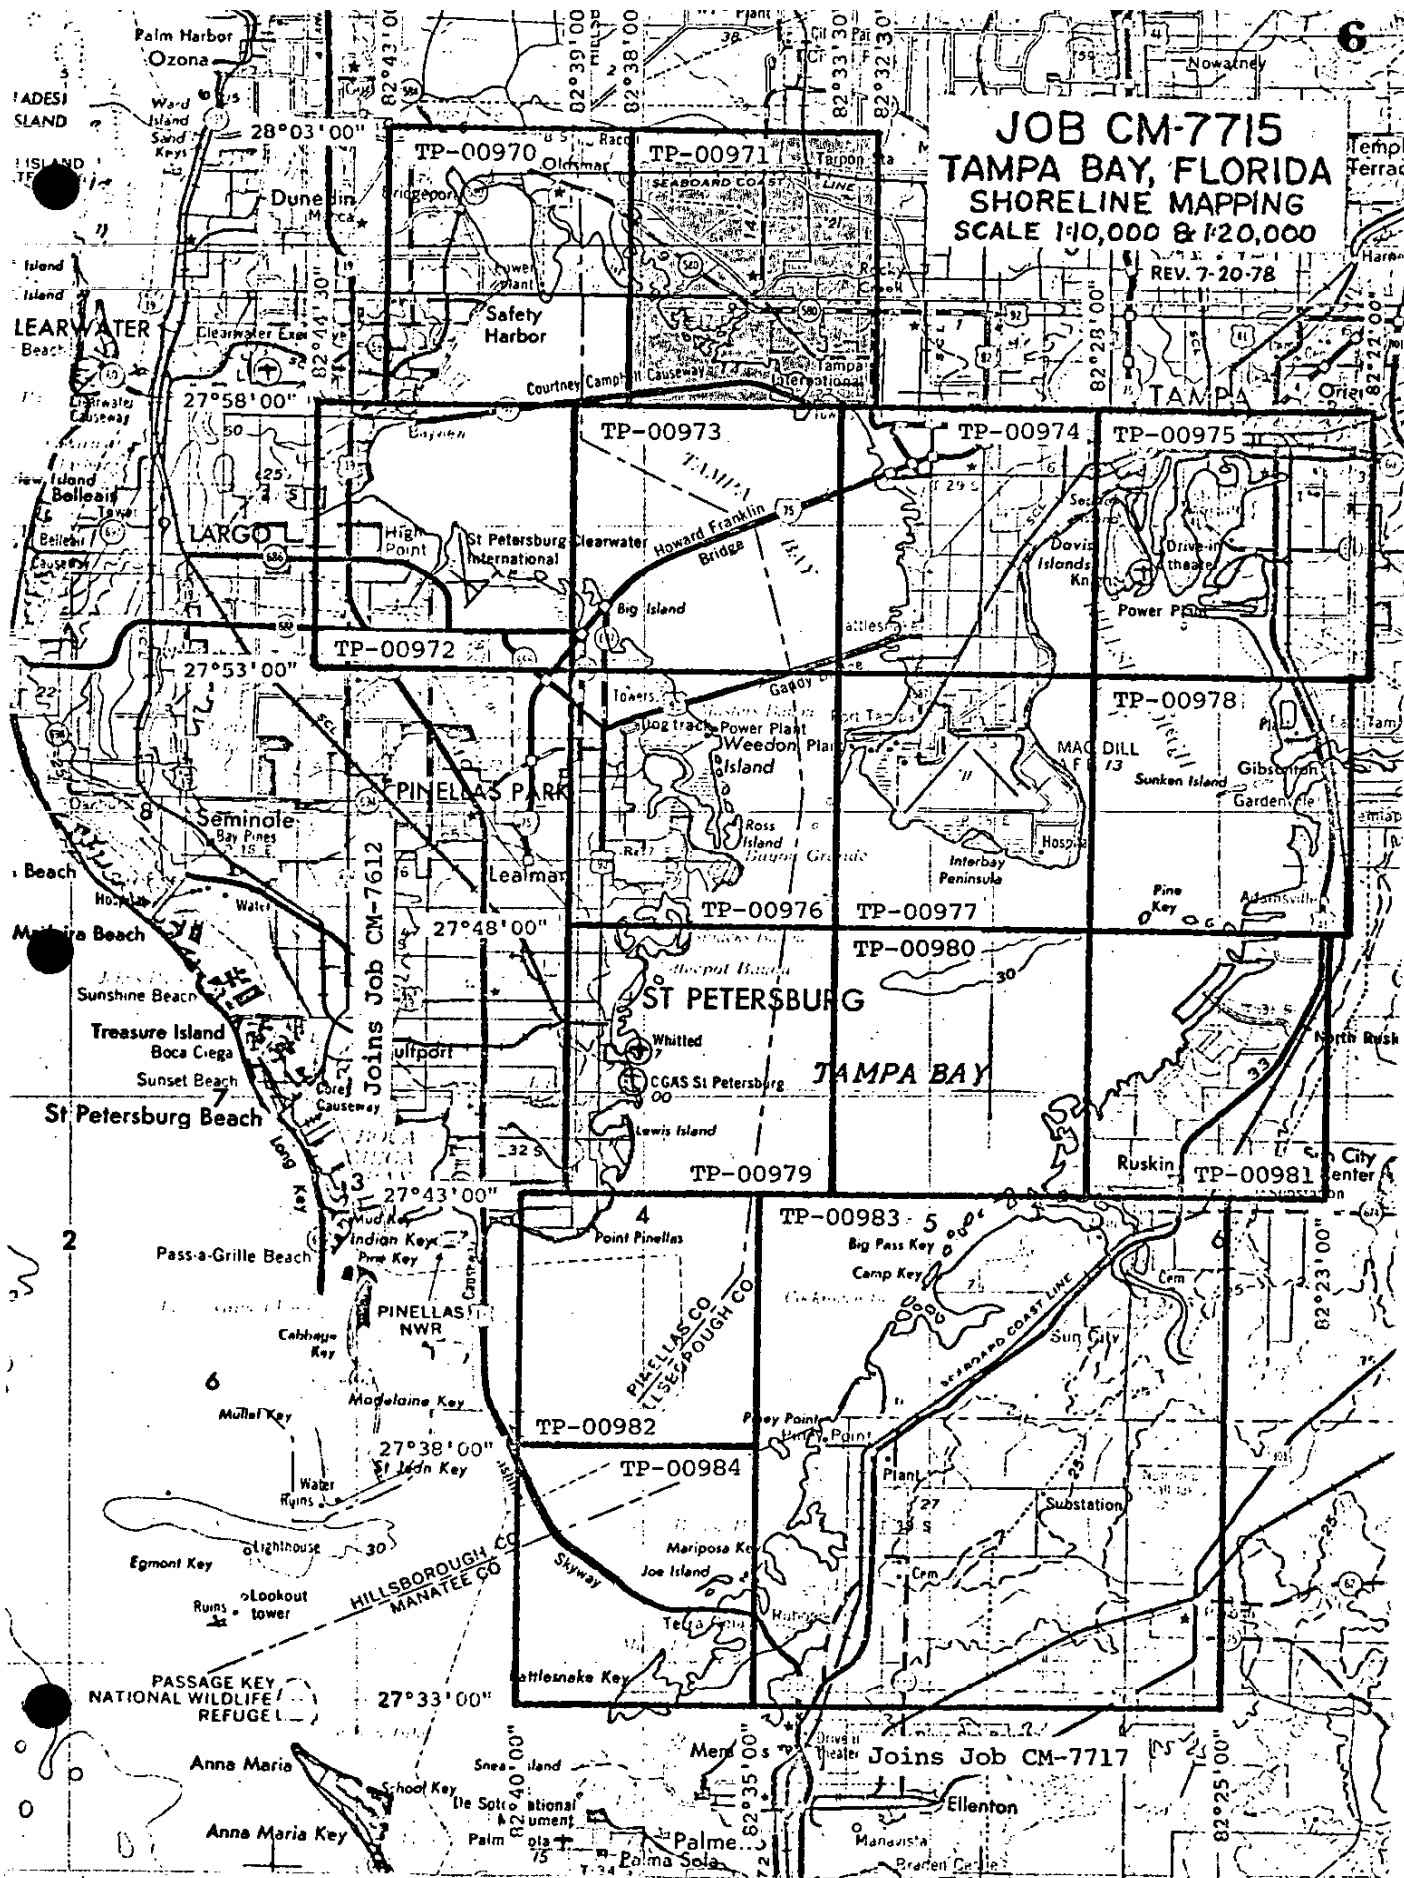
The layout for CM-7715 will show the location of the individual maps from Rattlesnake Key to Oldsmar, Florida. A copy of the layout is included in this Descriptive Report.
