| <h1>DESCRIPTIVE REPORT</h1> | |
| <b>Map No.</b><br>TP-00979 | <b>Edition No.</b><br>1 |
| <b>Locality</b><br>Snell Isle to Lewis Island | |

**JOB CM-7715**  
**TAMPA BAY, FLORIDA**  
**SHORELINE MAPPING**  
**SCALE 1:40,000 & 1:20,000**

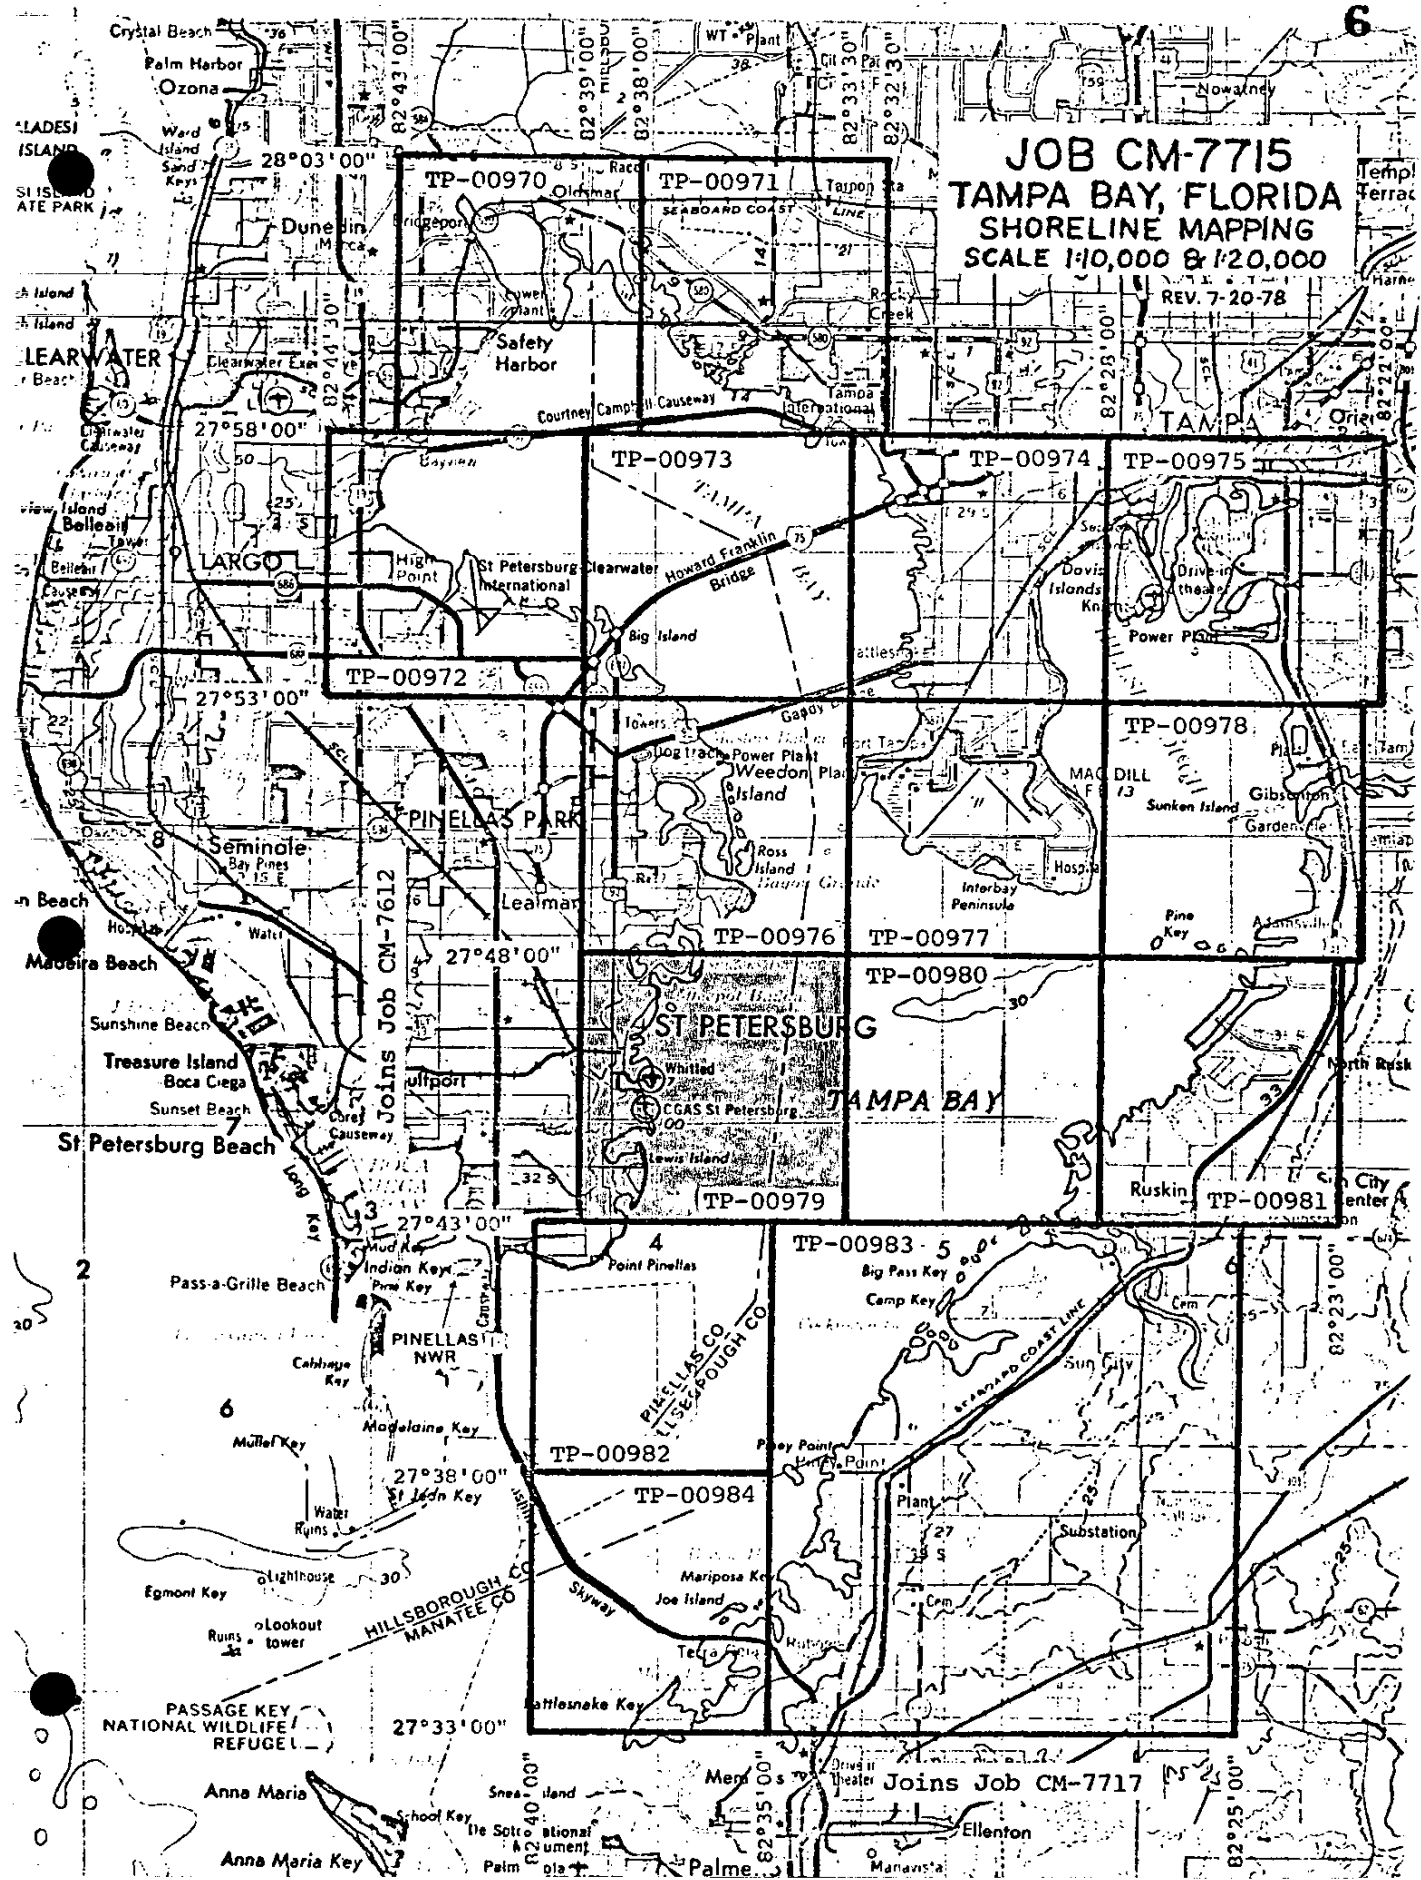
The layout for CM-7715 will show the location of the individual maps from Rattlesnake Key to Oldsmar, Florida. A copy of the layout is included in this Descriptive Report.
