APPENDIX A

REPORT ON THE INSTALLATION OF THE NATIONAL CORS PROTOTYPE MONUMENT

Written by
Dennis A. Hoar
Team Leader
Process Action Team 20
July 2000

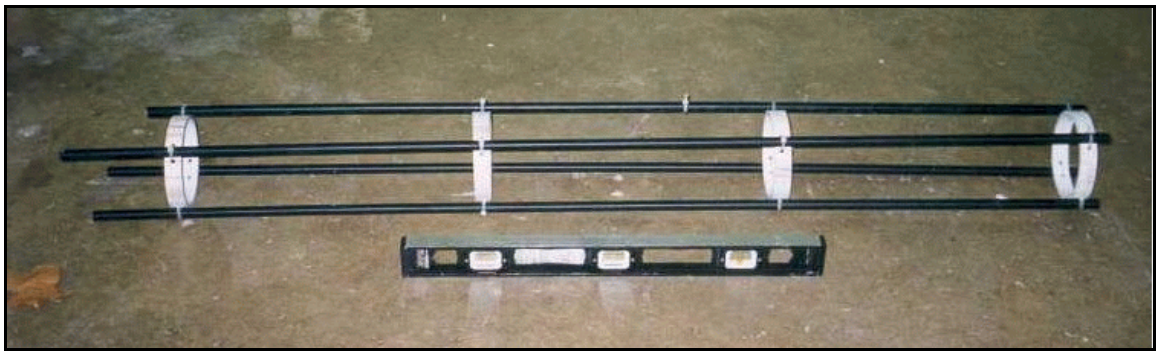
Figure 1

Shep Cofer performed the machining of the materials for the antenna mount (Figure 1). A lathe was used to smooth the edges of the 6-in.-diameter Delrin plate. The 1-in.-diameter Delrin rod was cut into three 1-ft.-long legs. Threads were machined at one end, a point

machined at the other, and groves machined in the sides to provide a place for the concrete to grip the legs. Holes for the legs and studs were drilled and tapped into the 6-in.-diameter plate. Three studs were machined from the 5/16- by 1-1/2-in.-long stainless steel bolts. The legs and studs were screwed into the plate. The feet were removed from a standard rotating tribrach adapter, the tribrach adapter was then placed onto the studs, and the set screws were tightened. The standard locking screw was removed from the adapter and replaced with a 10-32 by 1-1/2-in.-long stainless steel socket head cap screw. This will allow for tightening the locking screw after the antenna is in place. This antenna mount was placed in the top of the concrete pier.
