DESCRIPTIVE REPORT

Type of Survey TOPOGRAPHIC

State ALASKA

Locality ANCHUTKA ISLAND

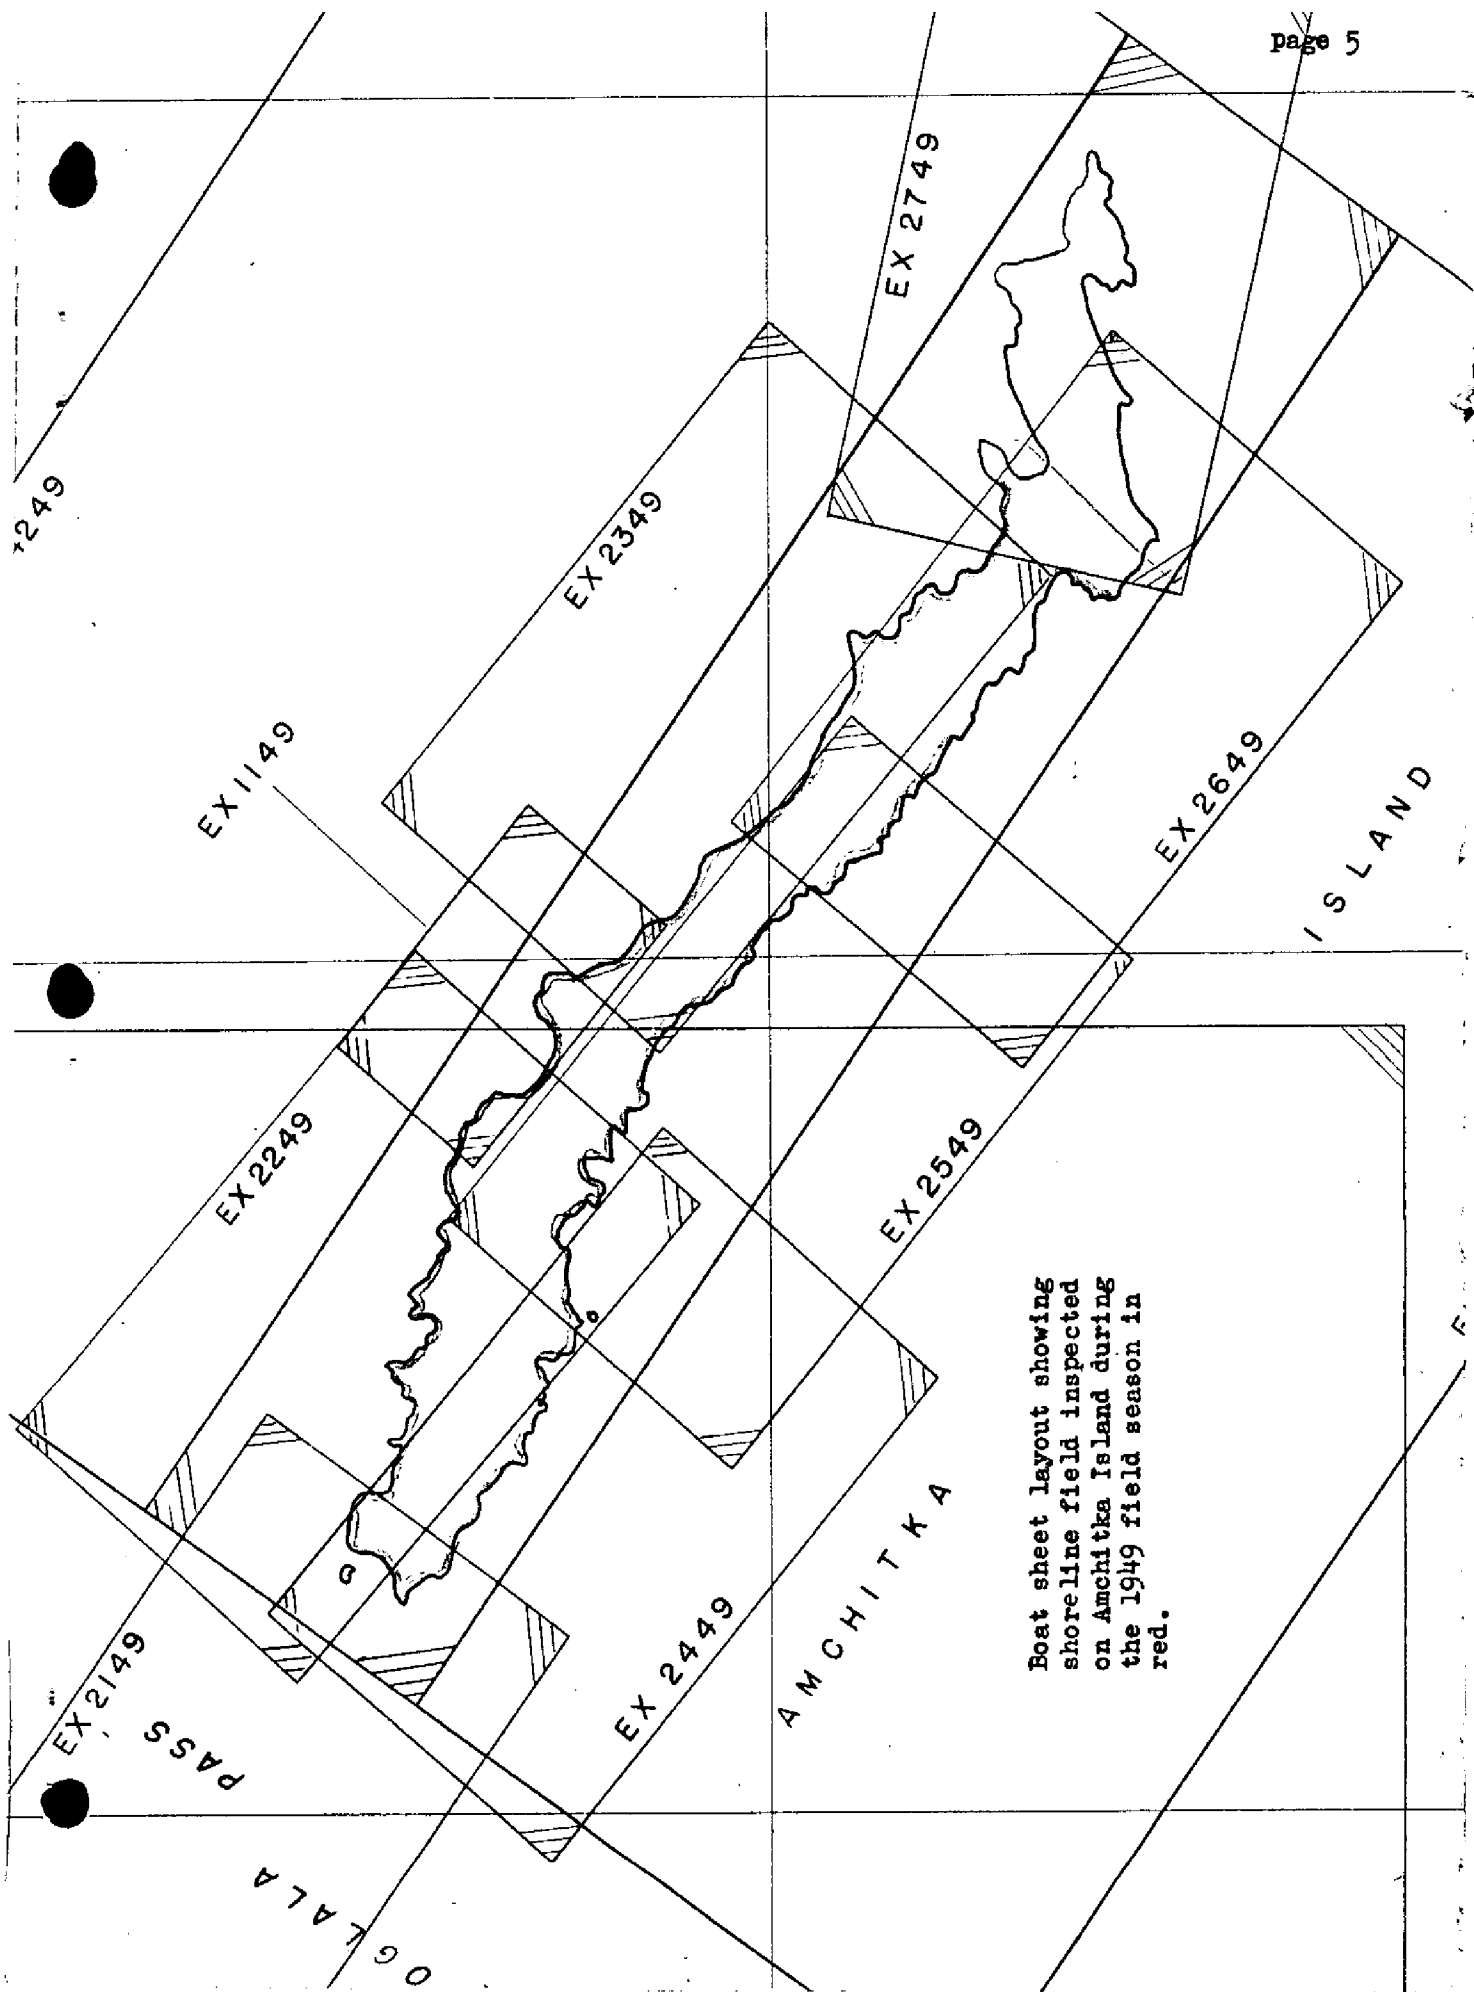
Boat sheet layout showing  
shoreline field inspected  
on Amchitka Island during  
the 1949 field season in  
red.

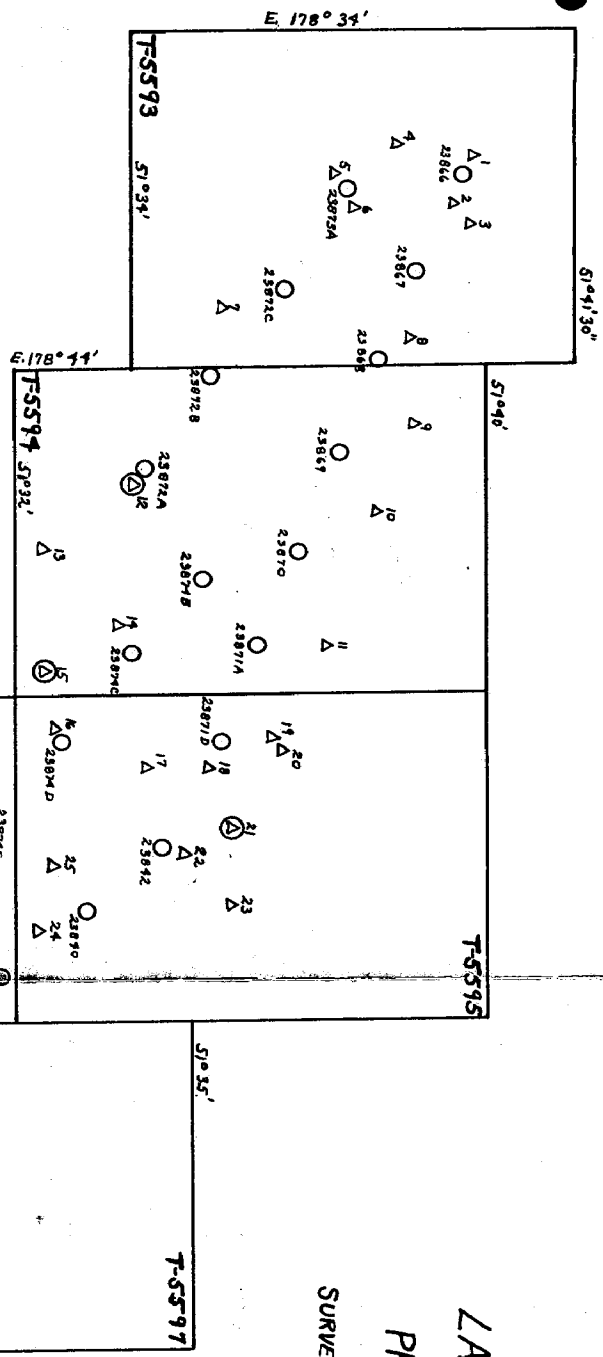
Fig. 1.

- Office Photographs
- △ Triangulation Stations (Identified in field)
- ▲ Triangulation Stations (Identified in Office)
- ⊙ Triangulation Stations (Not Held in Radial Plot)

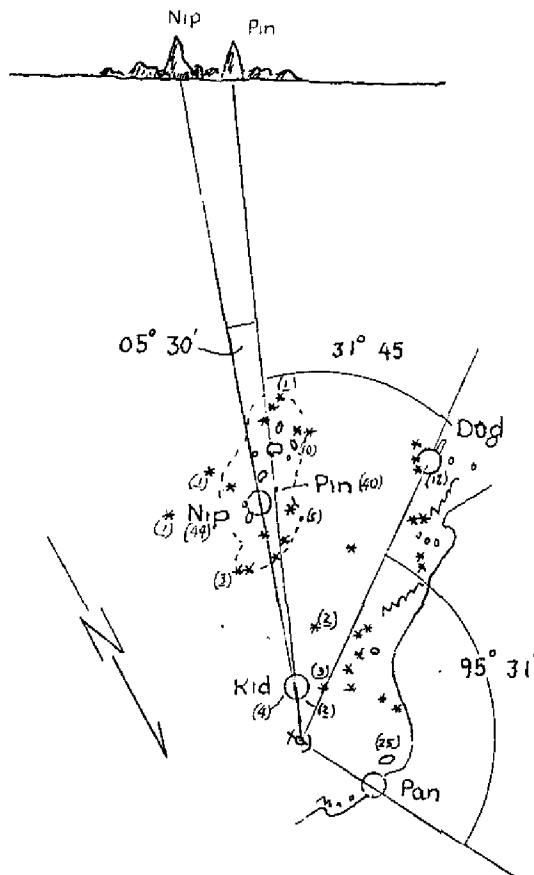
## ELEVATION OF RECOVERABLE H. and T. STATION NIP. 1945

Manuscript T-5599  
 Lat.  $51^{\circ} 21' N$ .  
 Long.  $179^{\circ} 20' E$ .  
 14:45, 28 May 1950

Sextant angles taken from anchored launch. Three point fix with check angle plotted on vinylite copy of map manuscript. Distance from launch position to NIP scaled. Vertical angle to top of pinnacle (NIP) read on and off the sextant circle.

Mean vertical angle  $01^{\circ} 13'.7$   
 Horizontal distance 640 m.
