U. S. COAST AND GEODETIC SURVEY

DESCRIPTIVE REPORT

Type of Survey TOPOGRAPHIC

Locality ANCHUTKA ISLAND

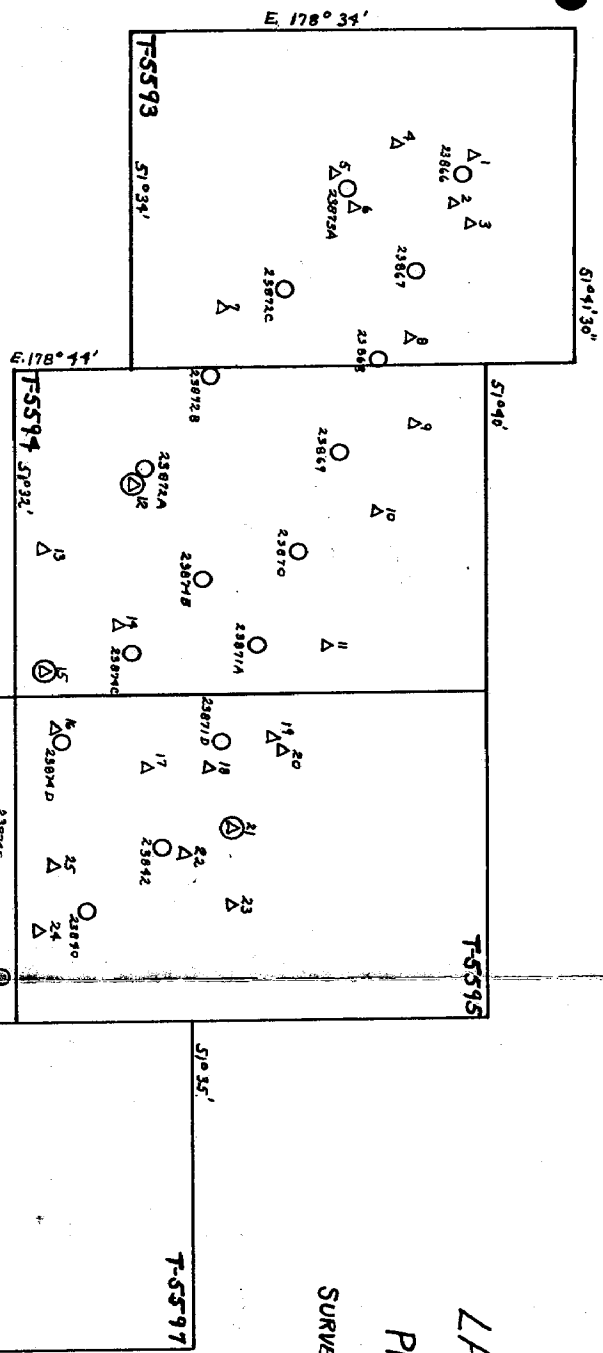
Fig. 1.

- Office Photographs
- △ Triangulation Stations (Identified in field)
- ▲ Triangulation Stations (Identified in Office)
- ⊙ Triangulation Stations (Not Held in Radial Plot)
