DESCRIPTIVE REPORT

Type of Survey TOPOGRAPHIC

Field No. PH-3 (LR) Office No. T-5593 50  
T-5600 incl.

Locality ANCHUTKA ISLAND

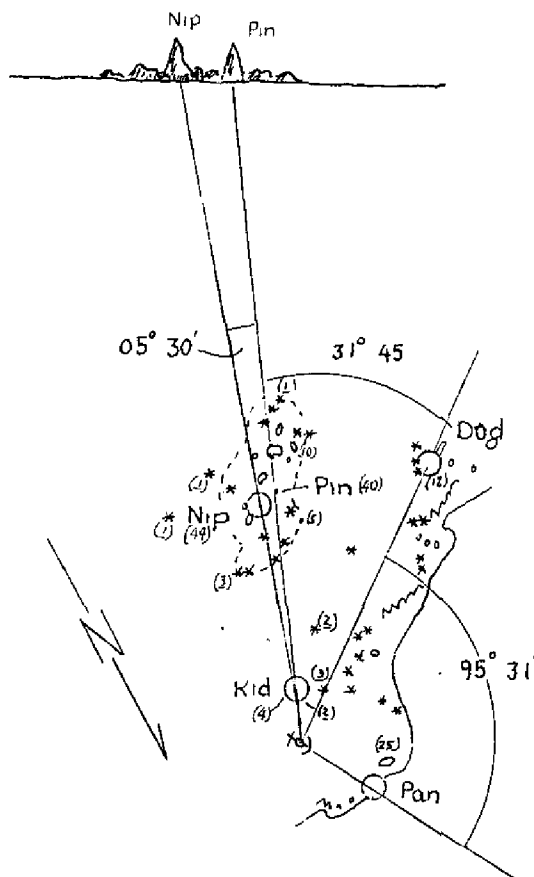
## ELEVATION OF RECOVERABLE H. and T. STATION NIP. 1945

Manuscript T-5599  
 Lat.  $51^{\circ} 21' N$ .  
 Long.  $179^{\circ} 20' E$ .  
 14:45, 28 May 1950

Sextant angles taken from anchored launch. Three point fix with check angle plotted on vinylite copy of map manuscript. Distance from launch position to NIP scaled. Vertical angle to top of pinnacle (NIP) read on and off the sextant circle.

Mean vertical angle  $01^{\circ} 13'.7$   
 Horizontal distance 640 m.
