DESCRIPTIVE REPORT

Type of Survey TOPOGRAPHIC

Field No. PH-3 (LR) Office No. T-5593 50
T-5600 incl.

Locality ANCHITKA ISLAND

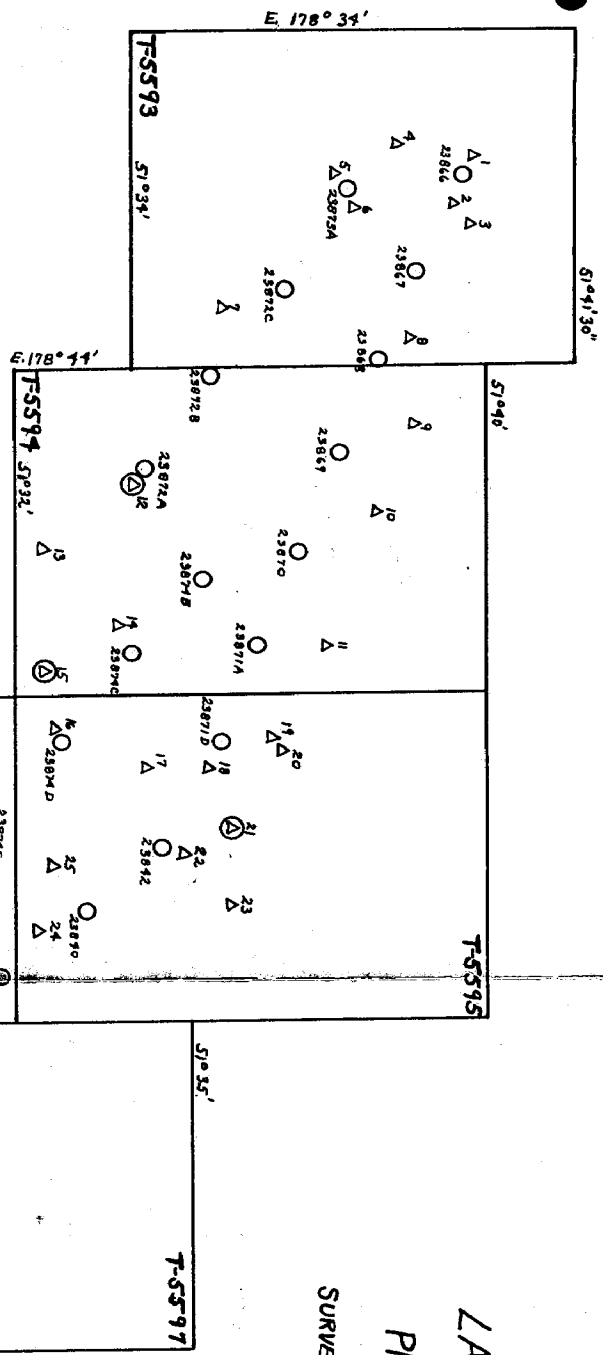
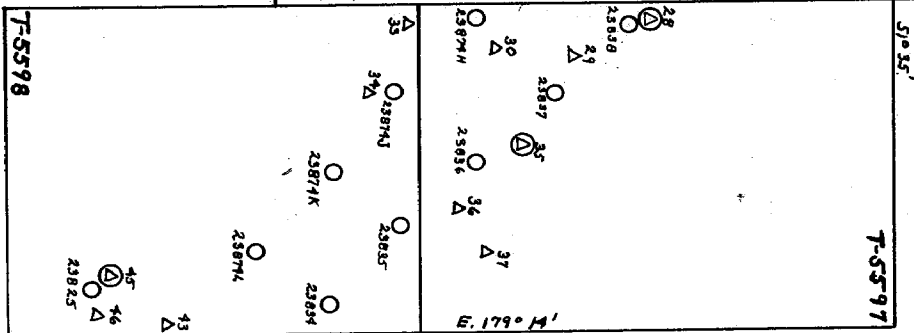
Fig. 1.

- Office Photographs
- △ Triangulation Stations (Identified in field)
- ▲ Triangulation Stations (Identified in Office)
- ⊙ Triangulation Stations (Not Held in Radial Plot)

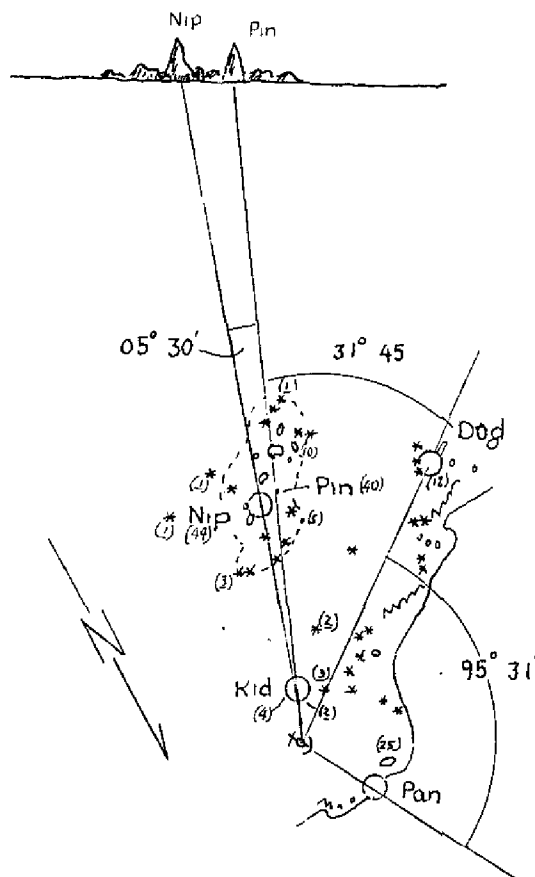
ELEVATION OF RECOVERABLE H. and T. STATION NIP. 1945

Manuscript T-5599
 Lat. $51^{\circ} 21' N$.
 Long. $179^{\circ} 20' E$.
 14:45, 28 May 1950

Sextant angles taken from anchored launch. Three point fix with check angle plotted on vinylite copy of map manuscript. Distance from launch position to NIP scaled. Vertical angle to top of pinnacle (NIP) read on and off the sextant circle.

Mean vertical angle $01^{\circ} 13'.7$
 Horizontal distance 640 m.
