TP-00387

DESCRIPTIVE REPORT

JOB PH-7108  
 SAN CLEMENTE ISLAND  
 CALIFORNIA  
 SHORELINE MAPPING  
 SCALE: 1:5,000 & 1:10,000

AEROTRIANGULATION SKETCH  
SAN CLEMENTE ISLAND, CALIF.

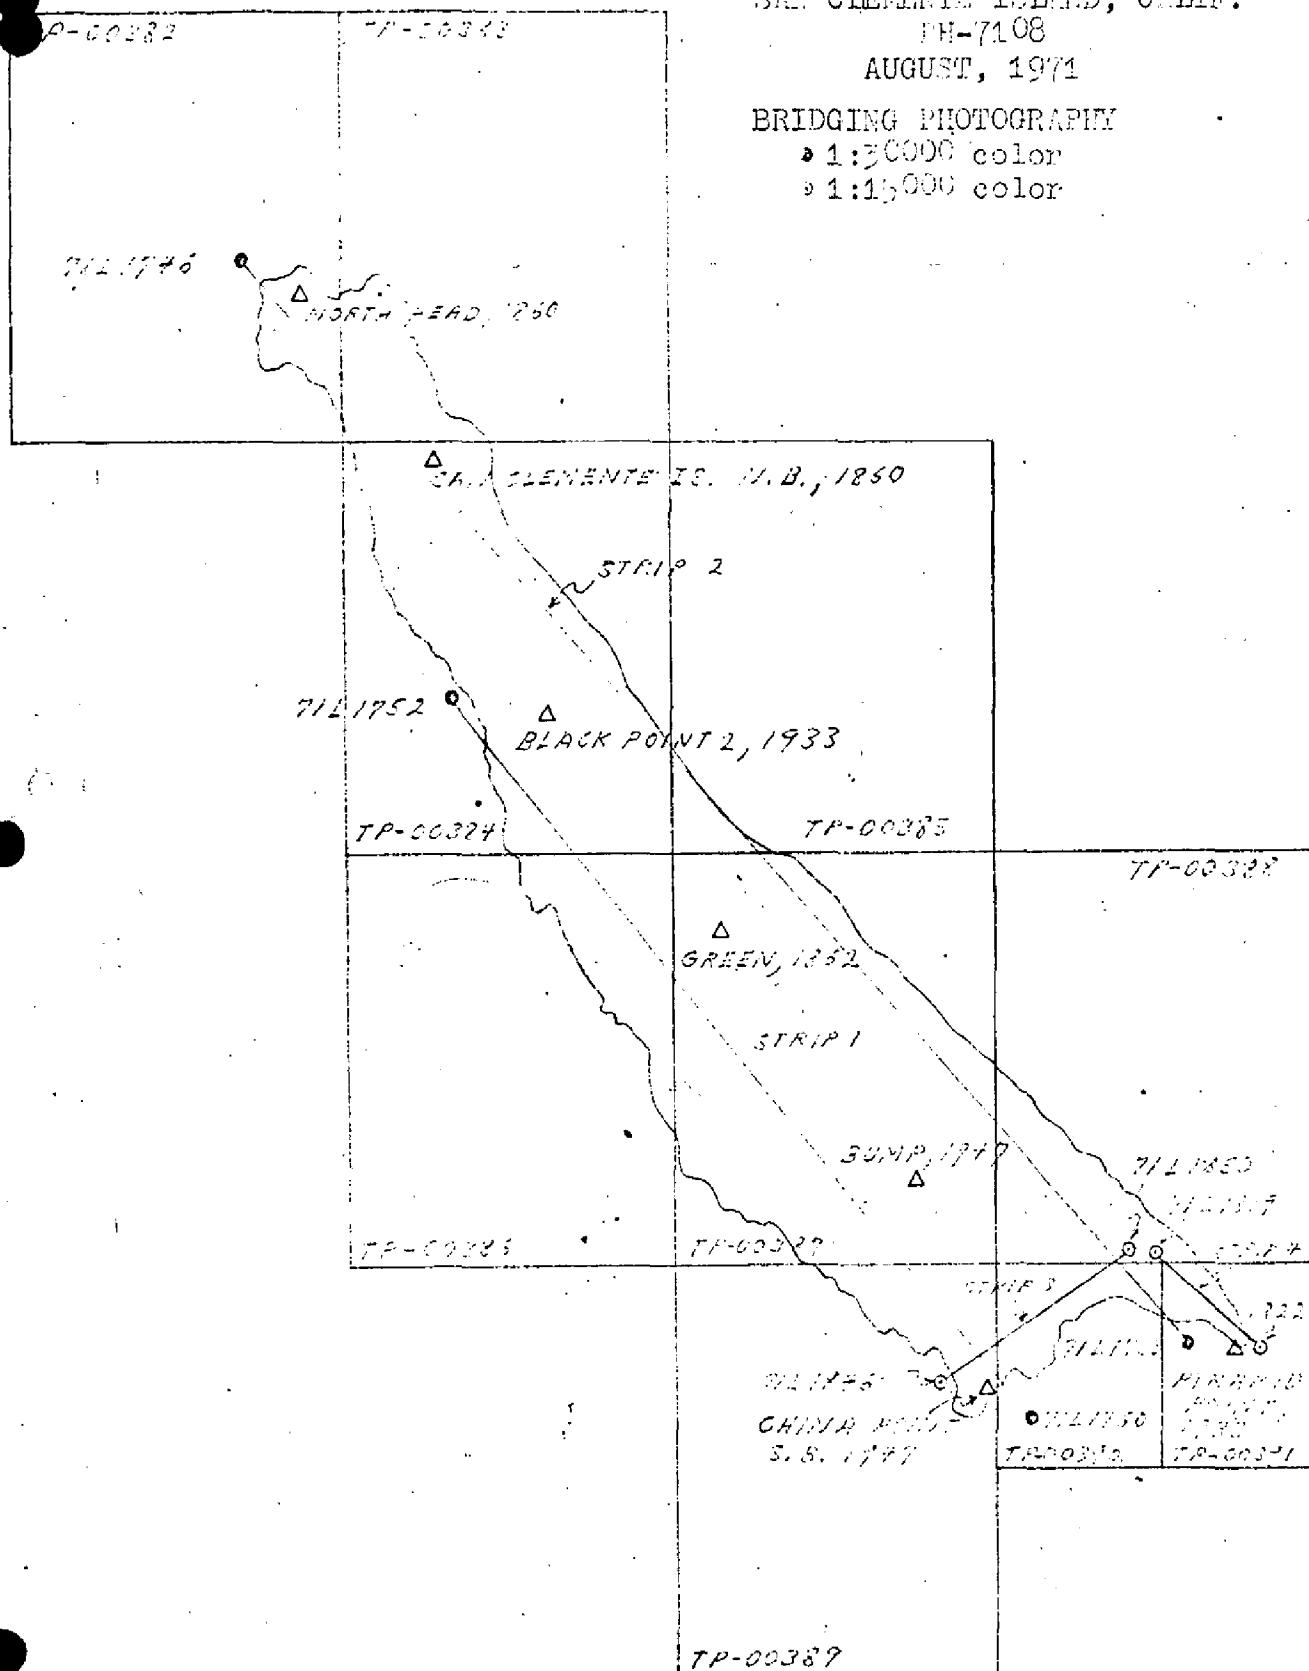
## BRIDGING PHOTOGRAPHY

- 1:30000 color
- 1:15000 color

Two strips of 1:30,000 scale photography (71-L-1733 thru 1746 and 71-L-1752 thru 1760) and two strips of 1:15,000 scale photography (71-L-1819 thru 1822 and 71-L-1846 thru 1850) were bridged by analytic triangulation methods. The
