## DESCRIPTIVE REPORT

Job No. PH-7119..... Map No. TP-00444.....

Locality Flat Point.....

SUMMARY  
for  
TP-00444 thru TP-00454

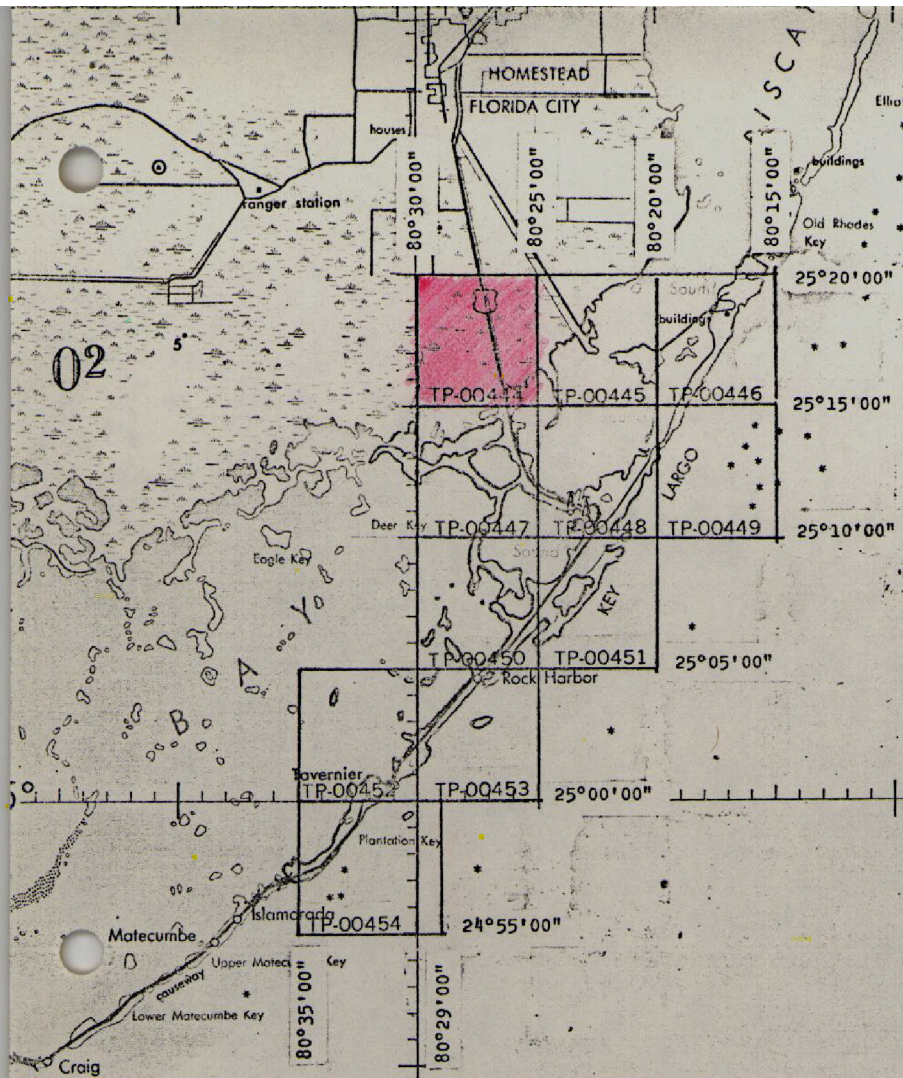
JOB PH-7119  
CARD SOUND to PLANTATION KEY  
FLORIDA  
SHORELINE MAPPING  
SCALE 1:10000

A layout of Job PH-7119 (revised since the aerotriangulation operation) will show the location of the individual maps. A copy of this layout is included in this Descriptive Report.

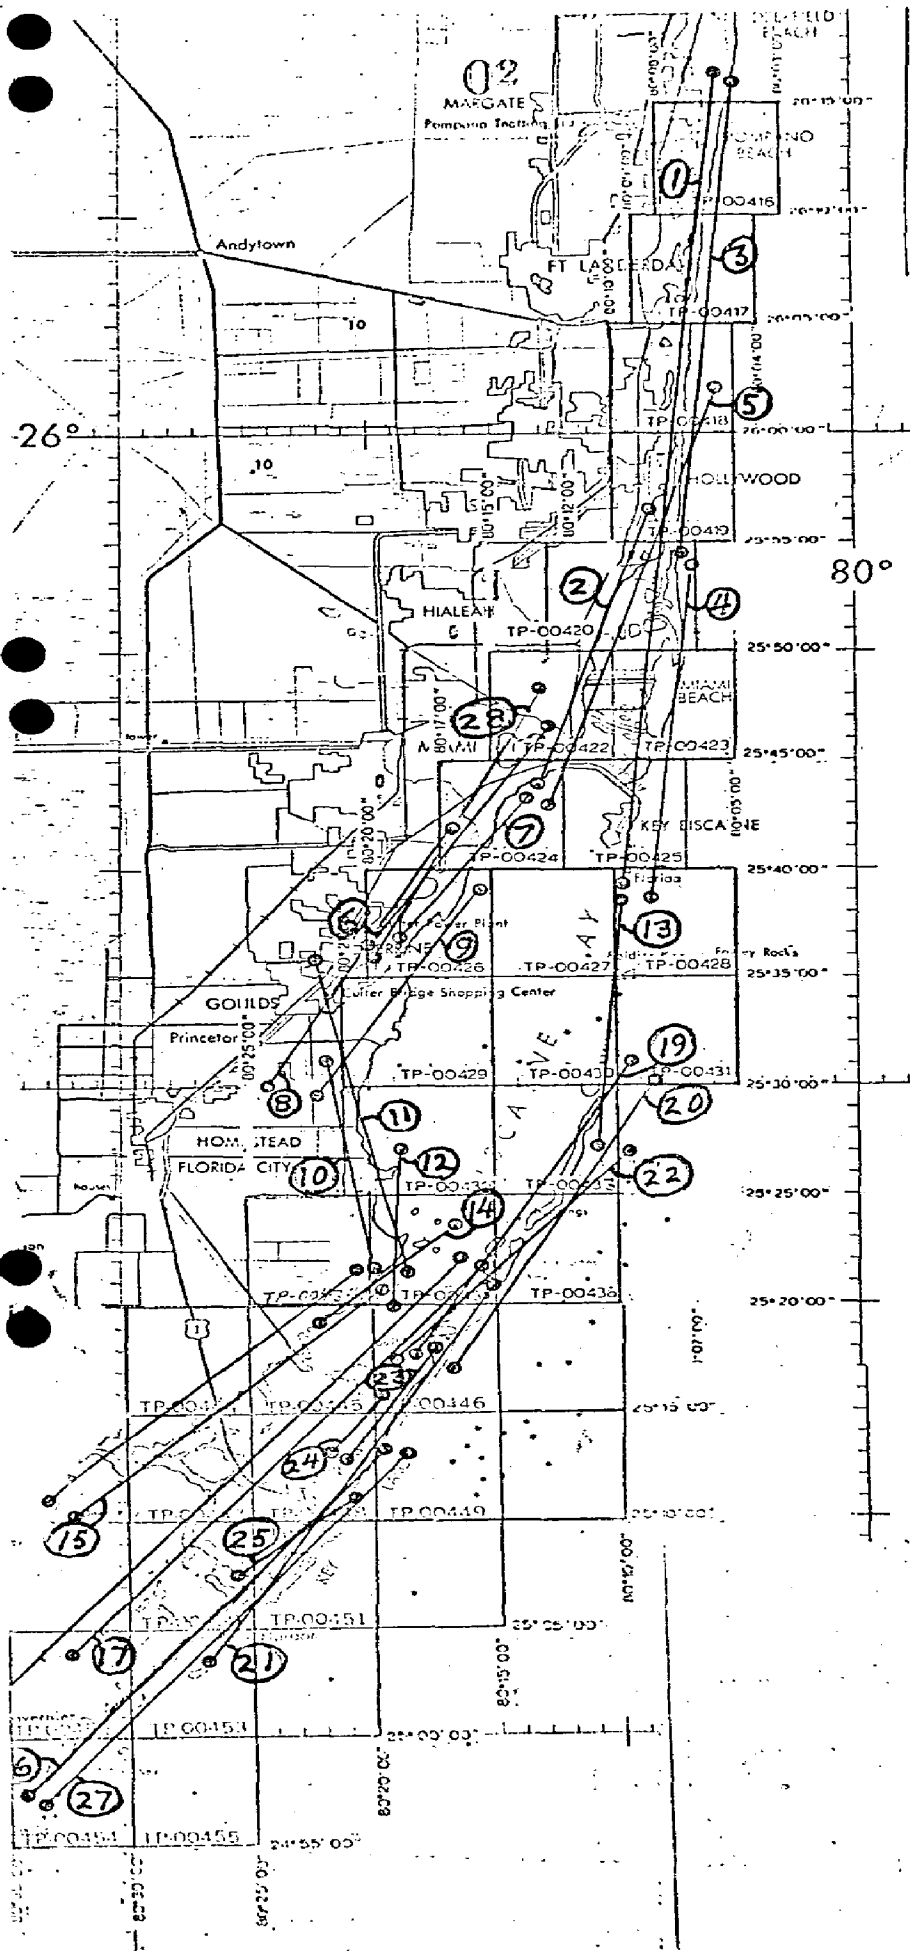
JOB PH-7113  
AND  
JOB PH-7119

HILLSBORO INLET  
TO  
PLANTATION KEY,  
FLORIDA

Due to the placement of control in relation to flight lines and due to large areas of water coverage, two block adjustments were made. Strip No. 2, No. 3, and No. 4 comprised one block. Strip No. 7, No. 9, No. 10, and No. 11 comprised the other block. Attached is a sketch showing the location of the strips and the blocks.
