DESCRIPTIVE REPORT

Type of Survey Shoreline

Job No. CM-7413 Map No. TP-00894

Locality Moraine Island

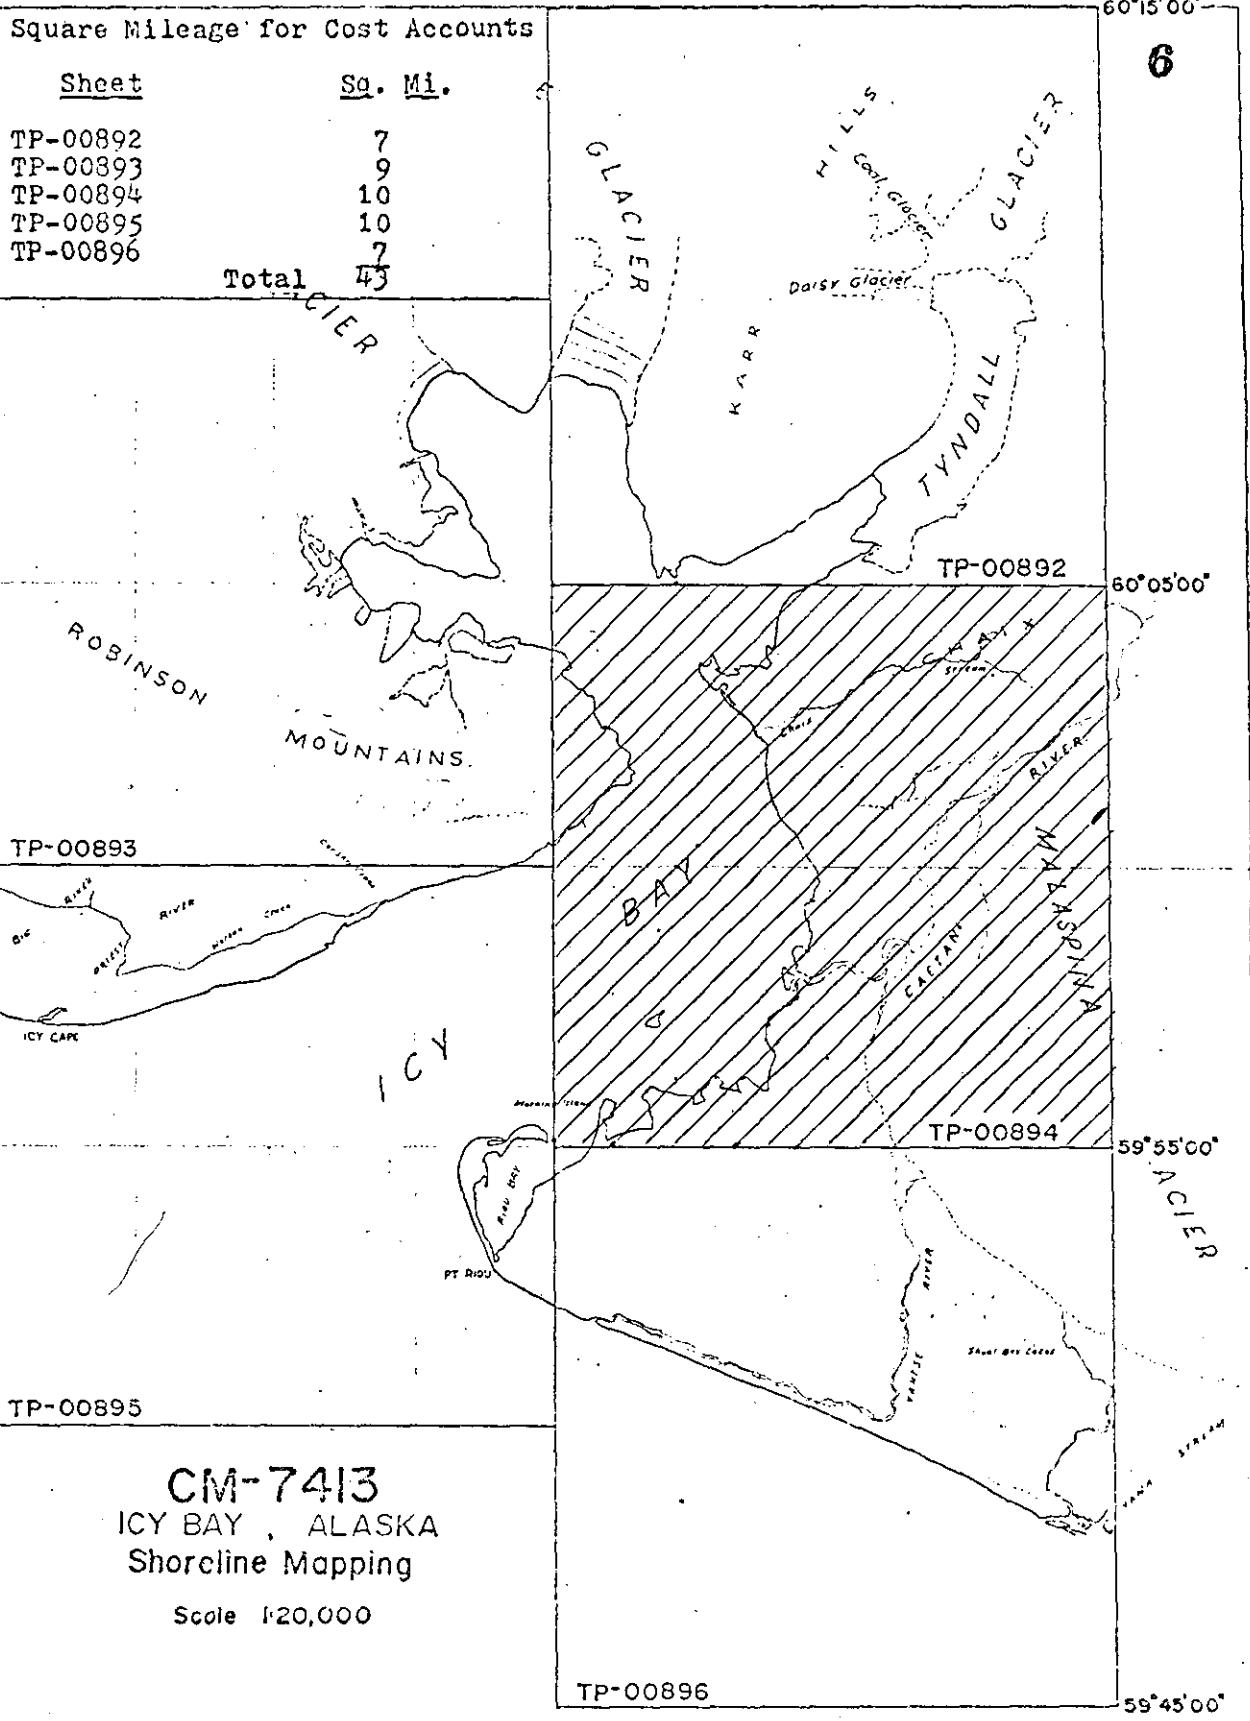
CM-7413
ICY BAY, ALASKA
Shoreline Mapping

Scale 1:20,000

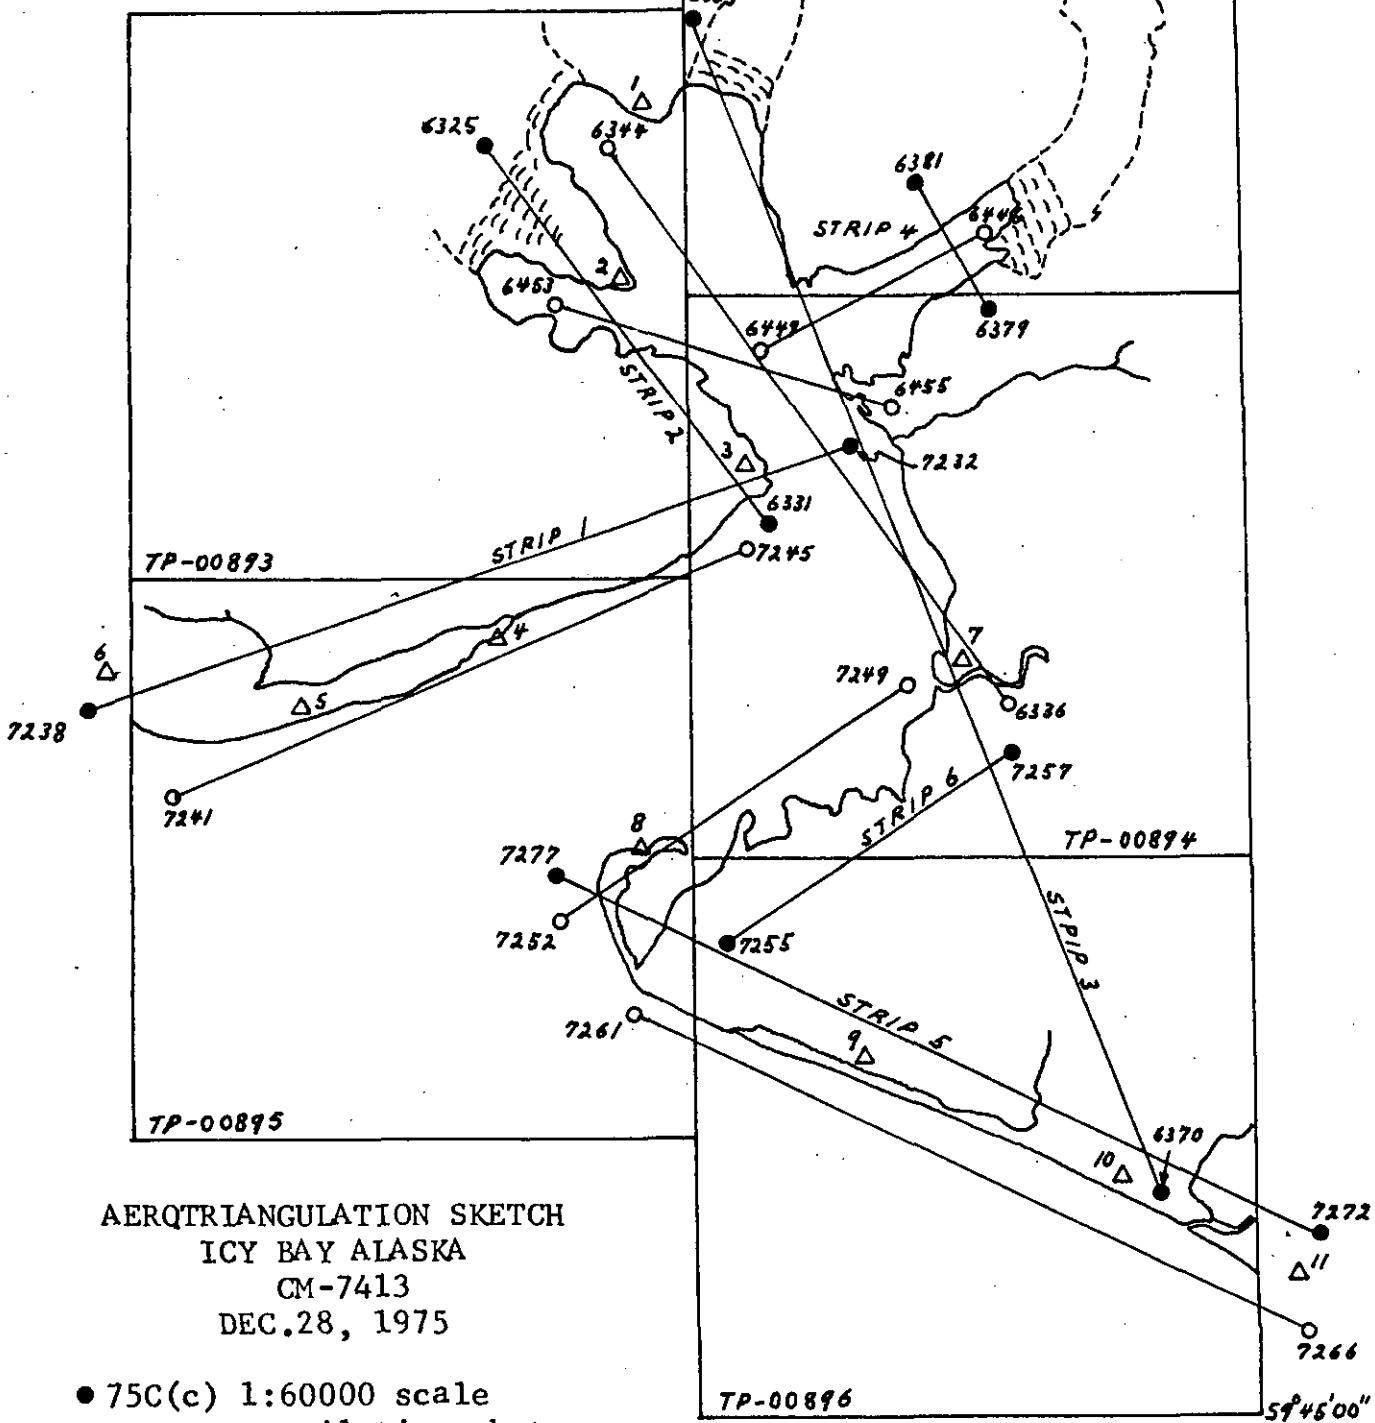
AEROTRIANGULATION SKETCH
ICY BAY ALASKA
CM-7413
DEC. 28, 1975

- 75C(c) 1:60000 scale compilation photos
- 75C(c) 1:60000 scale ratio photos

Fit to Control
(in feet)

Strip 1

3 KICHYATT	+0.2, +0.4
4 CARSON	-1.6, -1.2
5 WATSON	+1.2, -1.2
6 STOR	-1.0, 0.2

Strip 2

1 GUYOT	0.0, 0.0
2 TOYUG	0.0, 0.0
3 KICHYATT	0.0, 0.0

Strip 3

1 GUYOT	-0.6, -0.6
2 TOYUG	-0.5, +0.5
3 KICHYATT	+2.7, +1.1
7 CAETANI	-1.9, -1.1
10 YAHTSE	+0.3, 0.0

Strip 5

11 YANA	-1.3, +0.4
10 YAHTSE	+3.0, -1.0
9 JARL	-2.2, +1.0
8 RUNT	+0.5, -0.4

Strip 6

9 JARL	-2.7, +6.7
8 RUNT	-4.0, +2.1
7 CAETANI	-0.4, -0.8

Photogrammetric Plot Report
Icy Bay, Alaska
CM-7413
December 28, 1975

22. Method: Five strips of color photography at 1:60,000 scale were bridged by analytic aerotriangulation methods. The strips were adjusted to ground in the Alaska, zone 2 state plane coordinate system.

Points were established for setting one model (strip 4) of 1:60,000 scale photography. Points were also established for determining ratios of 1:60,000 scale offshore photography. Points for compilation were plotted by the Coradomat. Ratios were ordered.
